JOB REFERENCE: XXXXX

RESIDENTIAL BUILDING SURVEY

XXX
Roxton
Bedfordshire
MK44 XXX

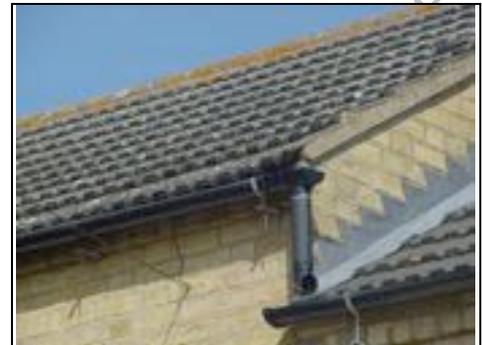
The original roof covering would have been slate. This has been replaced with a heavier concrete tile. Modern Building Regulations require a traditional structural support is provided where this takes place. We can't see any obvious additional support that has been added and equally we cannot see any significant movement in the timbers.

Main roof

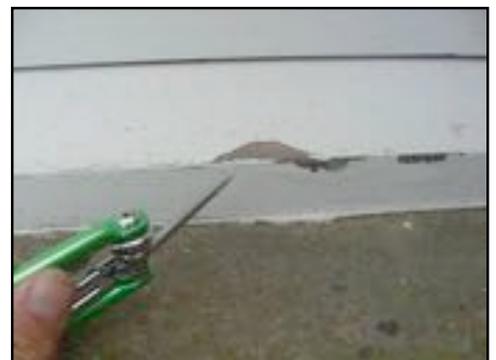
We noticed that some of the paint was flaking on the timber windows and bare timber was visible. We also noticed some areas had been filled in.

Flaking paint to timber windows

ACTION REQUIRED: Ideally repair, prepare, and redecorate in the summer of XXXX. We certainly wouldn't leave it longer than the summer of XXXX.

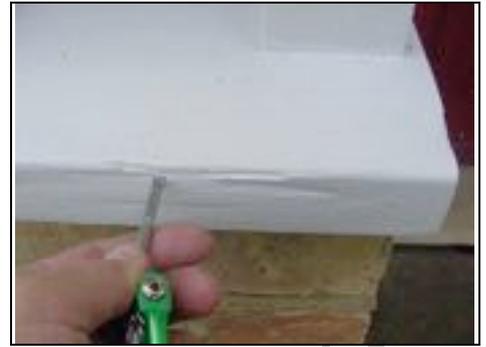
Deterioration to windows

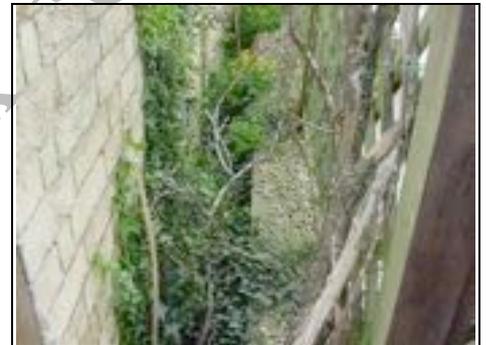
We believe there are some high ground levels to the property. We are recording high damp meter readings to the right hand side of the property. If you recall we visited next door and the existing owner, we believe, agreed to reduce the ground level in that area. The vegetation also needs to be cleared out.

Vegetation to right side area

ACTION REQUIRED: Ideally a French drain should be added to the rear of the property. As mentioned this is complicated by the garage to the rear which we have not seen inside. You do need to check this to see if there are airbricks within and if there is a concrete floor because a concrete floor will act like blotting paper against the property.

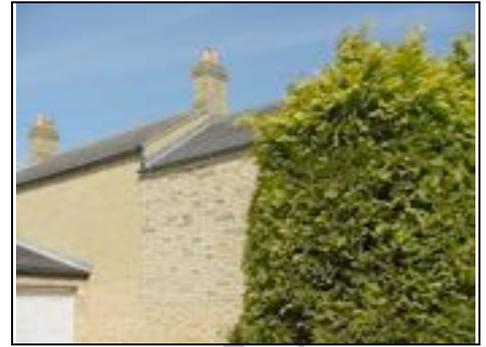
Large bush / tree

ACTION REQUIRED: Have another 'cup of tea' meeting with the rear neighbours (the neighbours with the high ground level and garage to rear) and ask them about the tree and advise that the Surveyor was concerned about it (there looks to have been some historic cracking that could relate to this on the gable end).

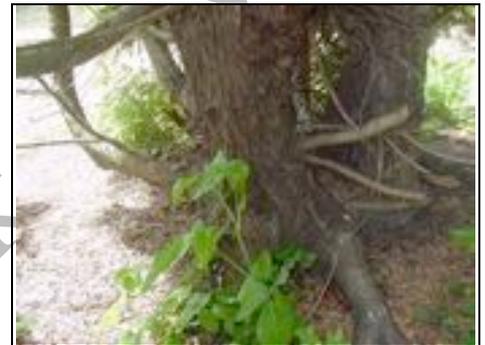
Base of large tree

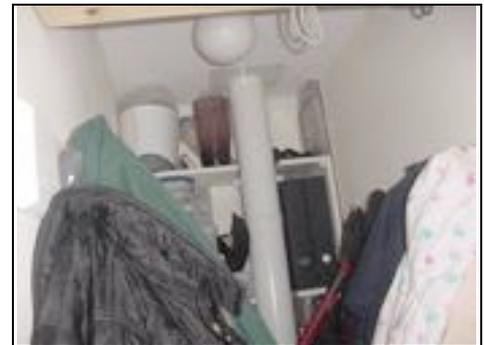
We are advised the boiler is relatively new, we could not see it due to the amount of stored items in the cupboard. We were pleased to see a plastic oil tank, typically these are double lined. We would recommend that the system be tested and overhauled before exchange of contracts and that a regular maintenance contract be placed with an approved heating engineer.

Stored items in boiler cupboard

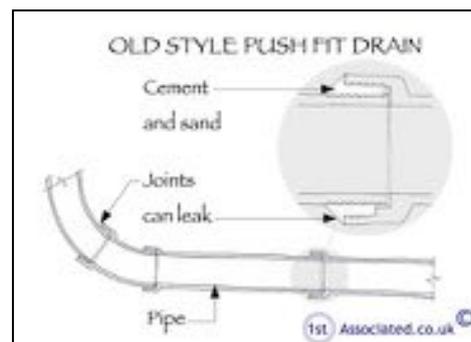
In older properties, such as this, drainage was often push fitted together rather than bonded together which means that they may leak over the years. Whilst we ran the tap for 15 minutes without any build up or blockages the only way to be 100% certain of the condition of the drains is to have a closed circuit TV camera report.

Push fit drain

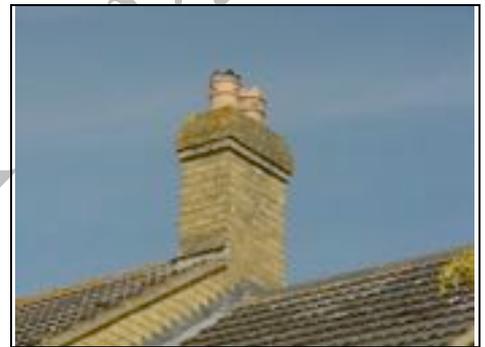
Left hand chimney

ACTION REQUIRED: In the next few years have a close inspection of the chimney.

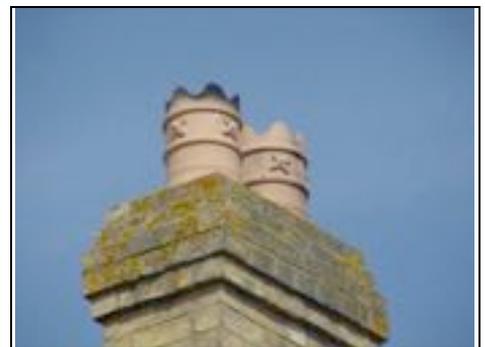
Minor moss

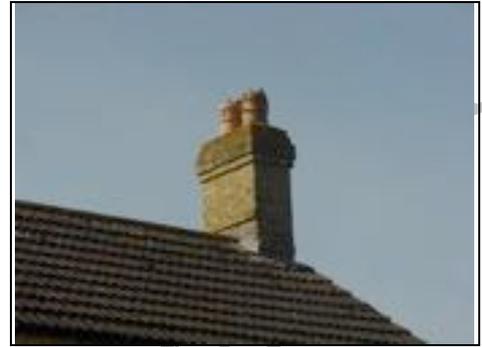
This chimney is brick finished with a lead flashing and two decorative chimney pots. From what we could see from ground level it looked in average condition considering its age, type and style. There is some moss at the top and there is a slight lean to the chimney.

Right hand chimney

ACTION REQUIRED: As per the left chimney.

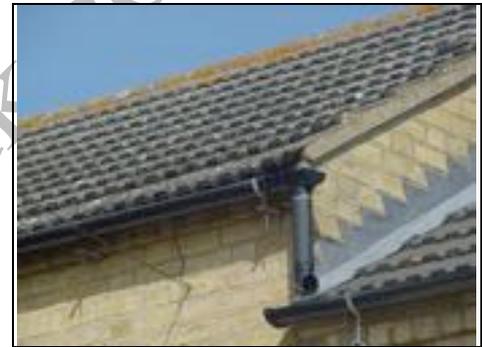
A heavier concrete tile has replaced the original slate (we did find some old slate tiles underneath the insulation in the right hand roof) and therefore there should be additional roof support which there isn't in this case.

Main Roof

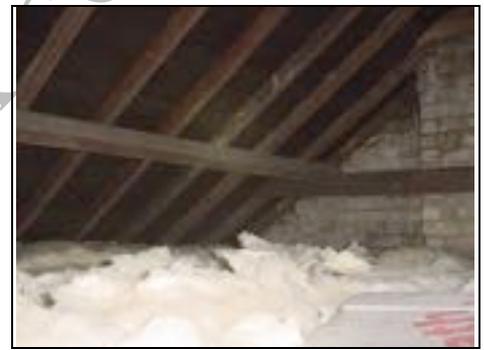
When we inspected the loft space we found a Hessian base Bitumen membrane to the right hand side. This type of membrane has been used since the 1960s. We generally found it to be in average condition, with damage in some areas which is what we typically find.

This photo shows the common rafters (the ones that form the pitch of the roof) and the dark area between is the underlayer

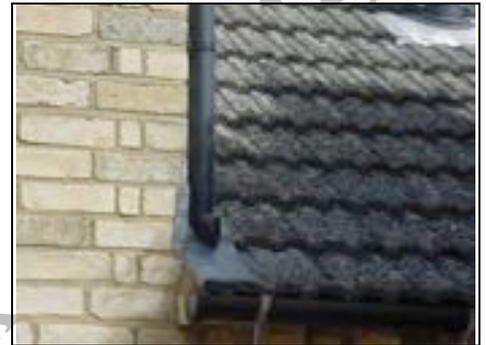
All the water from the main roof is surcharging onto the smaller roof to the rear of the property. We believe that the guttering may have trouble coping and may overflow.

Surcharging gutters and downpipes

We also recommend that the gutters and downpipes are cleaned out, the joints are checked and the alignment checked to ensure that the gutters fall towards the downpipes.

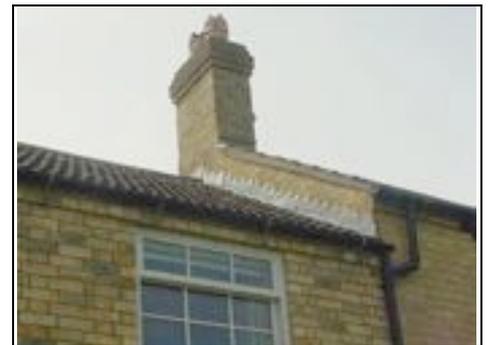
Overloading of gutters and downpipes

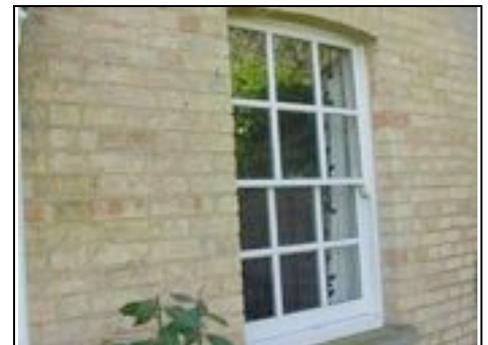
The property has modern double glazed timber sliding sash windows. The modern version of these sliding sash windows does not tend to have the problems of the older version unless it has been put in badly. These look in reasonable condition although there are some areas of soft rot.

Modern sliding sash window with double glazing

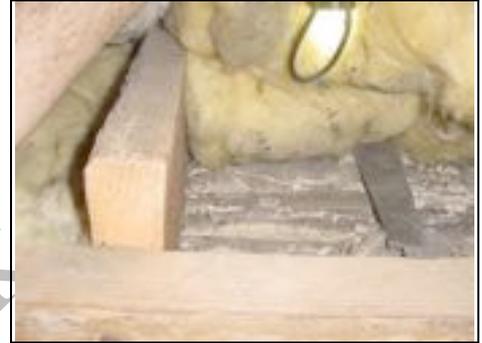
In the older part of the property on the right hand side there was originally lath and plaster ceilings; when we lifted the insulation in the roof space we could see the lath and plaster. It is not in very good condition and had loosened the grip on the lath.

Lath and plaster

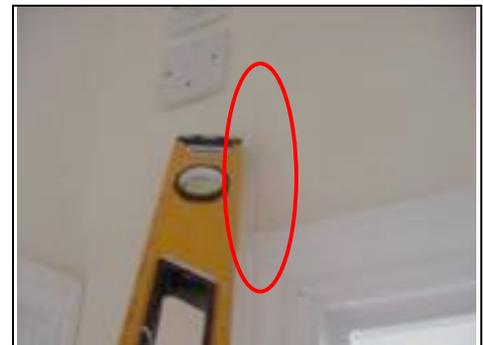
We can see a vertical crack between the new and old that looks to have been filled and painted over. This is effectively the focal point of any movement.

Hairline cracking

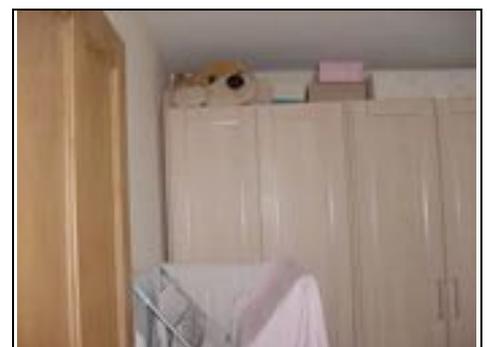
Washing drying in the right hand bedroom

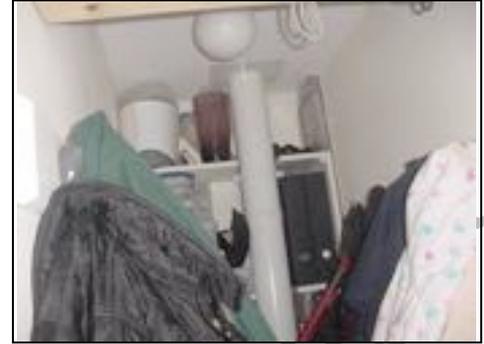
The wall mounted Worcester Bosch boiler was located in the ground floor cupboard. Unfortunately we could not see it due to all the stored items. We are advised the boiler was installed in 2007/2008.

Stored items in boiler cupboard

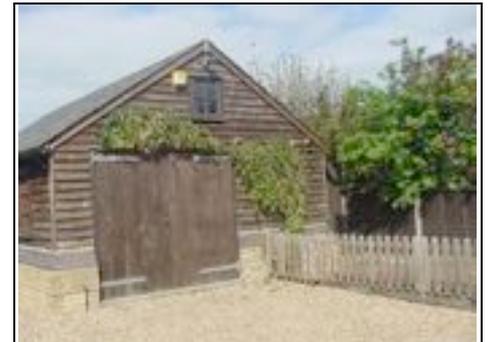
There is a substantial garage/workshop area. We were shown that it has electricity and an outside water supply. The current owner has put a lean-to type structure around it; we discussed the roofing of this with them and they said they had found problems with the corrugated roof that they had used and that it sagged and seemed to need a lot of support.

Garage and workshop
