RESIDENTIAL BUILDING SURVEY

XXXXXXXXXXXXXXXXXX,

**London,
SW3 xxxx**

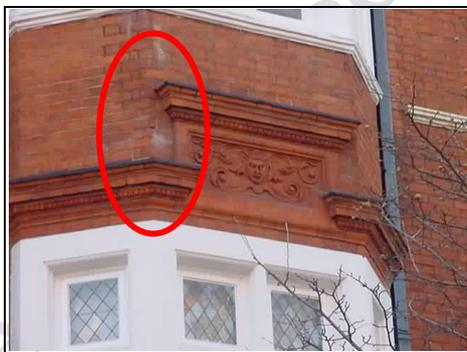
We can see pattern staining to the brickwork and areas that need repairs. We feel there should have been more repairs carried out to the external brickwork of the property.

Pattern staining;
repointing required

ACTION REQUIRED: Brickwork repairs and repointing and attention to the detailing of the brickwork.

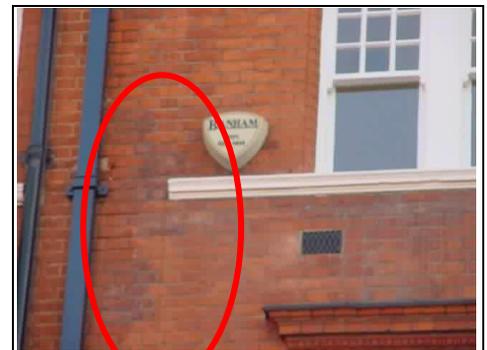
Repointing required

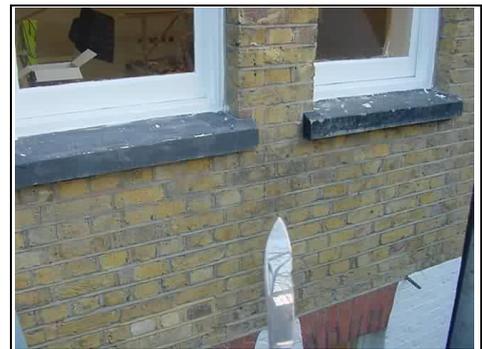
Hairline cracking can be seen to the rear bay through the brickwork in some areas.

Hairline cracking

ACTION REQUIRED: Confirmation required from the existing owners/the contractor as to whether this cracking is being monitored.

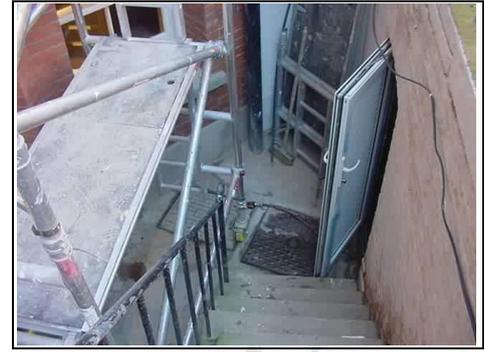
Manhole

During the course of the survey we could see that the drains were not clearing. It was noted that a tradesman was using the drains to get rid of waste material (photographic evidence available) and we feel there could be a problem with the drains.

ACTION REQUIRED: New closed circuit TV camera report of the drains before legally committing to purchase the property.

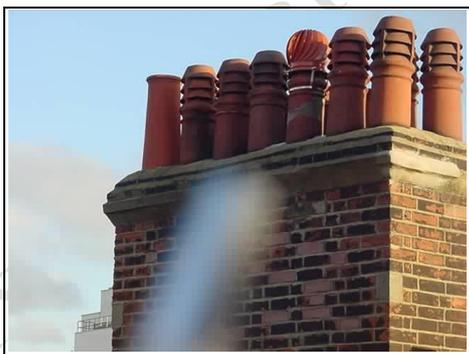
Front left hand chimney

This chimney is brick finished with a lead flashing and numerous chimney pots. From what we could see from ground level it looked in below average condition considering its age, type and style. We noted spalling brickwork which has been cement repaired. It also has a very awkward detail to the rear of it which we think will cause dampness.

ACTION REQUIRED: Generally we would recommend removal of cement repairs and replacing with a lime based mortar and an increase in the flashing where the awkward detail is and repair spalling brickwork.

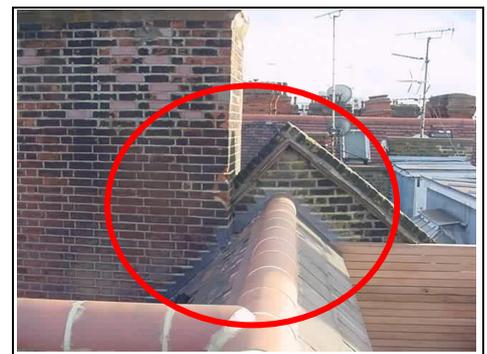
Awkward detail where chimney meets the roof

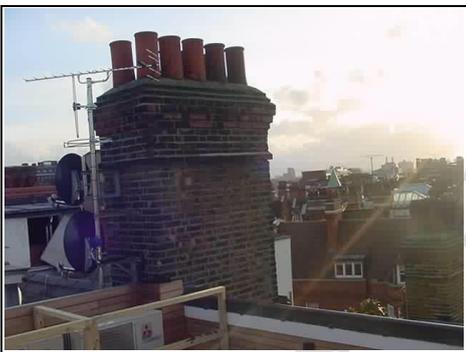
Middle left chimney

This chimney is also brick built with a lead flashing and numerous chimney pots. There are areas of spalling brickwork and areas where the cement mortar is coming away. The cement is already causing deterioration to the softer red brick.

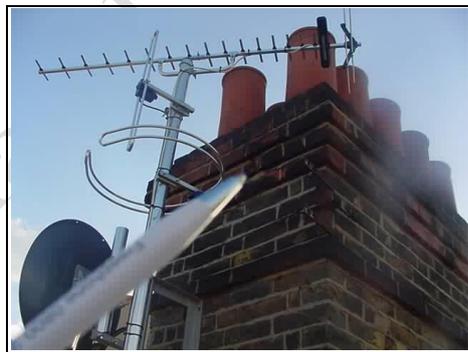
Spalling brickwork

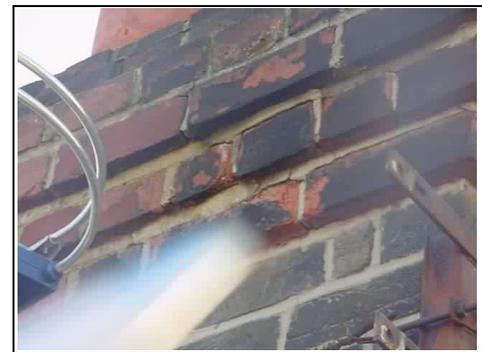
Close up of spalling brickwork

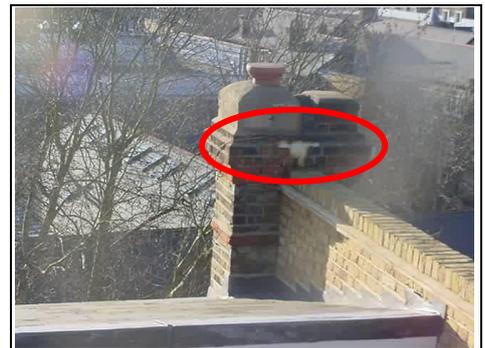
We have not been able to have a close inspection of this chimney and recommend a close up inspection. There is an area at the back of the chimney where we think dampness may come in but there is little you can do about this detail.

Cement mortar pointing

ACTION REQUIRED: We recommend a close up inspection as well as repair and repair spalling brickwork.

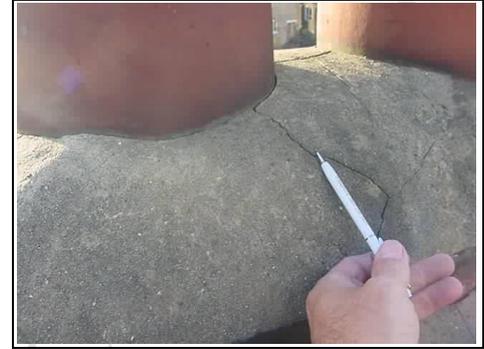
This chimney is brick built with two pots and a lead flashing. We would comment there is a crack to the haunching.

Crack to cement haunching

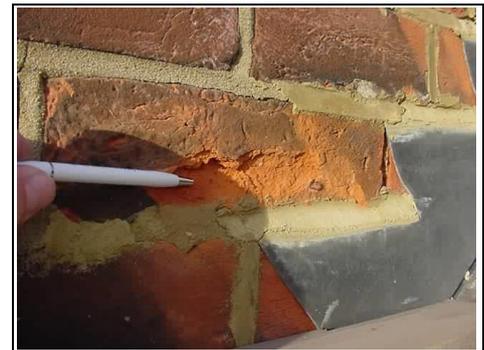
This chimney is brick built with a lead flashing. We would comment the bricks are spalling.

Spalling brickwork

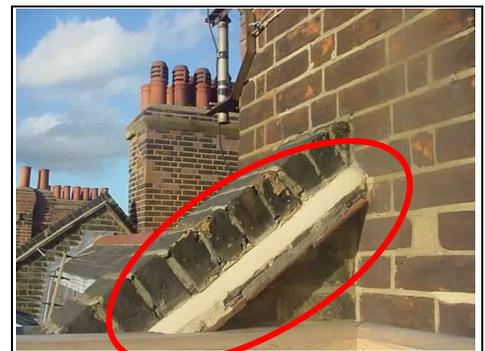
Additional brick built parapet wall. Some poor repointing has been carried out in cement mortar. No membrane as far as we can see to the wall and no repairs carried out before the cladding was added or we would say thought to the detailing.

Inappropriate cement repointing

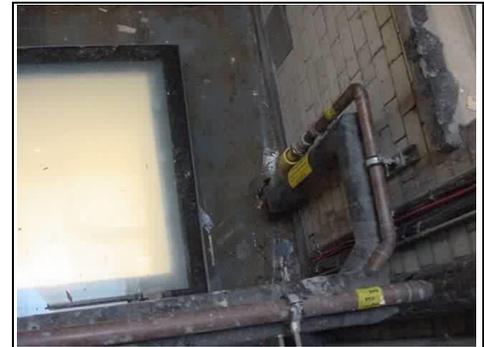
Roof window

We would add that with this sort of detailing it seems inevitable water will come in via the roof window. We do feel a better detail could have been provided.

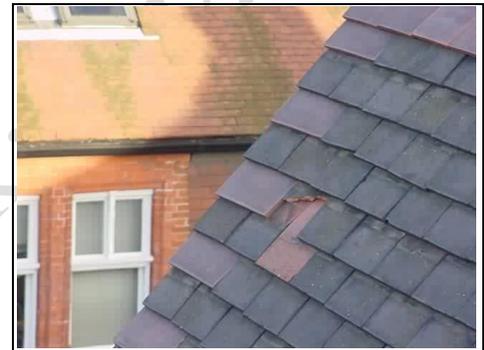
The main roof is pitched and clad with clay tiles and this looks in slightly below average condition particularly considering that this property has been newly refurbished as we can see there is a tile that's broken and some of the tiles look out of alignment. The only new work that we can see is the re-bedding of the ridge.

Broken and undulating tiles

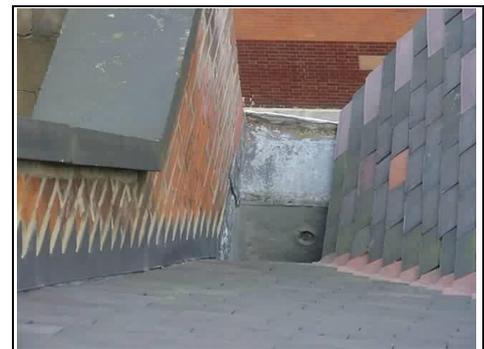
There are box gutters to the front of the property which are difficult to access. We feel these are likely to be a future area where you will get blocked gutters and thought should have taken place as to how to access these areas. This is what we would term as an original design defect (inherent defect).

Difficult to access box gutter

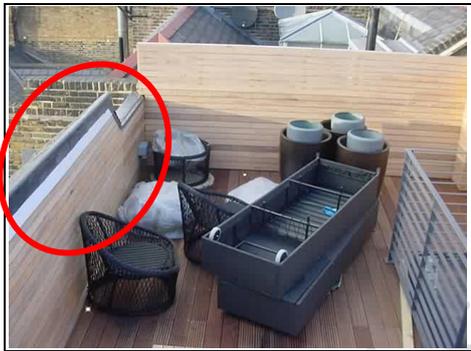
We noted around the terraced area there are areas of boarding; we feel these could have been detailed better as we feel they will suffer from pattern staining which will look unsightly.

Poor detail, allowing rainwater to drip down the cladding

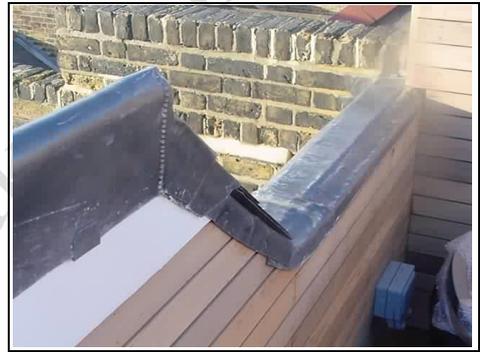
Poor detailing on terrace roof

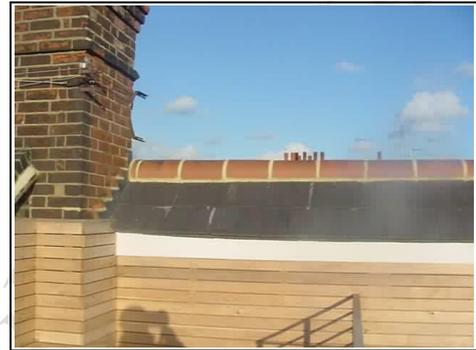
This is covered with slate tiles. It is poorly detailed and should have a guttering although this could be argued it is unsightly, equally pattern staining down the timber is unsightly.

Poor detailing where water will run down the timber and cause pattern staining we believe

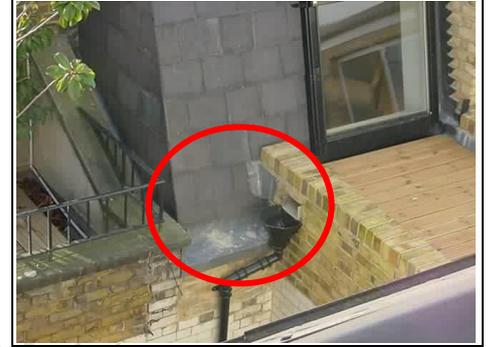
We noted an awkward detail to the left side and that there was no lead surround to the hopper head.

No lead surround to hopper head

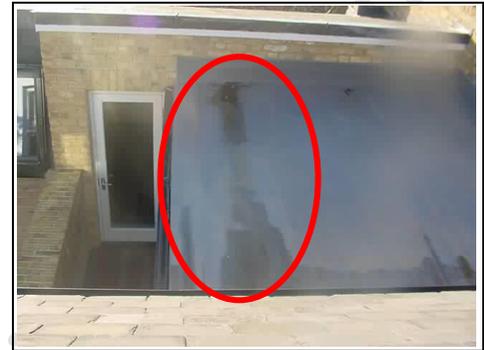
We noted there is ponding on the roof, indicating a lack of fall. The flashing does not look to be bedded in properly. Our general comment is that we find this the most economic roof that is often used by developers but it doesn't have a long term life.

Ponding on single ply roof

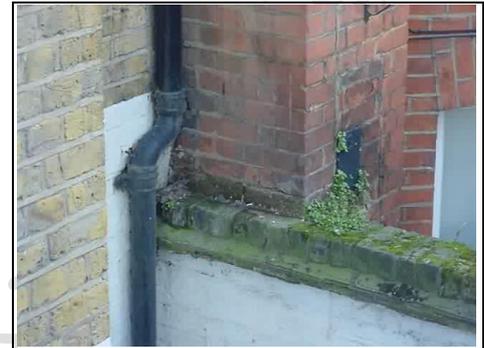
Leaking downpipe

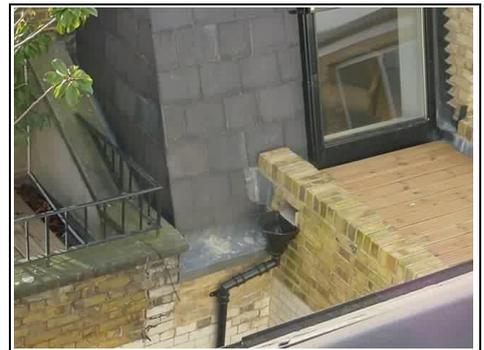
Green moss staining around hopper head indicating it is overflowing

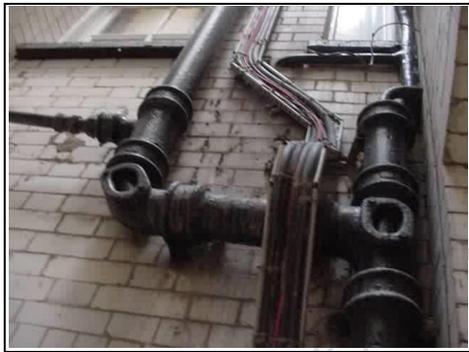
The property has internal soil and vent pipes within the central communal area, some of which are leaking.

Staining indicates soil and vent pipes are leaking

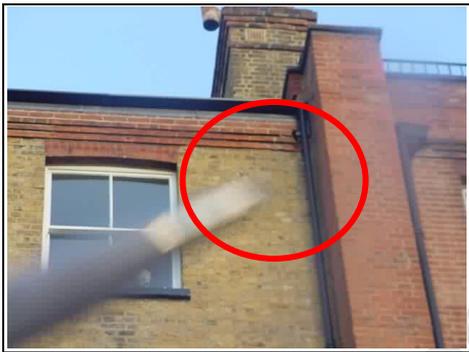
Hole at high level

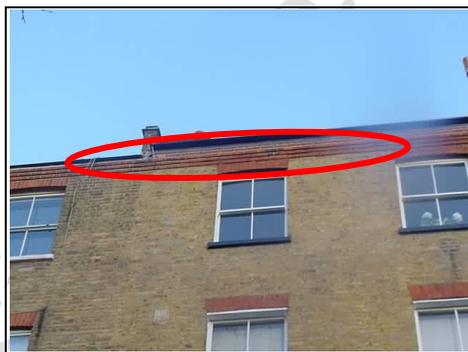
Appears to be deterioration to the red brickwork indicating that the gutter above may be leaking onto it.

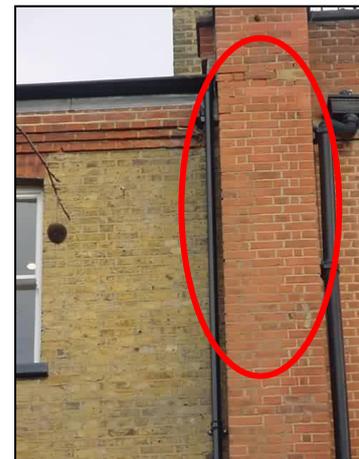
Pier needs repointing

ACTION REQUIRED:
Replace inappropriate cement mortar with lime based mortar.

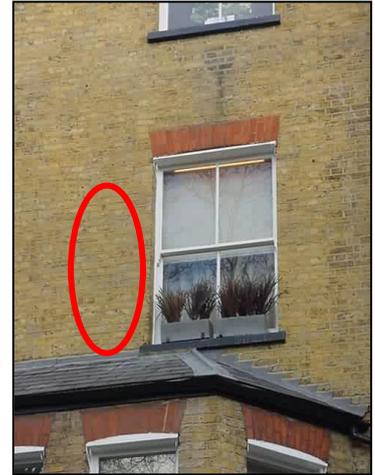
We are advised the pattern staining is to the flat areas only; no work has been carried out in these areas although we would disagree in some cases.

Pattern staining

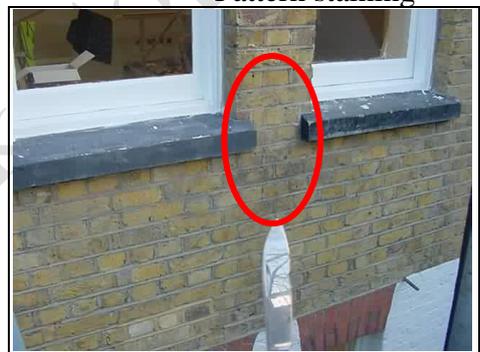
Hairline cracking

ACTION REQUIRED: The existing owners need to advise whether they have made a claim with regards to movement in the property or not.

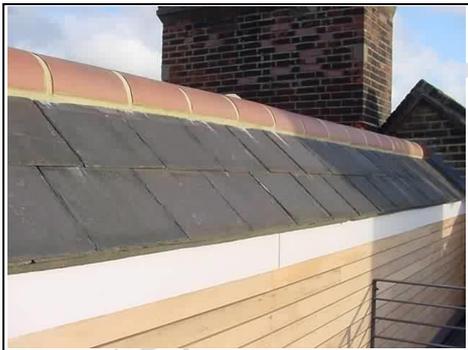
The fascias and soffits are timber. They are painted and we would comment they are in average condition for their age, type and style. There is no guttering to the fascia on the terrace; the contractor advised they didn't put one as it would look unsightly. This is something that has been raised in our snagging list as equally we believe the accelerated deterioration of the timber beneath and pattern staining will look unsightly.

Fascia on terrace has no gutter, without guttering pattern staining will occur

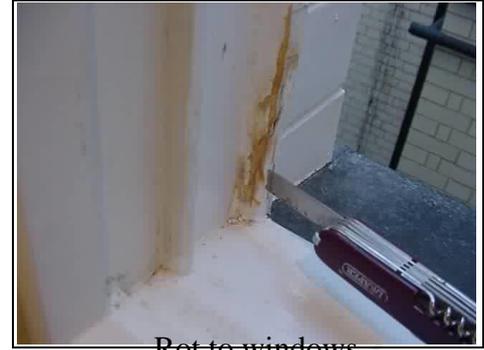
The property has mixture of timber sliding sash single and double glazed windows. We were surprised to find wet rot in one of the windows. We have been advised that all of the windows had been replaced. The windows look to have been filled poorly and rotten timber simply painted over.

Rot to windows

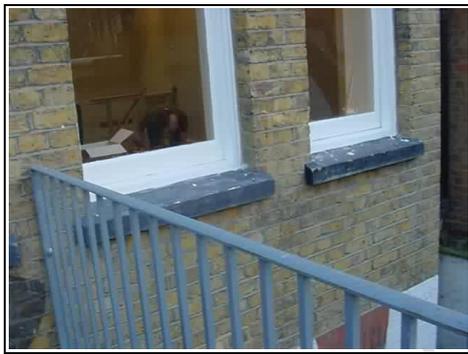
Window sills not decorated

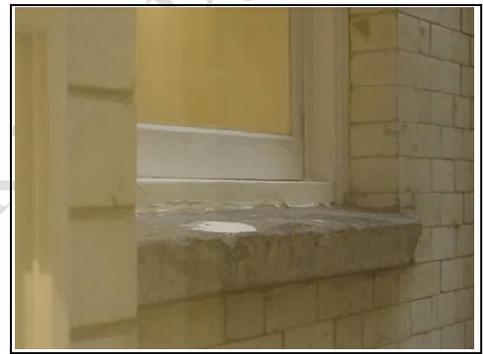
Window facing central void requires painting to window and window sill.

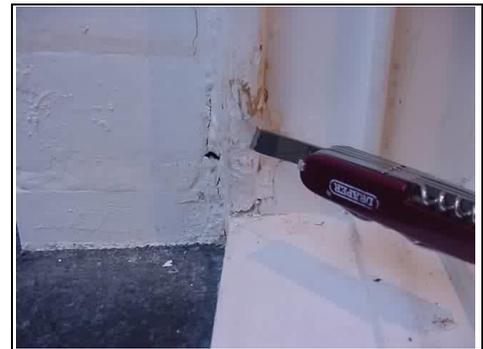
Knife test found rot

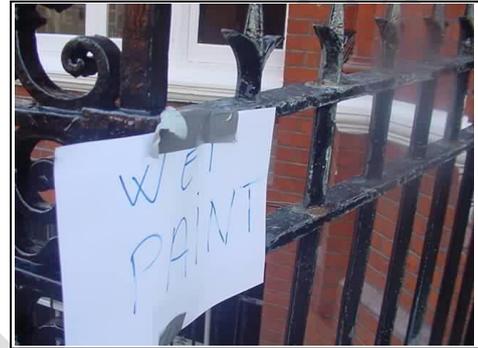
Our concerns are that the redecoration we have seen doesn't appear to be prepared correctly. Specifically we would identify the front railings where we believe rust has been painted over.

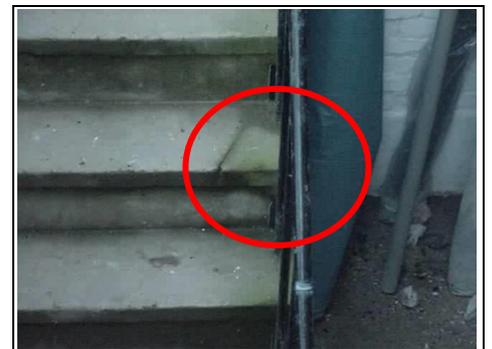
Cracked steps

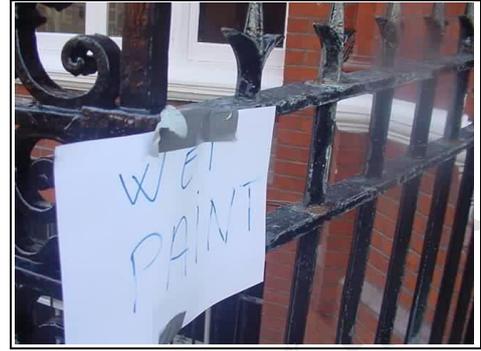
Rusting area

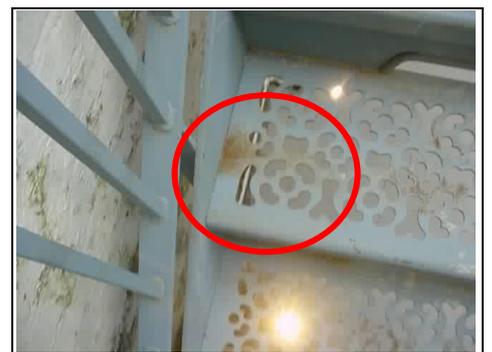
Rusting to stairs

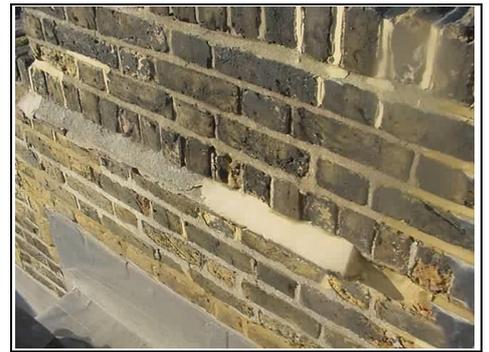
Poor workmanship
