RESIDENTIAL BUILDING SURVEY

Kent
CT6 xxx

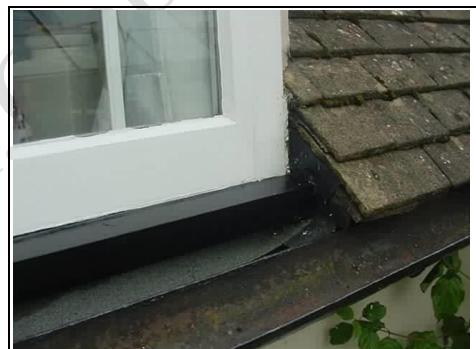
Some of the windows have been updated and some of the windows are double glazed. From what we understand Listed Building Consent was not obtained or sought. You will need to be aware that you will become liable for replacing these with appropriate windows if the listed building/conservation officer was made aware of them and felt them inappropriate.

Modern replacement timber window

ACTION REQUIRED: Your legal advisor to speak to the council/conservation officer to ascertain whether listed building consent should have been sought.

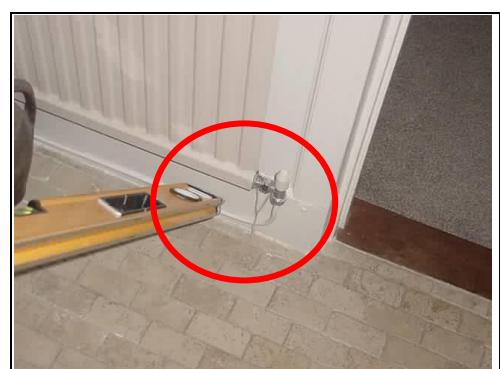
Micro-bore pipes

ACTION REQUIRED: We would recommend that the micro-bore is replaced. We would also change any single panel radiators to double panel convection radiators.

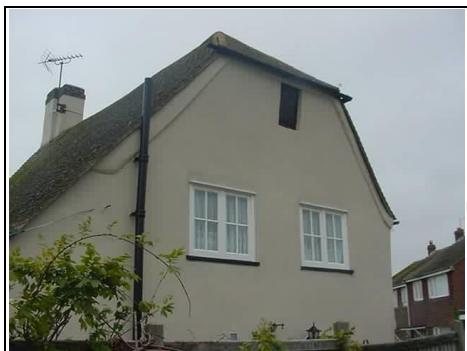
The entirety of the external of the property has had a cement render rather than a lime render which unfortunately with a timber frame structure that this property has will accelerate deterioration.

Thickening of the render at high level

ACTION REQUIRED: Ideally all of the cement render needs to be removed and replaced with a lime render to allow the property to breathe.

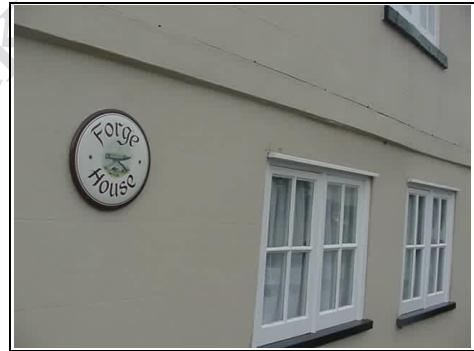
Lip on the render

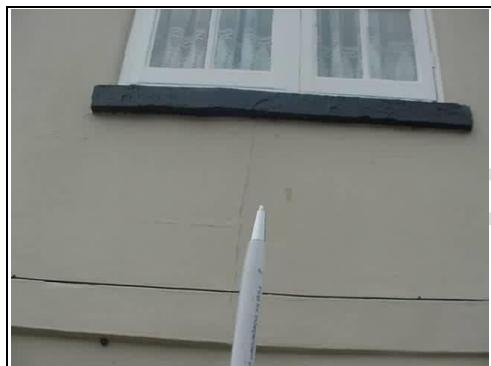
There is cracking in the render which can be caused by differential movement as you have a timber structure trying to move and it is being straight-jacketed with a cement render and modern gypsum plaster internally. In addition to this there may be other problems as indicated in the roof-spread item of this report.

Cracks in render

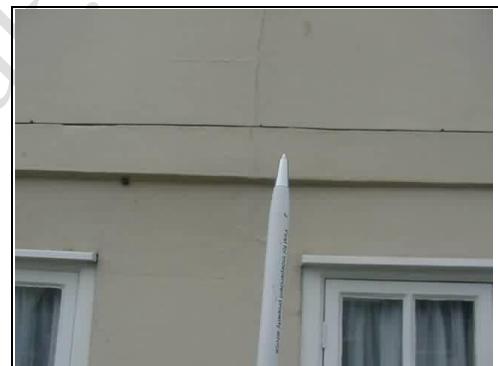
Cracking to render

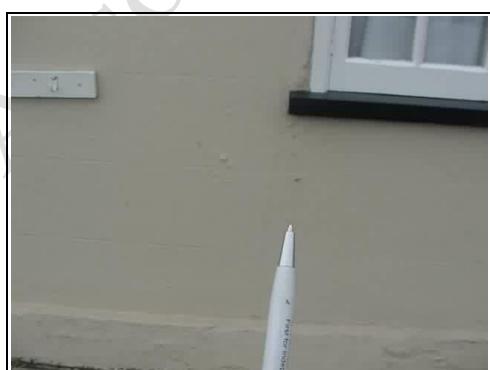
Cracking occurring to render

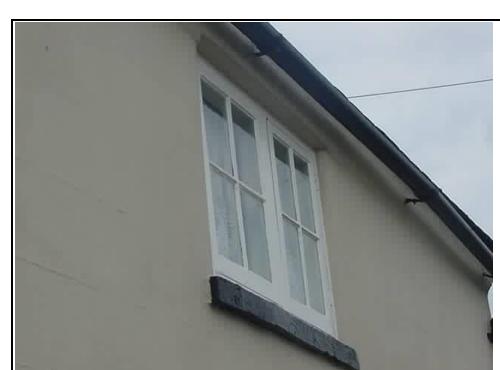
Render has cracking

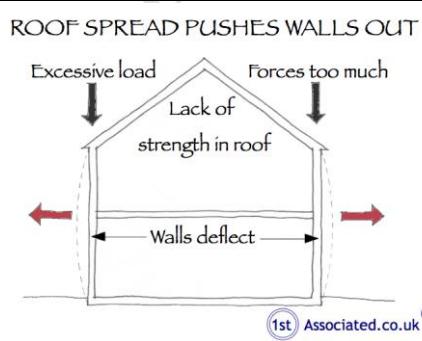
The original roof is likely to have been a clay Kent peg tile which then has been replaced with a heavier concrete tile which can cause roof spread. We could see hairline cracking in the cement render which is vertical indicating that the walls are moving out or down albeit relative minor.

The roof-spread may well have been occurring with the Kent peg tiles.

Roof spread

ACTION REQUIRED: There may be an option of the existing owner placing an insurance claim which you would then take over (approved by your legal advisors of course) with regard to the potential roof spread and then the insurance company could monitor for at least a year which is the recommended timescale. However this still would not get over the problem of having the cement render on the outside of the property.

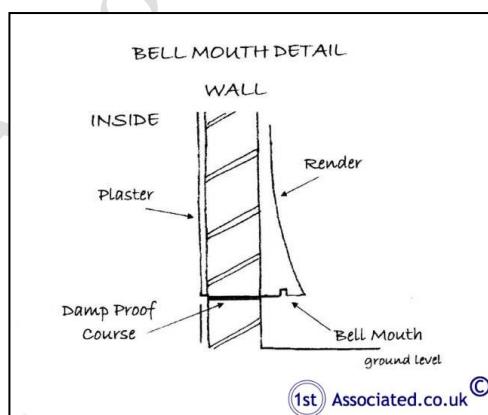
We also noted to the base of the render there was no bell mouth detail.

Bell mouth detail

ACTION REQUIRED: Removal of cement render externally and cement/modern gypsum plaster internally and replace with lime based render and plaster which would then allow the property to breathe. Add bell mouth as this would help with the dampness.

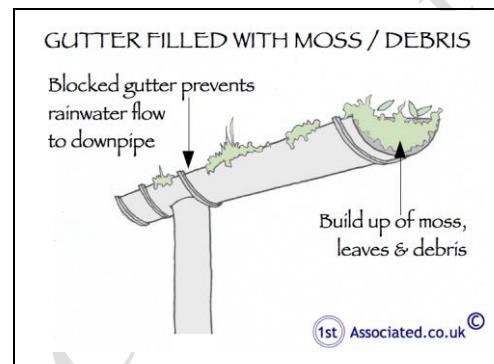
Clear gutters regularly

We would recommend in the short term that the ground level around the edge of the property is reduced slightly and an effort is made to ensure that all gutters and downpipes are watertight and discharge rainwater away from the property.

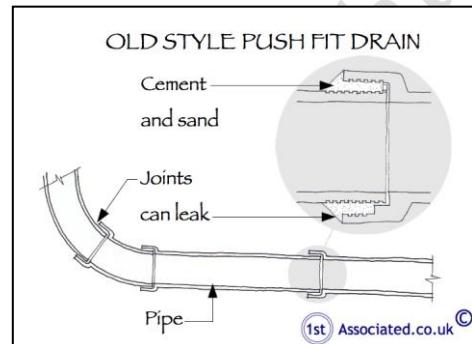
In older properties, such as this, drainage was often push fitted together rather than bonded together which means that they may leak over the years. Whilst we ran the tap for 15 minutes without any build up or blockages the only way to be 100% certain of the condition of the drains is to have a closed circuit TV camera report.

Push fit drain

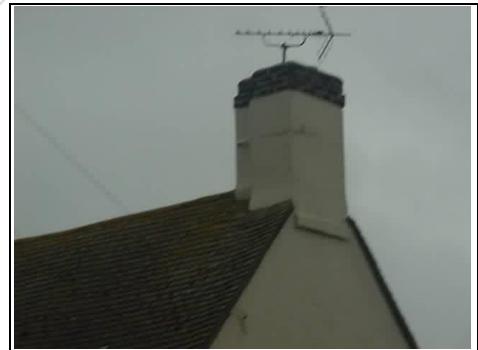
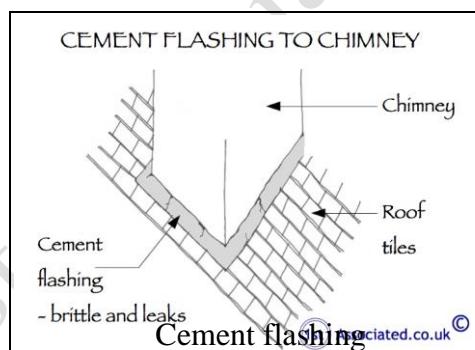
This chimney is render finished with a cement flashing and no chimney pots. From what we could see from ground level it looked in slightly below average condition considering its age, type and style due to the cement flashing.

Chimney from front of the property

ACTION REQUIRED: Replace

cement flashing with a lead flashing.
Periodically inspect the chimney.

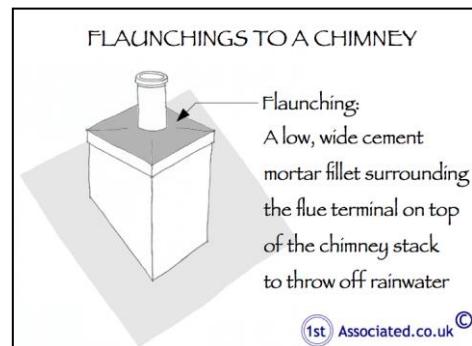
Flaunchings

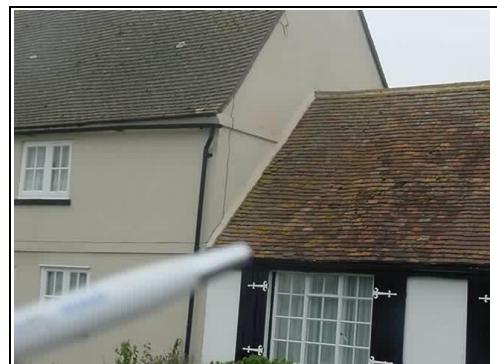
There is some poor quality roof detailing with cement mortar etc, which ultimately will crack one way or another and allow rainwater in. We would much prefer to see a lead flashing which moves with the structure rather than fighting against the structure. It could be argued that this is next doors detail but it is likely to affect this property first.

Poor quality roof detailing

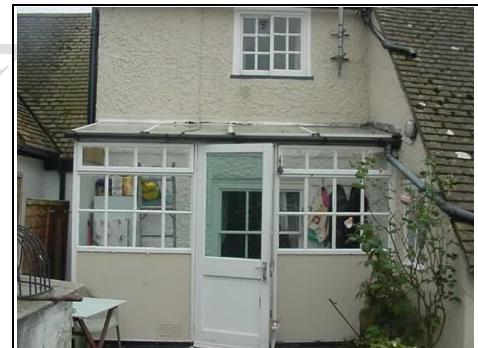
The property has a rear polycarbonate low level roof with poor detailing. This is very shallow pitched and we could not be certain that it is watertight. We can see that repairs/flashband has been used around it

Flashband is a sticky backed felt which is best used for temporary repairs only.

Rear low level roof

ACTION REQUIRED: You need to decide whether this area is useful or whether you wish to renew it. If it is to be kept we would recommend replacement of the roof and an increasing of the height.

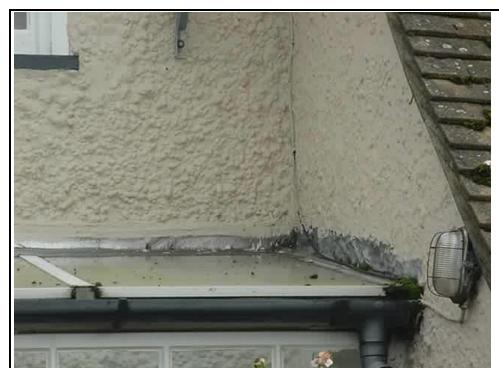
Poor detailing to rear low level roof

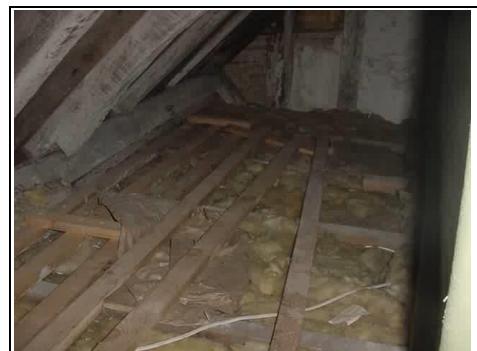
We could see that there have been repairs to the timbers which is quite common in older properties to have replacement timbers. Many of these have been re-used in other constructions. Or, the adding of additional timbers in what is known as back to backing, where timbers are strengthened by timbers being added back to back.

Back to backing of timbers

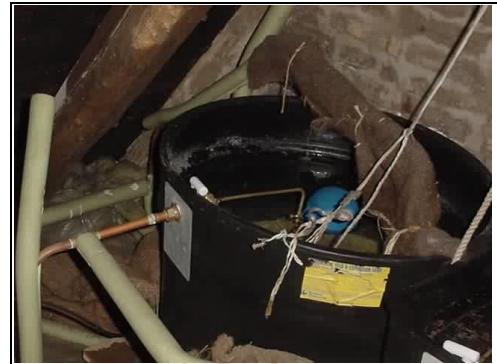
Un-insulated water tank

We would always recommend that water tanks be drained down and cleared of any debris etc. (we have seen dead birds and other unmentionable things in these tanks). As you are often cleaning your teeth with this water it is best that it is as clean as possible!

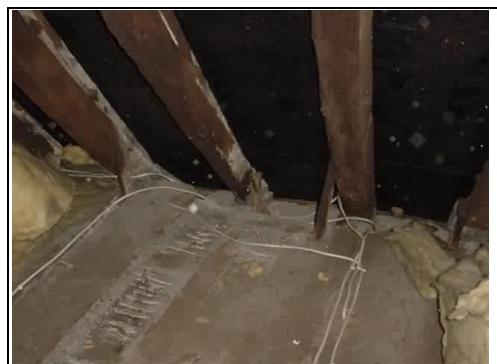
We can often identify the age of an electrical installation by the age of wiring found in the roof. In this case we could see a number of these, some of which were old.

Wiring in the roof

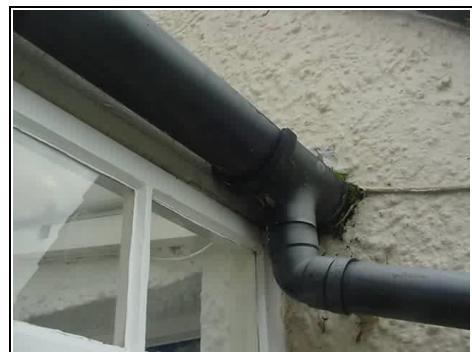
There may be some minor leaks but most people would be happy to live with these providing repairs are carried out within the next six to twelve months.

Awkward gutter and downpipe detail

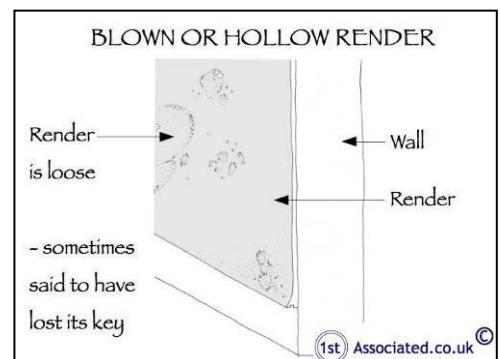
Blown or hollow render

ACTION REQUIRED: Please see our comments in the Executive Summary.

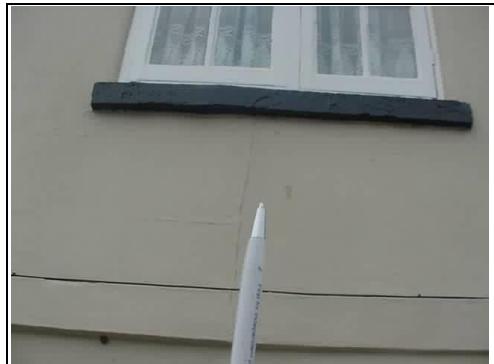
Cracks in render

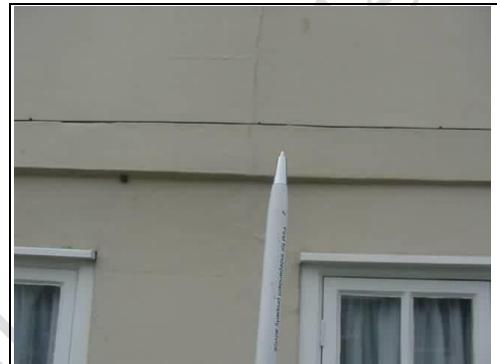
Cracking to render

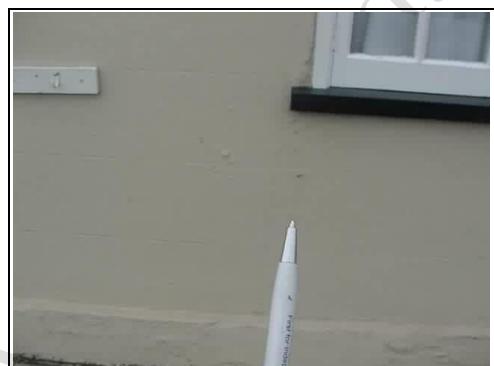
Cracking occurring to render

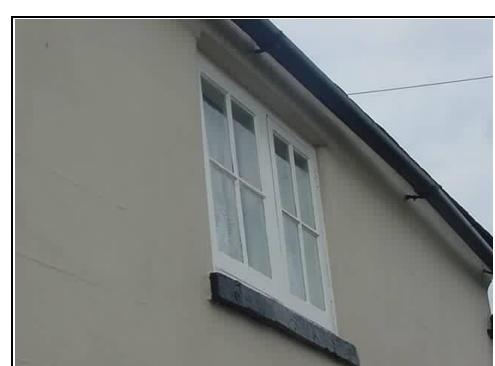
Render has cracking

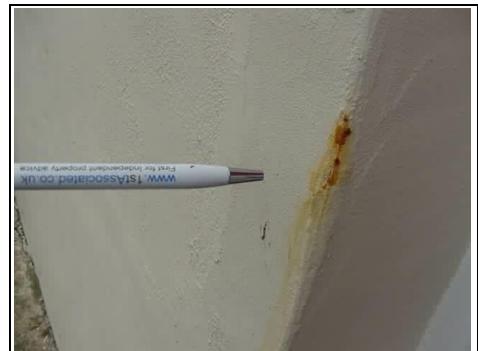
We noted rusting due to the wrong angle bead being used.

Rusting

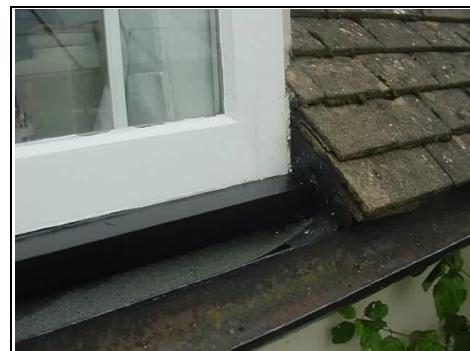
From what we understand Listed Building Consent was not obtained or sought. You will need to be aware that you will become liable for replacing these with appropriate windows if the listed building/conservation officer was made aware of them and felt them inappropriate.

Modern replacement timber window

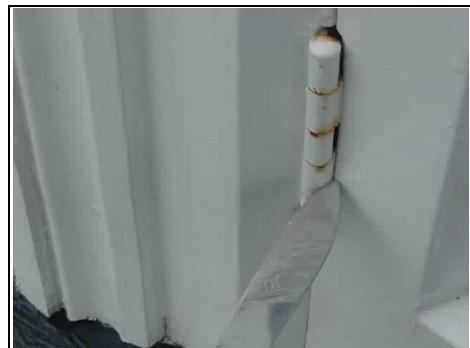
Rusting to hinges

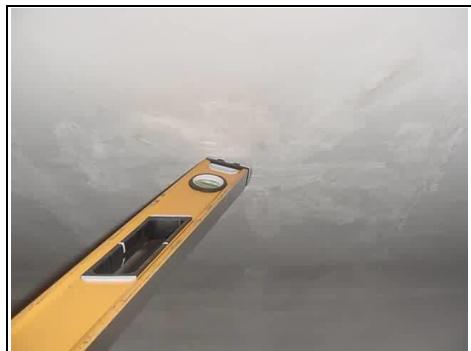
Advised by owner the mark in ceiling was due to wife's poor decorating skills rather than roof leak

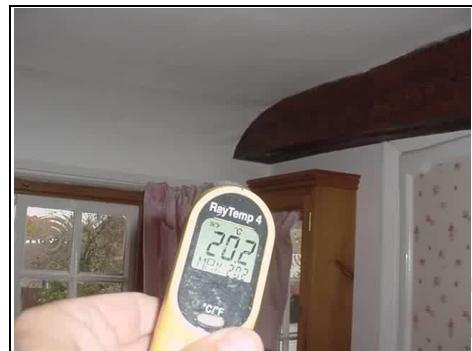
Slightly rounded ceiling in rear bedroom indicates the possibility of cold bridging

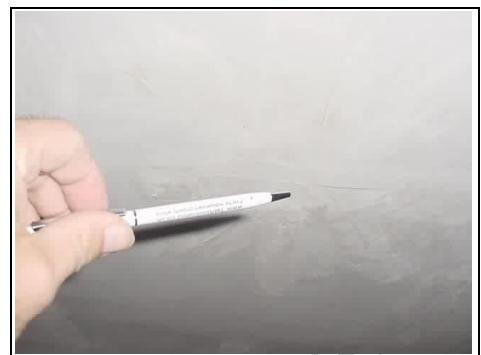
Cracking is due to a mixture of old and new plasters.

Hairline cracking

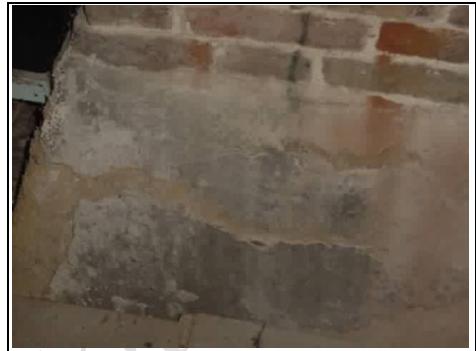
Dampness to chimney breast in roof

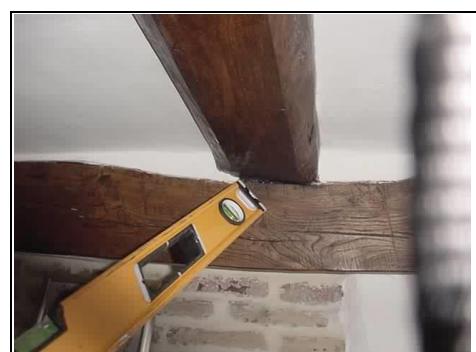
Spine beam that does not tie in

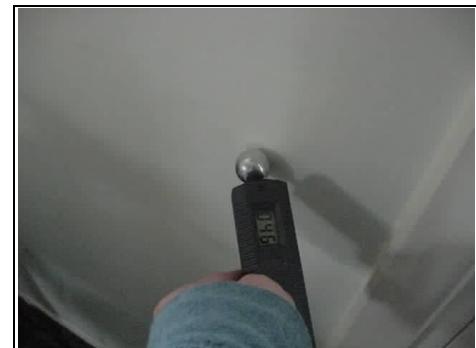
A visual inspection and tests with a moisture meter have been taken to the perimeter walls. In this particular case we have found significant rising damp.

Testing for rising damp

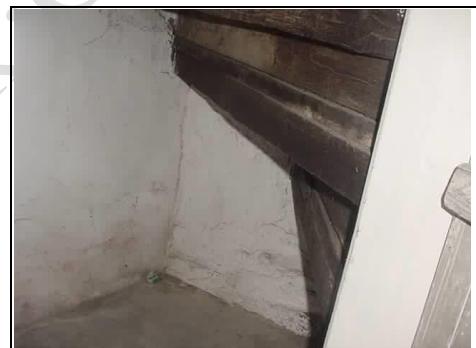
We noted that the underside of the staircase was exposed. It is more normal today to have a half hour fire barrier to stop fire spreading from the ground floor to the first floor in a worse case scenario. You may wish to take a view on whether you add this.

Unlined staircase

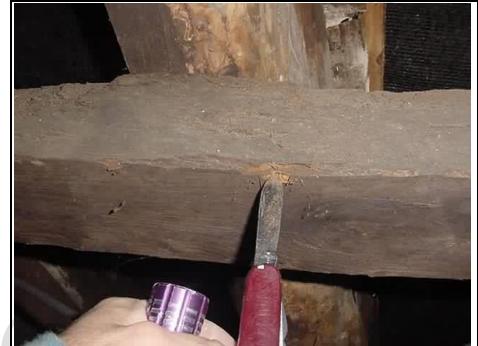
We found signs of frass, which are the chewed up remains of wood in the roof. We would have expected woodworm in a property of this age, unfortunately it appears that the woodworm may be active.

Frass indicating woodworm

ACTION REQUIRED: Whilst we do not consider that the woodworm is structurally significant that is present it does need to be monitored. We generally recommend the environment is changed to an environment that woodworm are unhappy to live in. We would be happy to return in the Spring of 2015 to give a further opinion.

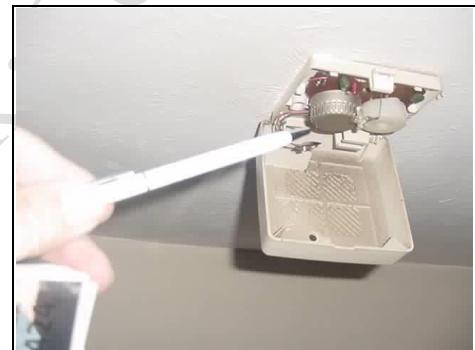
Some smoke detectors were noted, some without batteries. The current Building Regulations require that they be wired into the main power supply. Obviously in a property of this age this is difficult, as it would mean having surface mounted wires or cutting wiring into the plaster.

Smoke alarm without battery

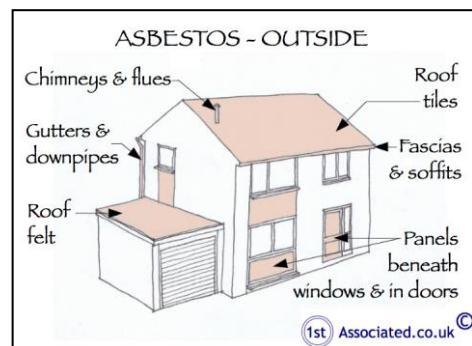
Asbestos externally

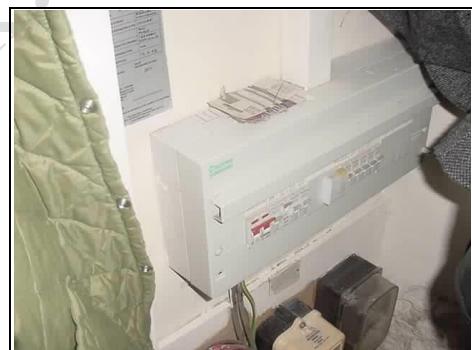
The electric fuses and consumer units were located in the entrance hallway. The fuse board looked dated 1970s/1980s and better are now available. In an older property a defective fuse board can be particularly dangerous.

Fuse Board
