JOB REFERENCE: XXXX

RESIDENTIAL BUILDING SURVEY

London

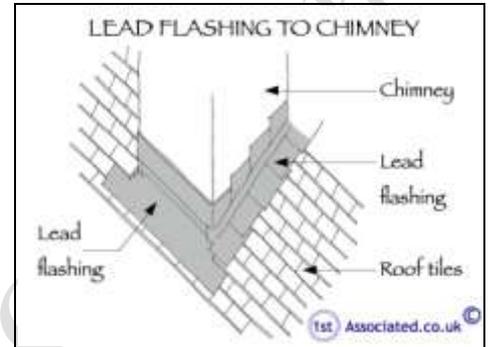
1.1) We could see that the front left hand chimney and also rear right hand chimney (all directions given as you face the property) requires work. To the front left hand chimney we believe re-pointing and possibly repair work to the flashings and to the rear right hand chimney we believe repairs are required to the flashings although we could not view the chimney properly.

Chimney flashing

ACTION REQUIRED: Repair as necessary the chimneys to make water tight. We believe it is likely re-pointing and adding/amending flashings required.

ANTICIPATED COST: The main cost relates to the scaffolding required, we would anticipate costs for the chimneys to be in the region of £1,500 to £4,000; please obtain quotations. If this work is left deterioration will occur to the roof structure.

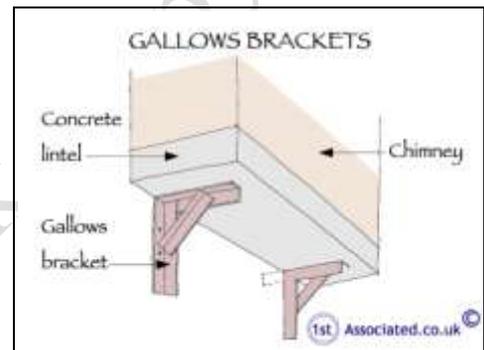
We could see from within the roof space the chimney breast has been removed and a gallows bracket added. This was a very common technique used for supporting chimneys when they were removed although this is no longer permitted, as we understand, by Local Authority Building Regulations. Having said this from a considered point of view we could see no stress fractures internally which would lead us to believe there are problems.

Gallows brackets

ACTION REQUIRED: When chimneys have been removed on one side of the property you need to check to see if the chimneys have been removed on the other side as the gallows brackets are effectively taking support from this wall.

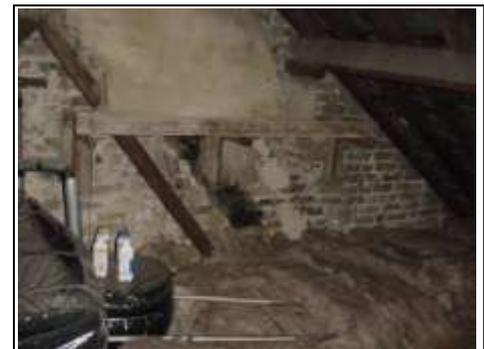
Rear left hand chimney being supported on gallows brackets

We knocked on the neighbour's door at the time of our survey but did not receive a response. We would recommend a return visit to speak to the neighbours to ascertain if they have also had their chimney removed or not. If they have you will need to remove the upper section of your

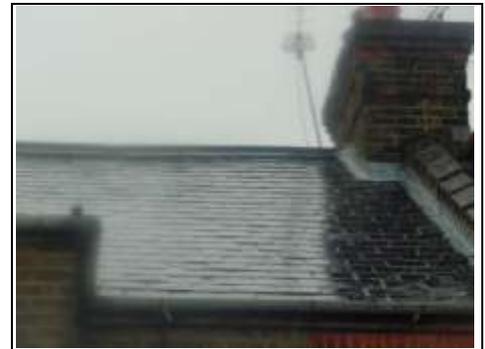
Having stood inside the roof space for quite awhile whilst it was raining there was not very much rainwater getting inside. Looking at the timber battens and common rafters (the timbers that form the pitch of the roof) we could see staining from where rainwater has got in which is probably wind driven rain that has penetrated the roof.

Rear roof undulates

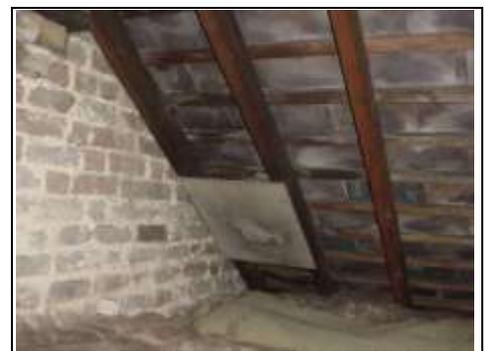
Underside of roof showing slates and piece of asbestos

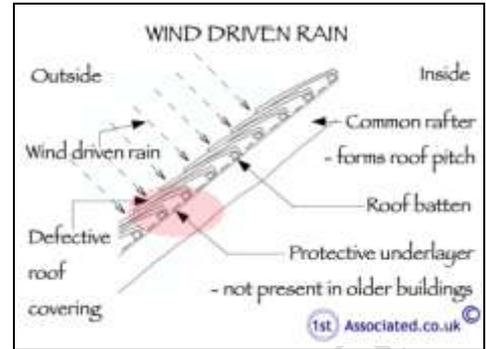
Wind driven rain

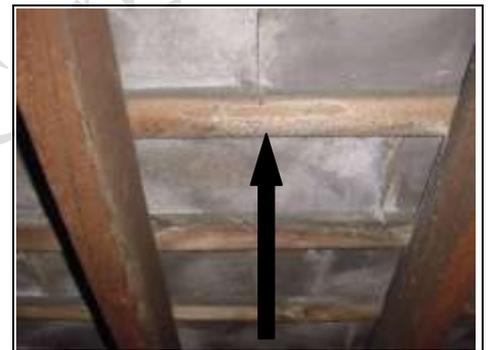
Close up of timber batten showing white salts which is a sign of dampness

ACTION REQUIRED: As a short term measure we would suggest boarding out the roof with a board with a solid insulation back (such as Celotex or Kingspan) which would then give a pseudo second line of protection for any dampness penetrating through the slates and

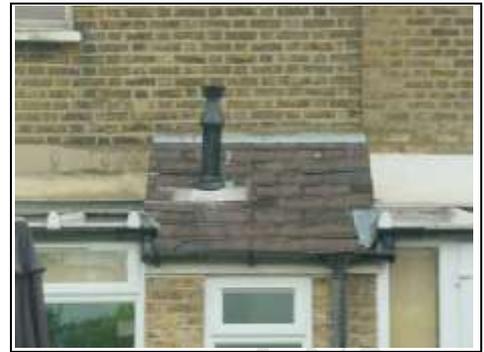
3.1) Whilst the rear roofs did not leak during the course of our inspection they are a miss mash of different types, styles and ages of roofs. These roofs, we would say, will suffer from problems in years to come probably starting with the middle tiled roof where the tiles already look to be uneven and displaced.

Rear low level slate roof

ACTION REQUIRED: Next time it rains heavily observe how the roofs cope with heavy downpours if you intend to keep them and then employ a roofer to carry out repairs during dry weather and also obtain a supply of the slates.

ANTICIPATED COST: Regular maintenance of a few hundred pounds until you decide what to do with the roofs; please obtain quotations.

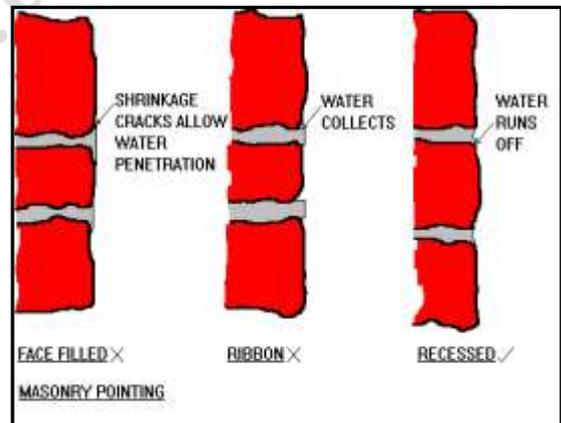
Re-pointing is carried out where the existing mortar has failed and broken away to stop damp penetration and further deterioration. The mortar should be raked out to approximately 20mm and then replaced with a mortar of a similar type, therefore, stopping damp occurring.

Pointing

ACTION REQUIRED: We normally recommend you need to employ the oldest brick layer you can find and asking him to come and carry out re-pointing work for the next few years using a stiff brush once or twice a year on the cement and re-point in a lime mortar until a good proportion of it is replaced.

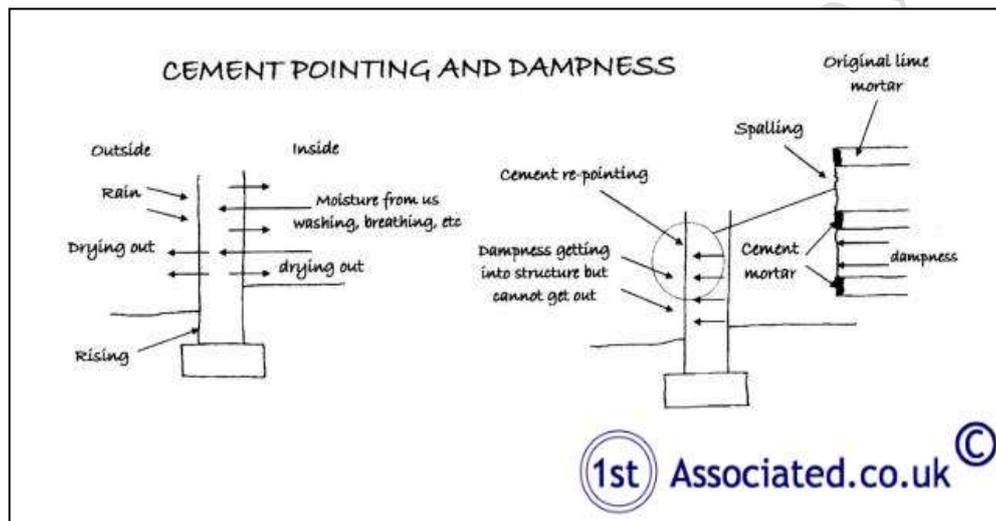
Unfortunately the cement re-pointing, whilst well meaning, is not appropriate for this type of construction. A cement mortar has been used rather than a lime based mortar. We recommend you use lime mortar in any future repairs regardless of what the builders say! Using lime mortar will limit further damage to the brickwork, which is almost impossible to repair successfully. However, we would add that many, if not most, of the properties that are re-pointed are re-pointed wrongly; it is only in recent years that we have discovered the problems that can occur from it.

Dampness and pointing

The re-pointing work should be carried out in lime and we certainly would not recommend carrying out this work without being trained first as lime can burn.

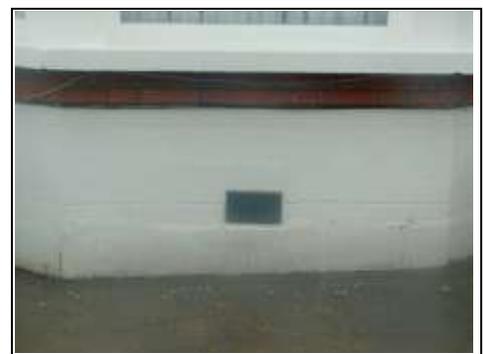
Airbrick to front. Has the property had a damp proof course added? Guarantee required if it has been added.

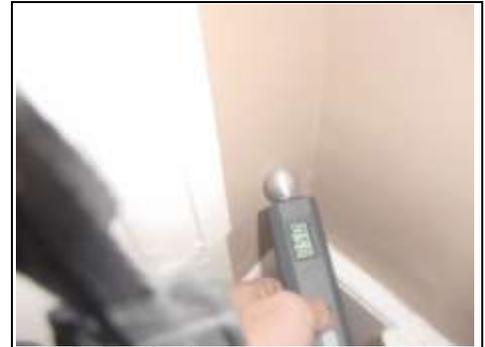
We found higher than we would typically find damp meter readings to the entrance door. We believe this is probably due in part to the cement re-pointing and in part to the weather being a wet day on the day of our inspection and possible condensation.

ACTION REQUIRED: Re-pointing as previously recommended.

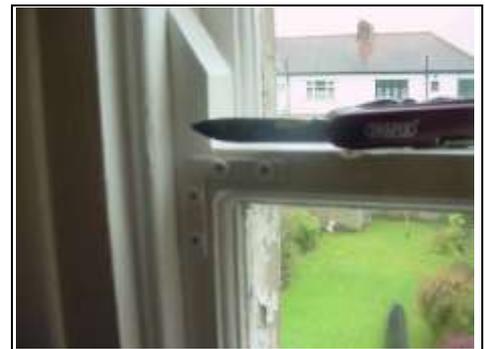
Some of the windows have seen better days particularly the rear right hand window (all directions given as you face the property) which is currently held together with metal brackets. If you recall we showed you these brackets internally.

Window held together by metal straps

ACTION REQUIRED: We recommend re-decoration of windows and repairs as necessary.

ANTICIPATED COST: Likely to be in the region of a few hundred pounds to have repairs carried out professionally per window; please obtain quotations.

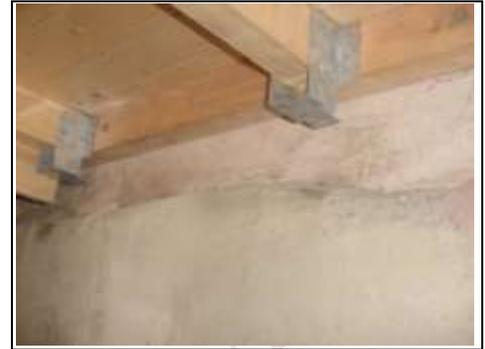
When we went into the cellar area we noted the timbers had been removed. Also we think we noted minor woodworm and we mean minor woodworm in the roof space, our view was very limited due to the mass of insulation that had been literally placed all over the roof space.

Woodworm or wet rot previously to the floor

ACTION REQUIRED: We would therefore recommend that you live in the property to see if there are any signs of woodworm in the form of flight holes with frass.

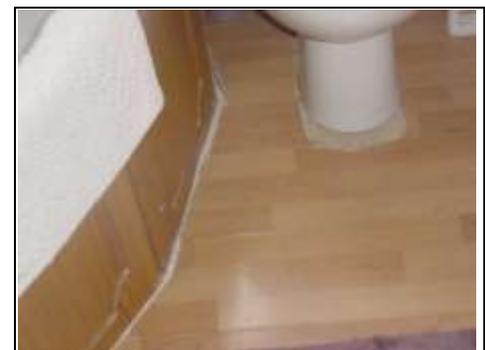
The laminate boarding that has been fitted is very poor in some areas and worn particularly in the bathroom.

DIY laminate flooring

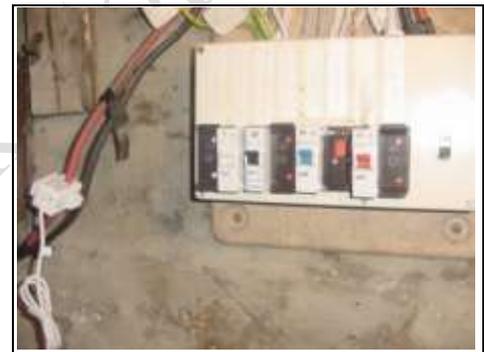
Fuseboard

The fuseboard is dated which to us also means it is likely the electric system is dated. We carried out an earth test in the kitchen which was satisfactory however this is not the same as having a qualified electrician carry out a test. For the electrics we would recommend an Institute of Electrical Engineers standards (IEE) test and report carried out by an NICEIC registered and approved electrical contractor or equivalent, which is recommended whenever a property changes occupancy.

ACTION REQUIRED: Replace fuseboard.

ANTICIPATED COST: £250 to £500 to replace the fuseboard; please obtain quotations. We would also recommend additional power points are added as today we have a higher demand for socket points than in the past.

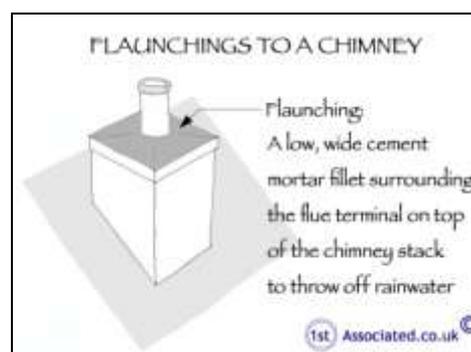
The only other point to make with regard to the chimney is the straps that have been used for the aerial. We have found in the past that

Chimney flaunchings

these cause damage to the brickwork as they produce pressure points on the chimney; we suggest that this be checked.

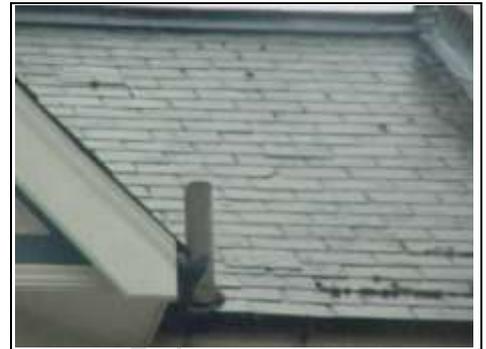
Possible asbestos flue to front right hand side

ACTION REQUIRED: We always recommend all asbestos is removed as not only does it have the potential for problems it does tend to affect value as some people simply will not buy a property with any asbestos present.

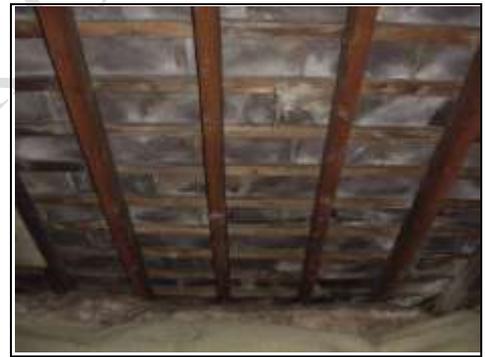
No protective underlayer is present. Often an older roof will have no protective underlayer at all unless it has been re-roofed post war and then it will have a Hessian base bitumen membrane.

This photo shows the common rafters (the ones that form the pitch of the roof) and no protective underlayer. White salt stains indicate dampness is getting in.

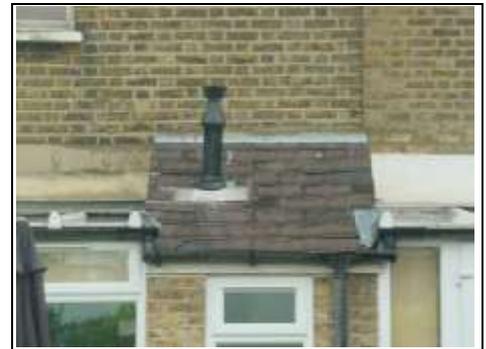
We are aware with regard to your comments about extensions to the rear of the property and would refer you to our comments within the Executive Summary with regard to the slate roof which is in below average condition.

Low level slate roof

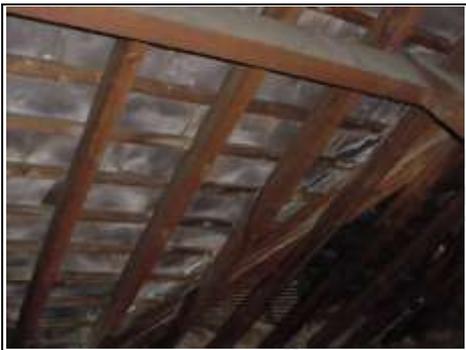
Dampness visible to timbers

Purlin on rear left hand corner balanced on a brick needs securing

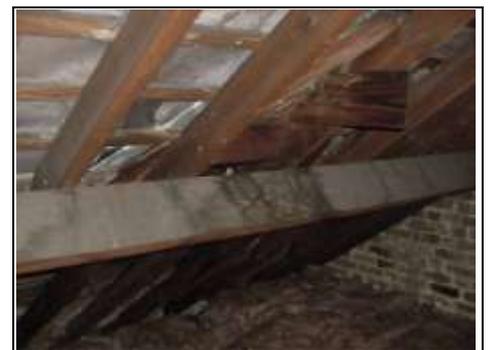
Dampness visible through timbers

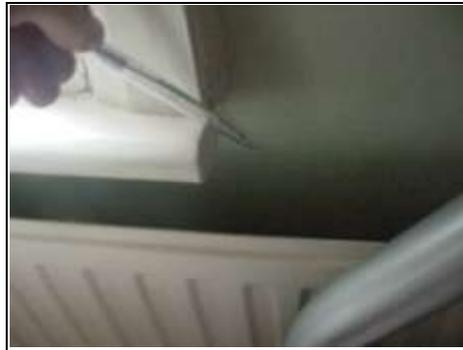
We noted some hairline cracking to front left hand bedroom plaster and rear left hand bedroom (all directions given as you face the property). Whilst there has been movement in the property we believe this cracking relates specifically to a modern gypsum plaster being applied, please see our sketch.

Hairline crack to rear left hand bedroom

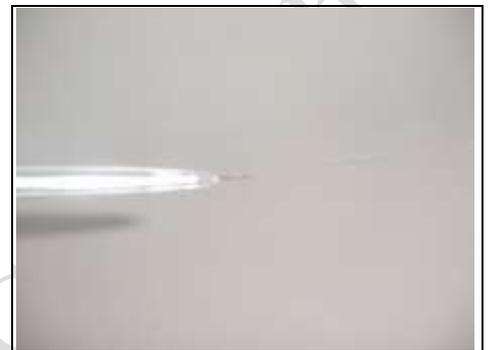
Cracking in plaster front left hand bedroom

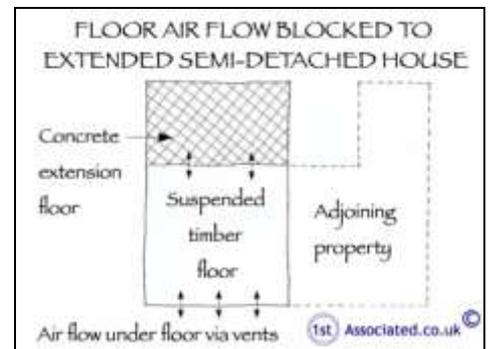
Blocked air flow

Please see our comments in the Executive Summary and ensure the airflow is kept clean.

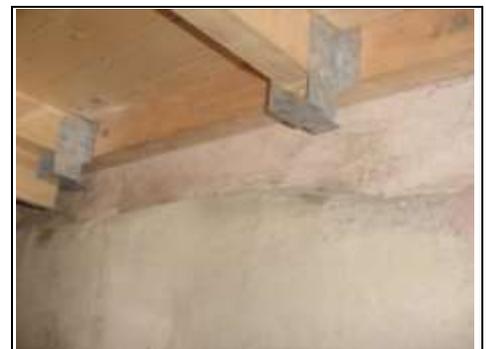
Wet rot and/or woodworm previously to the floor
