# RESIDENTIAL BUILDING SURVEY

**Camberwell,  
London,  
SE5**

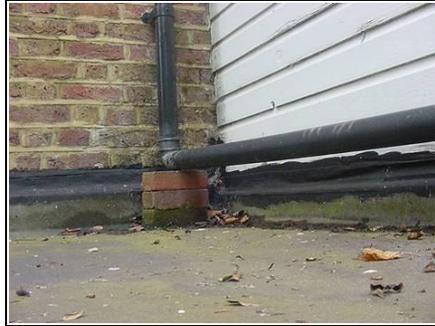
The flat roof to the rear over the toilet is leaking. We can see/obtained damp meter readings within this area.

Moss on flat roof

**ACTION REQUIRED:** We recommend that the roof is re-roofed.

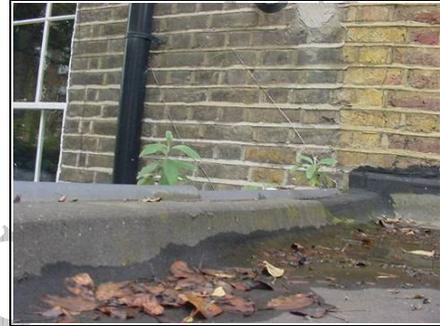
Leaking flat roof

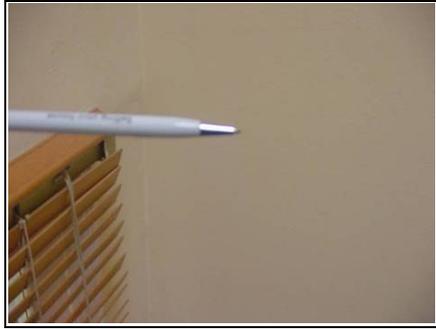
Hairline cracks in walls on staircase

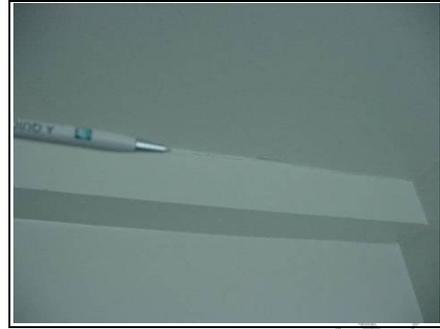
Hairline cracks in WC area

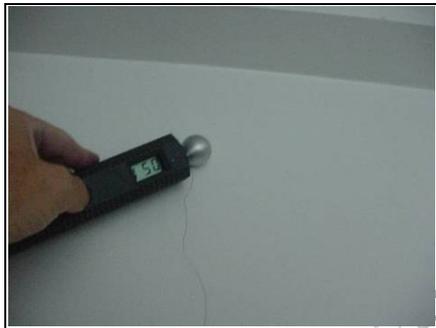
Gann meter readings showing dampness in the WC on the half landing

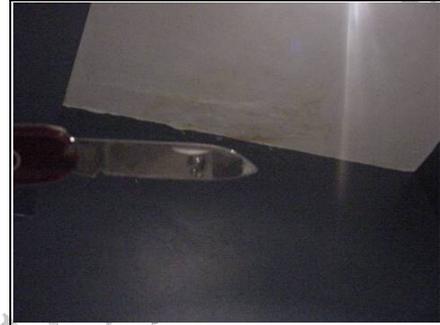
This may well be historic, as when we ran the shower for ten minutes on the top floor there was no visible signs of dampness coming through. However, having said that often there needs someone to actually be in the shower to cause problems.

Knife indicates water damage on bathroom ceiling below

**ACTION REQUIRED:** We recommend that you live in the property to check whether it is still leaking.

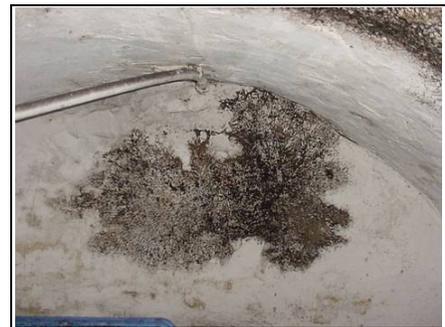
Within the ground floor vaults that are partly under the pavement we noted what looked to be a dead fruiting body of dry rot. Our concern is that there may have been problems in years gone by with regard to dry rot which can very methodically affect the timbers in the property.

Dead fruiting body of dry rot

**ACTION REQUIRED:** Whilst we believe the fruiting body to be dead it may well have left traces underneath the floor and it can quite easily travel that distance. We did once come across dry rot that had travelled to a number of adjoining houses so you do need to open up the floor to check its condition.

**ANTICIPATED COST:** A best case scenario would be £100 to £200 to open up and check, a worst case scenario would be into the thousands of pounds. There are no obvious signs to show that there is dry rot within the property. Please obtain quotations.

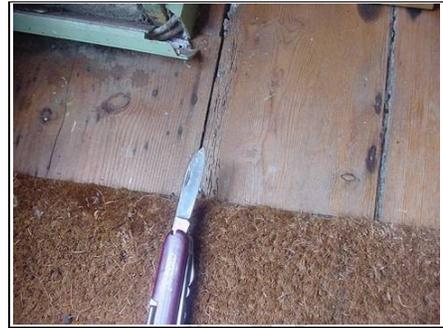
Signs of old woodworm on lower ground floor

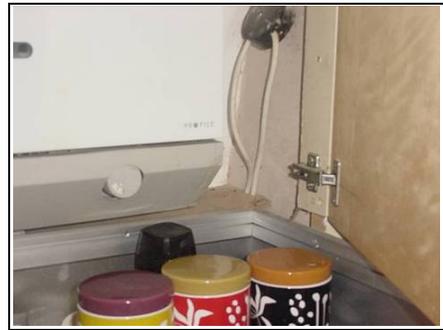
Dated Potterton profile boiler

**ACTION REQUIRED:** We recommend replacement. You may also have to power flush clean and/or replace some of the radiators as the pressures tend to be different between old and new heating systems.

**ANTICIPATED COST:** In the region of £6,000 to £7,000; please obtain quotations.

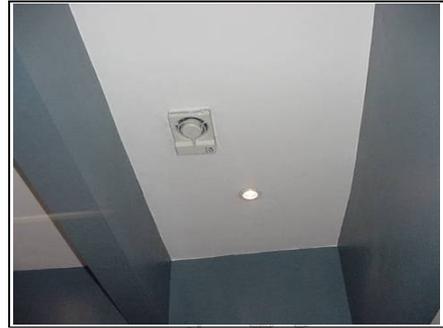
The extract fan in the first floor bathroom had minimal suction. This will cause condensation throughout the property. Again in the top floor shower room the fan did not seem to have that much extraction, however there was of course the roof window to open.

Extract fan first floor bathroom does not work

**ACTION REQUIRED:** Install humidity controlled large extract fans in the bathrooms and in the kitchen.

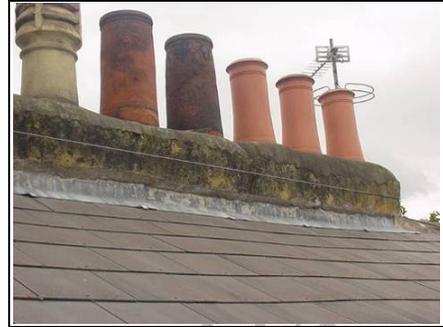
This chimney is render finished. The render is starting to discolour indicating that dampness is getting into it. The chimney pots however are sitting straight and true unlike the left hand side. We would advise that we believe these to be in average condition.

**ACTION REQUIRED:** Periodically inspect the chimney.

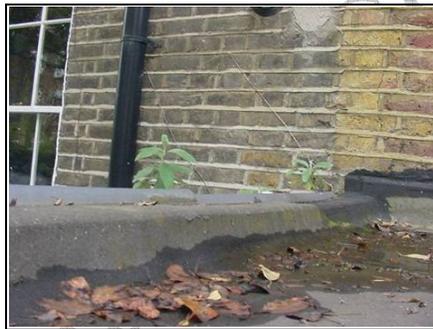
The flat roof is covered with asphalt. It has moss growing on it, which may cause dampness to enter the property. We believe it is leaking from the damp readings we got internally.

Leaking flat roof covered with moss

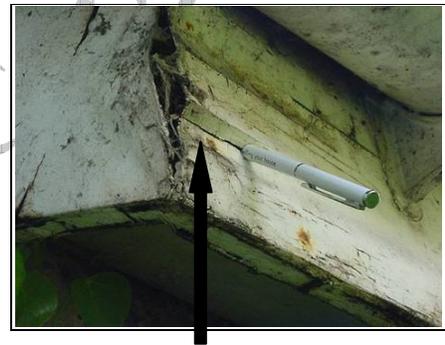
The main property does not have any fascias and soffits as it has parapet walls, however to the rear to the conservatory and to the flat roof there are some fascias and soffits. There are painted timber. The ones to the conservatory are rotten; you can see in the photo that the pen is pushing through them.

Pen pushing into deteriorating fascias and soffits

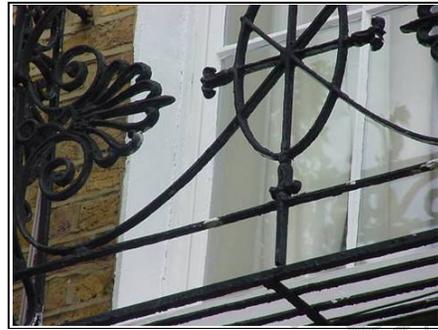
Cast iron in front of window  
rusting slightly

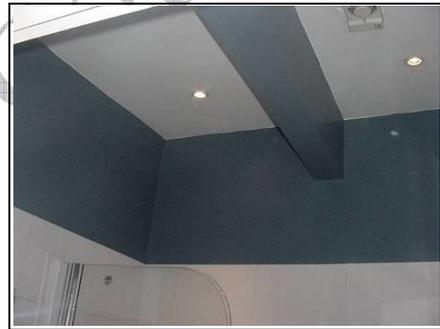
Ceiling in central bathroom on first floor – there are leaks in the ceiling, likely to be modern plasterboard

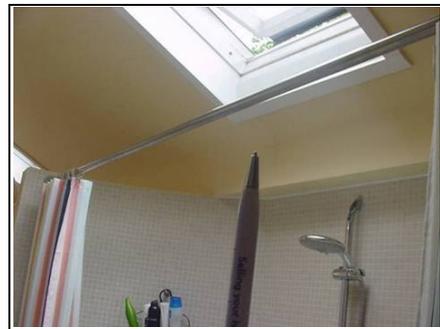
Pen indicates hairline cracks in top floor ceiling, again likely to relate to plasterboard

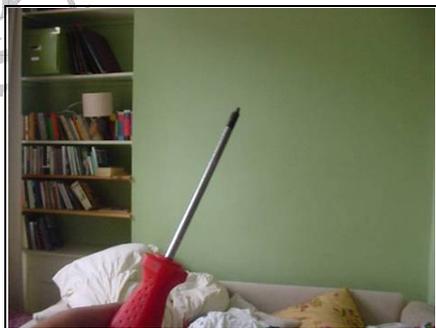
Cracking in first floor lounge

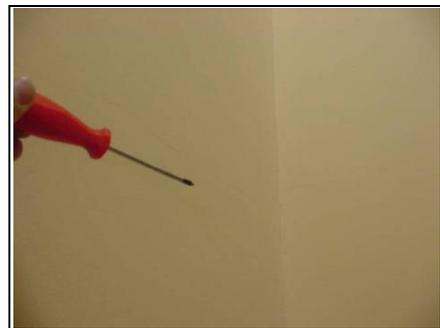
Hairline cracks top floor

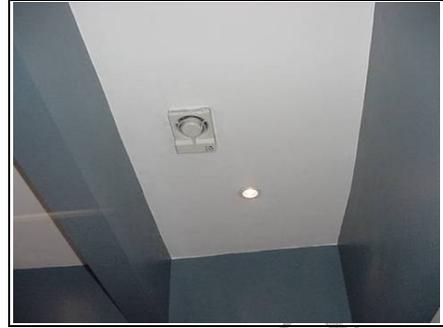
Extract fan doesn't work and will cause condensation throughout the structure

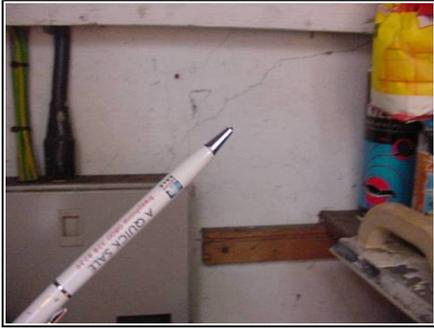
Cracking under stairs

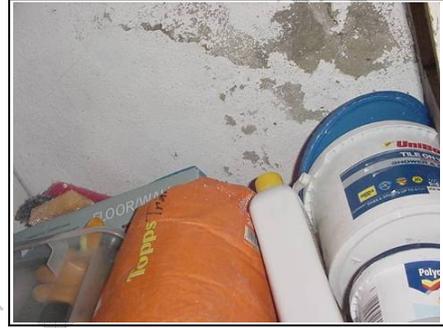
We found dampness underneath this, as we always do. The only way to stop it is to damp proof the steps using a good asphalt, but to some extent you need to accept that this sort of area is always going to have some dampness, including the vaulted areas.

Damp under stairs

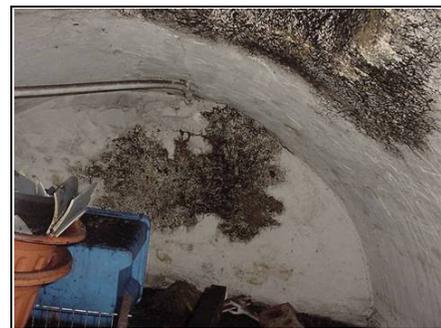
Possible fruiting body of dry rot in lower ground floor

**ACTION REQUIRED:** Please see our comments in the Executive Summary about fruiting body of dry rot in lower ground floor

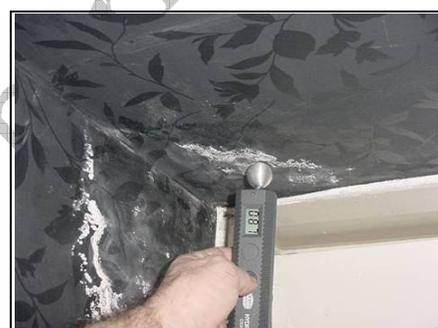
Dampness found using a Gann meter. Is this rising damp or a water leak?
