RESIDENTIAL BUILDING SURVEY

**Kenley,
Surrey
CR8**

**Three Storey
Mid-Terraced
New House**

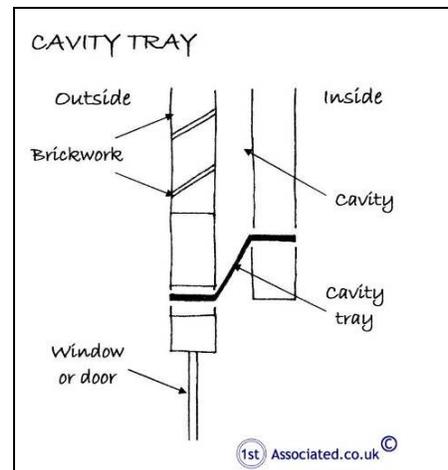
Cavity tray

This type of problem happens on new builds where they are built very quickly and are, we believe, of poor quality control standards. This is where mortar goes into the cavity and causes a bridge between the front wall and the rear wall. To explain this better let us start with the wall construction:

ACTION REQUIRED: We recommend having your property opened up and the cavity tray cleared.

ANTICIPATED COST: This should be part of an NHBC claim. We would recommend that your legal advisers check and confirm with the NHBC that they will be happy to carry out the work before you legally commit to purchasing the property.

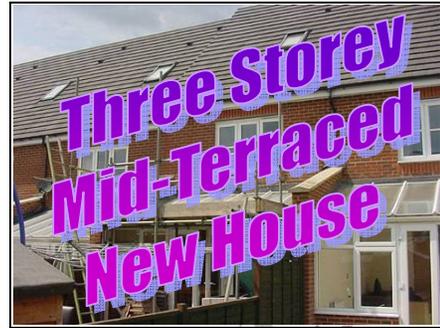
ACTION REQUIRED: We recommend you speak to your neighbours at No. 6 to talk about the problems they have had. At the time of our survey they had scaffolding to the rear conservatory for a problem which we believe is likely to affect you as well.

Next door's scaffolding

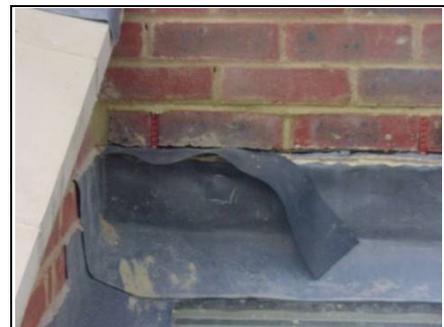
If built quickly, with poor quality standards, then the mortar can be dropped in the cavity and span between front and rear walls which can lead to dampness coming in. This is the problem that No. 6 has been facing.

Next door's flashing being repaired – once the brickwork cavity tray has been worked on

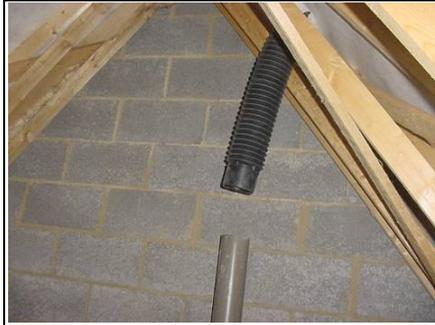
We noted in the roof space that the mechanical vent pipe (also known as Elephant trunks in the trade) from the bathroom has come undone, and another vent pipe is discharging into the rear cupboard.

Vent pipe is not connected

What concerns us about vent pipes not being fixed is that these things are obvious visually and have been left and the simplest of checks should have found this out.

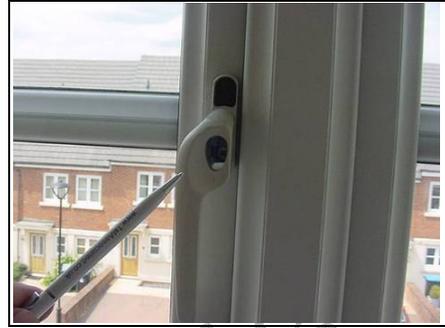
We are advised this building was tenanted and in our experience the way that tenants use a building is different to how a home owner/occupier does. There are various bits of damage in the property, such as the broken window locks and the handle literally coming off and also the locking mechanism to the roof space was missing.

Broken window locks, with the handle literally coming off

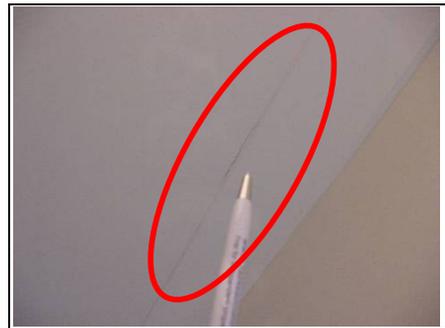
Unfortunately, we would say that modern buildings are generally being built to a lower standard and very much to a price rather than quality standard. This has resulted in various problems where there has been a combination of issues coming to the attention of owners when they have been in the property for some time. One of the main ones with a relatively new build is hairline cracking throughout.

Crack on ceiling

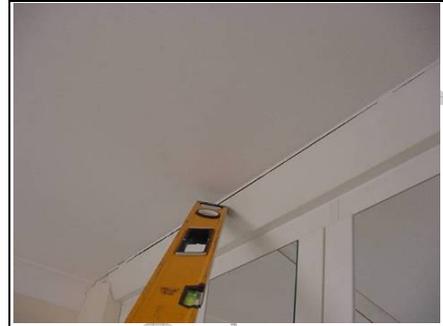
It used to be said that a lot of the cracking was due to initial settlement but we would comment that we believe much of cracking in this property is due to the way the plasterboard has been finished, which is literally but jointed and then taped from what we can see without a skim coat of gypsum plaster. This means that with moisture, humidity and condensation in the property, which we often find you get where a property is rented out, then the taped joints open up.

Settlement crack

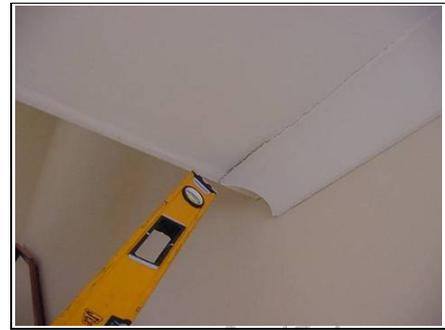
Crack in hallway

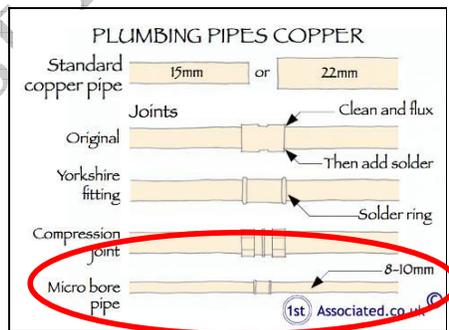
As is sometimes the way on more modern properties, microbore pipes have been used. We are not particularly keen on these as in our experience with running rental properties, they do not have the same flow. In this case they are plastic, which we do not think there in an in-use history of; remember as surveyors we like to see a good 30 years of something being used before we recommend it! You will need to accept that this is a characteristic of the property.

Microbore pipes

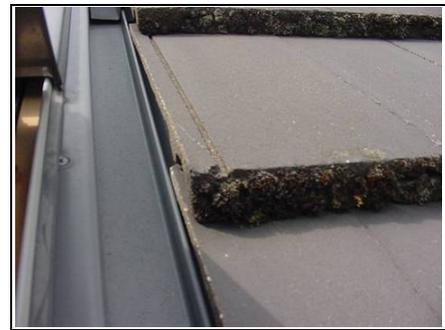
The main roof is pitched and clad with an interlocking clay tiles and from ground level this looks in average condition considering the roof's age, type and style. We did note some moss on the edge of the tiles.

Moss on the edge of the tiles

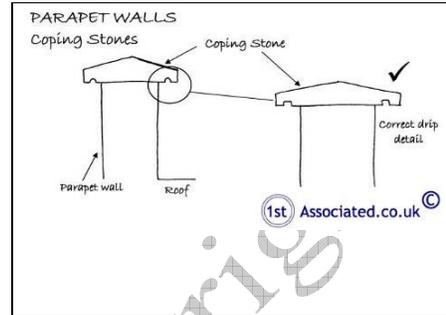
Problems with coping stones

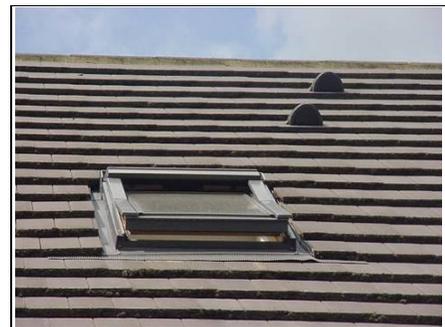
The property has a purpose made roof light to the rear, which looked in average condition. The important factor with roof lights is the flashing around them, in this instance we would comment we could see minor dampness coming through internally, which may be from wind driven rain, where the window was left open.

Roof window to rear

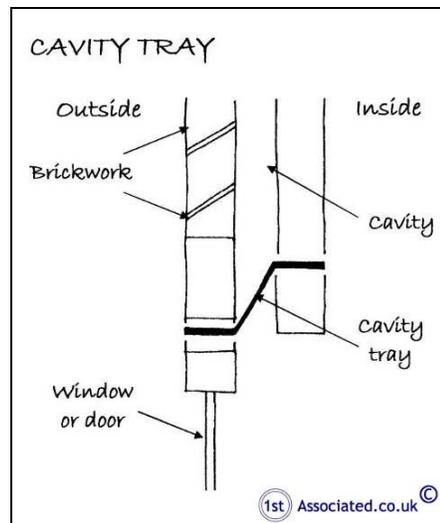
Please note our comments with regard to cavity wall repairs.

Cavity tray

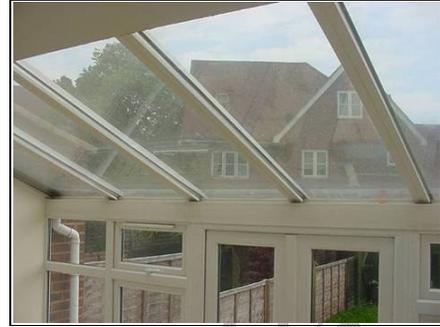
Inside conservatory

During our question and answer session with next door they advised that they had a pane of glass crack, which we would say relates to there not being enough expansion in the design of the conservatories.

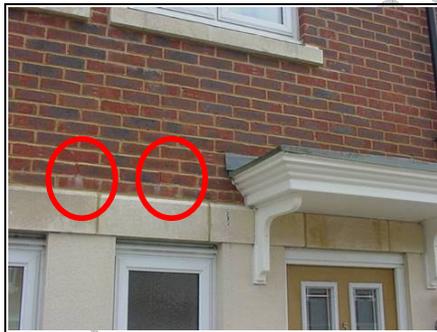
We noted some efflorescence on the brickwork.

Small bits of efflorescence to the front brickwork

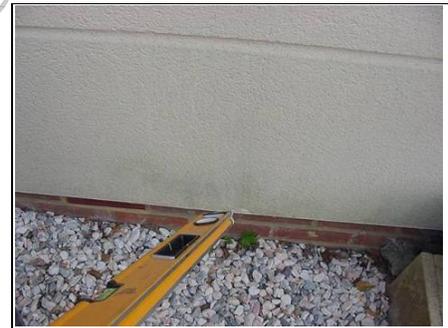
We can see that mould is starting to occur at the bottom of the rendered panels, which we believe will become a big problem.

Mould starting to occur

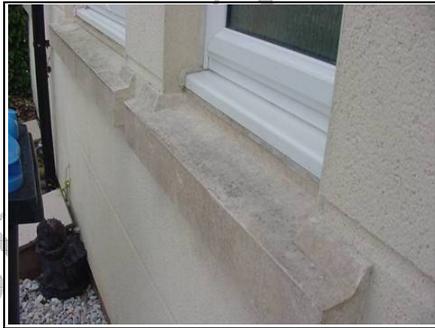
Slight moss on window sills

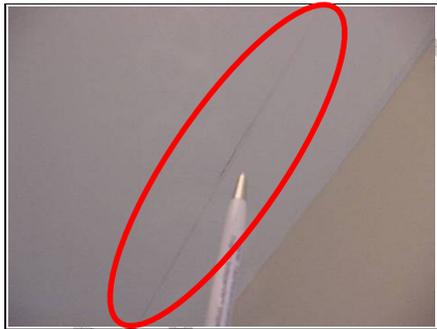
This is quite a common occurrence in older properties, brought about by differential movement in the structure to what the plasterboard can cope with. They tend to be very straight cracks.

Hairline plasterboard cracking
on landing

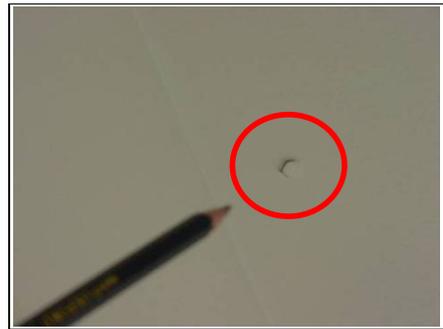
Popping to plasterboard rear left
hand side indicating there could
be dampness in

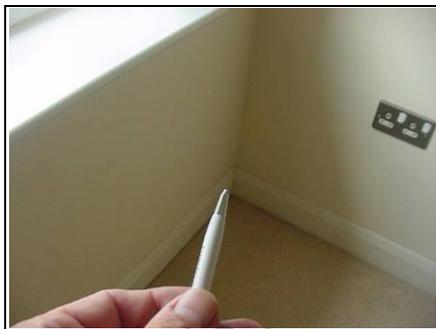
Movement cracking front bedroom left corner

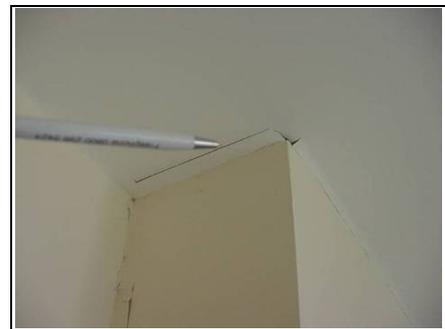
Cracking and movement in rear bedroom

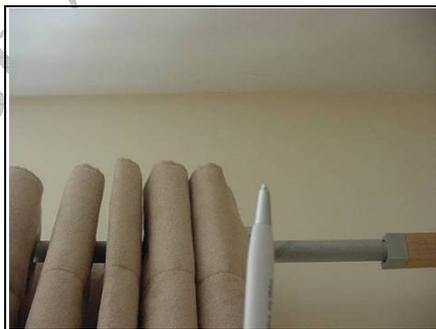
Cracking on wall in rear bedroom

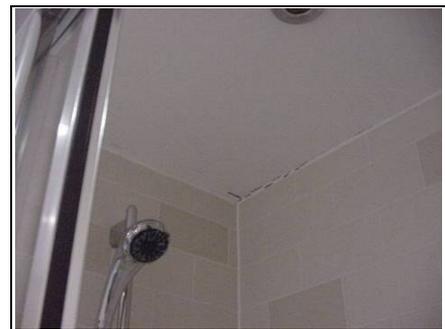
Cracking in shower

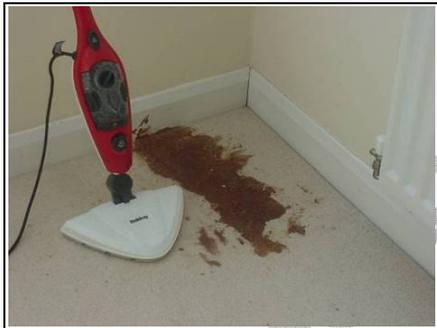
Damaged carpet

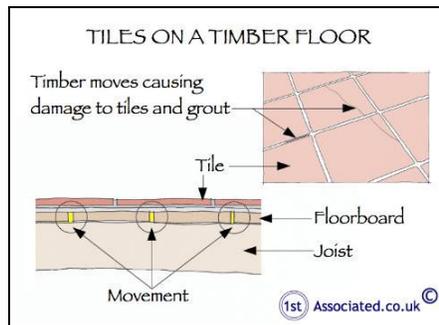
We noted that tiles have been laid on top of a wooden floor in the bathrooms, which is not ideal.

Tiles on to wooden floor

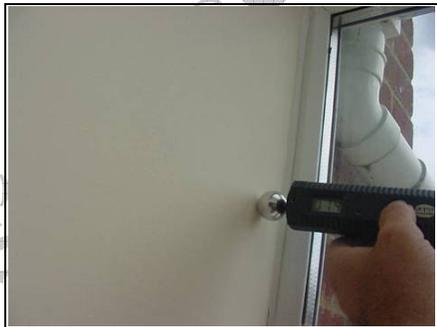
We found dampness in the conservatory and double checked the level of dampness with our electronic damp meters.

Taking damp readings in conservatory

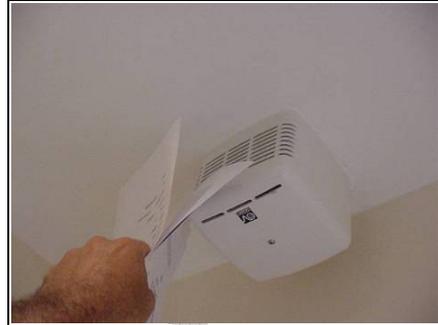
At the time of the inspection there were no signs of condensation. The extract fan in bathroom gives very poor extraction and this may lead to condensation.

Extract in bathroom gives poor extraction

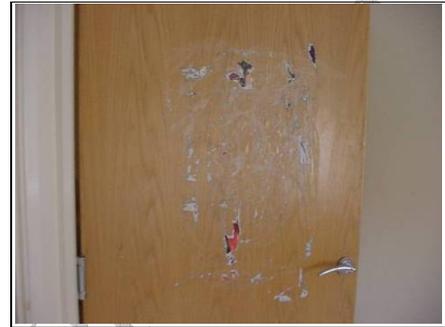
The doors are hollow core doors with a veneer finish. One of the doors looked damaged and in need of a good clean.

Damaged veneer door

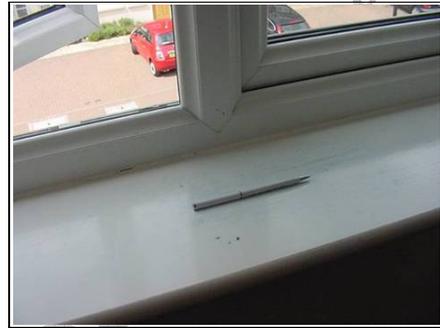
Colour grinning through window sill – in need of redecoration

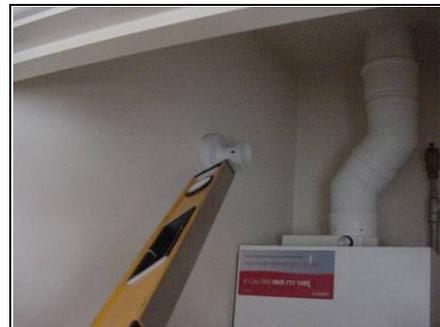
Vent discharging internally

The wall mounted Potterton boiler was located in the cupboard the master bedroom on the top floor. We noted the vent was discharging internally.

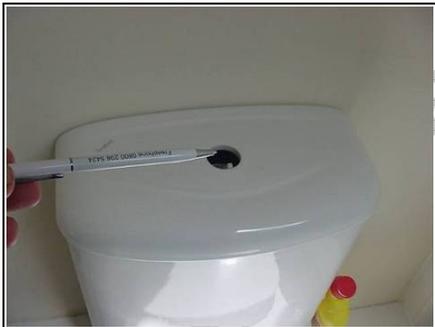
We noted that the flushing button on the WC in the master bedroom en-suite is missing.

Flushing button missing

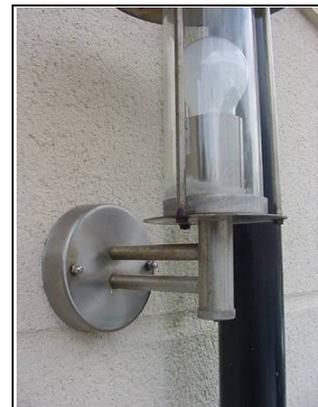
The front porch light is starting to rust.

Light starting to rust
