RESIDENTIAL BUILDING SURVEY

Stanmore,
HA7

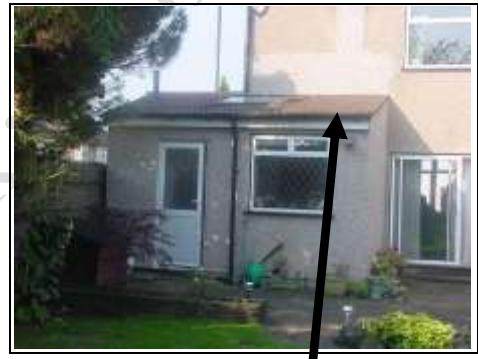
We are always slightly concerned when there is such a shallow pitch on a tiled roof as wind driven rain can get underneath it. From a visual inspection internally there are no visual signs of dampness coming in.

Shallow pitched roof to kitchen extension

ACTION REQUIRED: Keep all the gutters clear and remove moss and tree debris as the build-up can aid water getting into the roof.

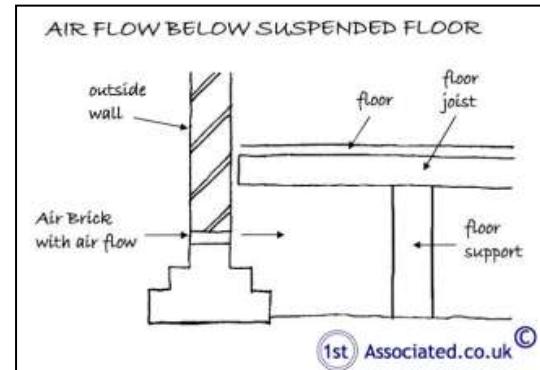
Suspended timber floor

Blocked air vents

ACTION REQUIRED: We recommend that you double check that there are airbricks to both the front and the rear of the property to allow a through flow of air. Next time the carpets are replaced (or before 2014) we recommend you open up a section of the floor to check the condition of the timbers underneath.

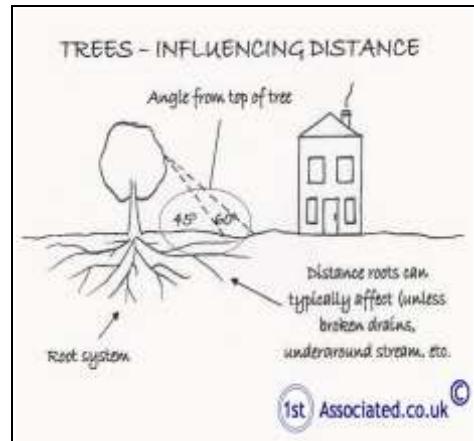
Influencing distance

However in this instance we can see roots are starting to get into the drainage system so these need to be cut back. This also indicates that the trees need to be lopped.

ACTION REQUIRED: Your Legal Advisor should specifically ask in writing if the owners have had problems with roots in the drains in the past. We would recommend a closed circuit TV camera report to establish the condition of the drains to check if there are roots within them.

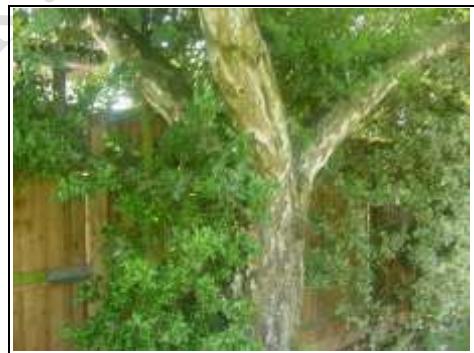
Trees to the rear of the property

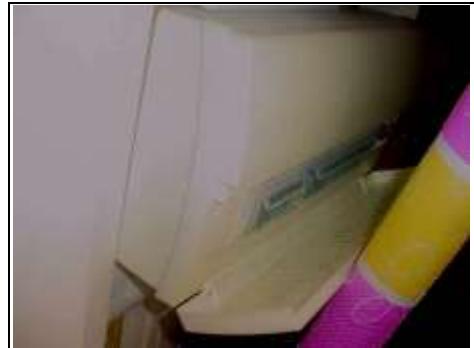
Dated fuse board

ACTION REQUIRED: We would recommend replacement of the fuse board.

We would also recommend increasing the number of socket points as there seemed to be a fair number of extension leads and adapters being used.

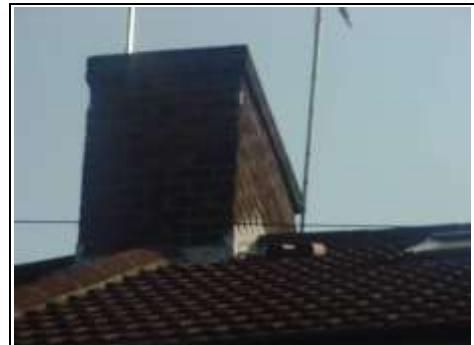
Chimney (left)

This chimney is brick finished with a lead flashing and no chimney pots. From what we could see, as we had a limited view, it looked in average condition considering its age, type and style.

There is a large aerial on the chimney supported by wires. In this case if the wire does get displaced it could cut into the brickwork, like cheese wire into cheese!

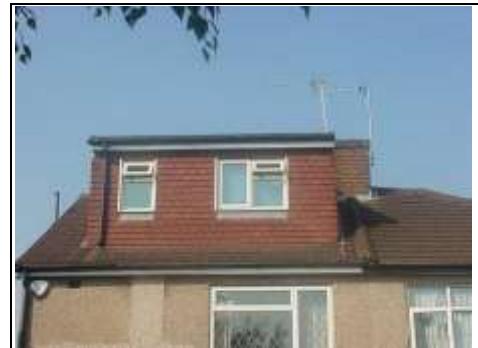
Dormer window

To the rear of the property a major dormer window has been added to allow for full height within the loft extension. The dormer window is made from a vertical tile with a felt roof (we could only see the edge of this). Our main concern about this is we cannot see the flat roof. What we could see seemed to be in average condition for its age, type and style.

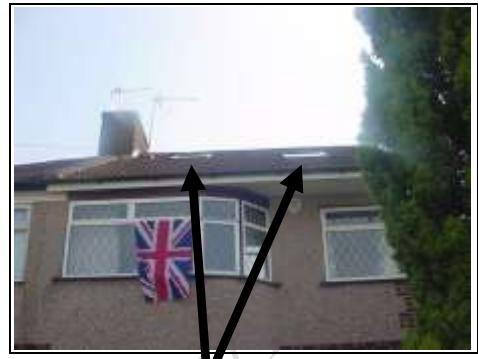
Roof windows (front)

The property has four purpose made roof lights, two at the front of the main roof and two to the rear extension roof which all looked in average condition. The important factor with roof lights is the flashing around them.

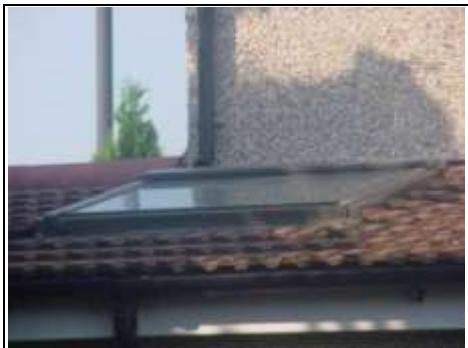
Roof window to the rear extension

It seems inevitable with roof windows that they will sooner or later leak. If this doesn't occur then they seem prone to condensation.

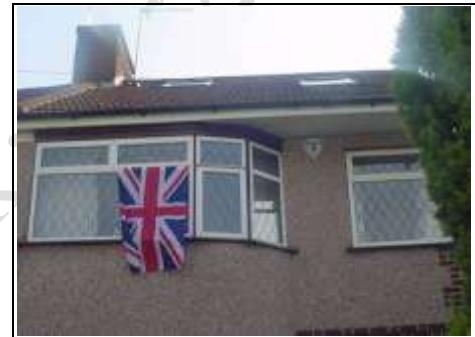
Main roof

The main roof is pitched and clad with a small concrete tile (we are not one hundred per cent certain of this) and, from ground level, this looks in average condition considering the roofs age type and style. With this age of roof there will usually be a few missing or displaced tiles, this is nothing unusual.

ACTION REQUIRED: Carry out periodic inspections and maintenance of the roof and clear roof of moss occasionally or as required. We would not recommend the roof is pressure cleaned.

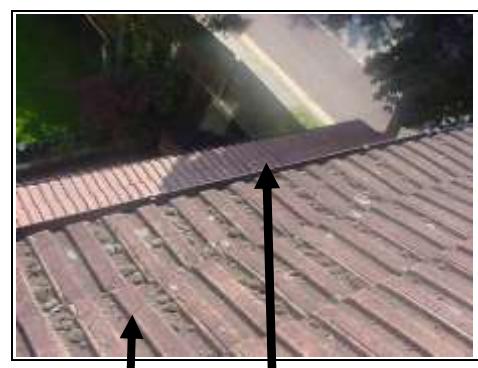
Main roof. Shallow pitch roof.

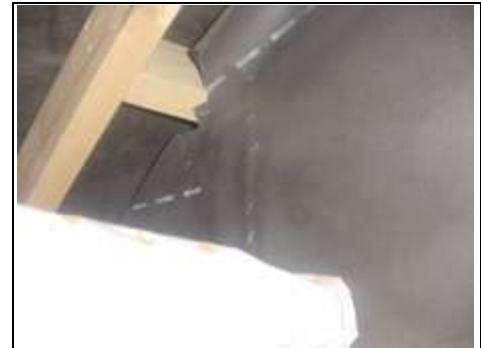
Limited view of roof timbers

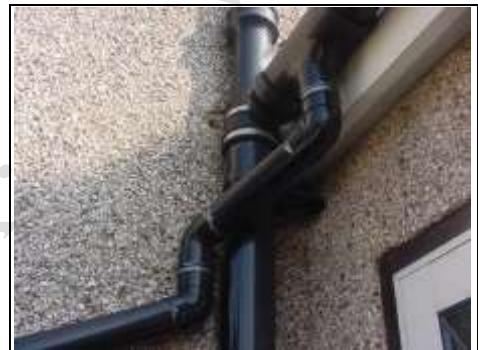
Plastic downpipes with wide joints,
we assume that these leak

We would always recommend that the gutters and downpipes are cleaned out, the joints are checked and the alignment checked to ensure that the gutters fall towards the downpipes.

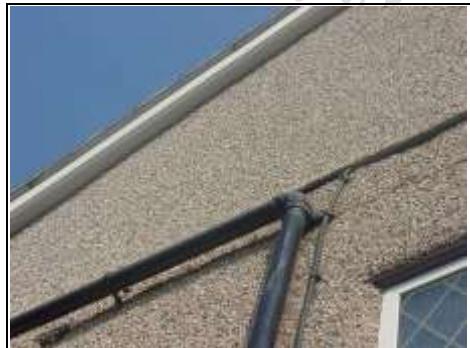
Awkward bend in downpipe

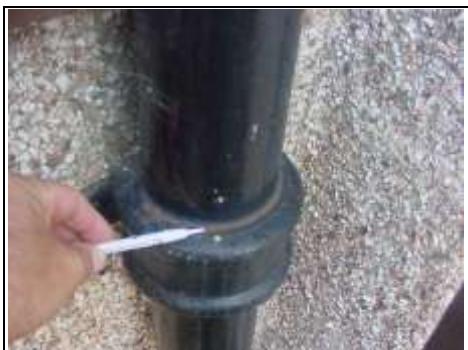
Minor rusting on soil and vent pipe that is expected on cast iron

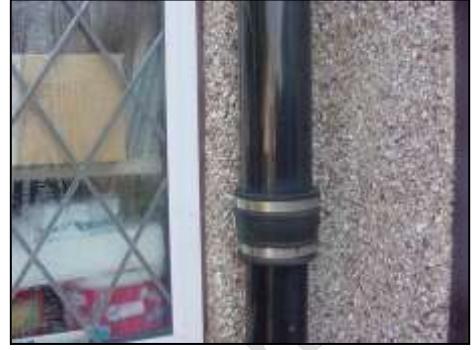
Combination of cast iron and plastic soil and vent pipe

ACTION REQUIRED: We would always recommend you stand outside the property next time it rains heavily and see how well the drains cope with the rainwater particularly looking at the guttering and the joints.

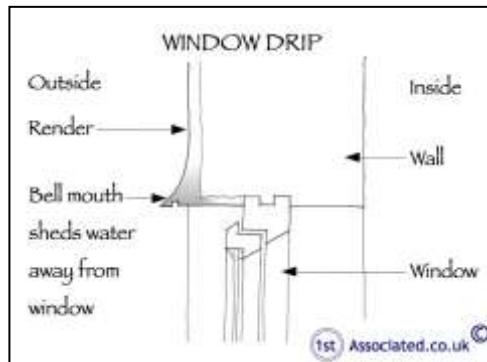
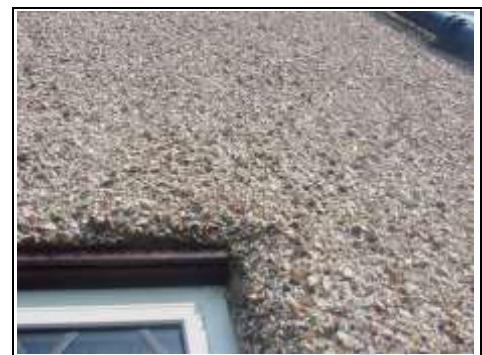
In this case we found no drip detail to the windows.

No drip detail over the window

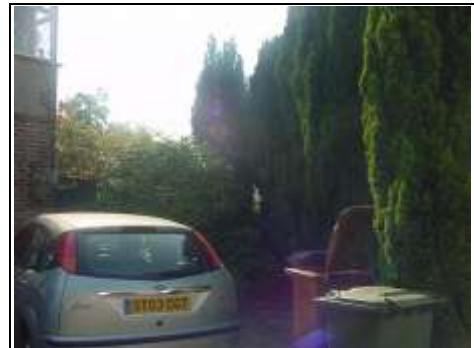
There are a fairly large number of mature trees in this garden. Most insurance companies are not keen on trees and these trees are within what insurance companies would term as influencing distance of the property.

Trees to the right of the property
(all directions given as you face the property)

ACTION REQUIRED:

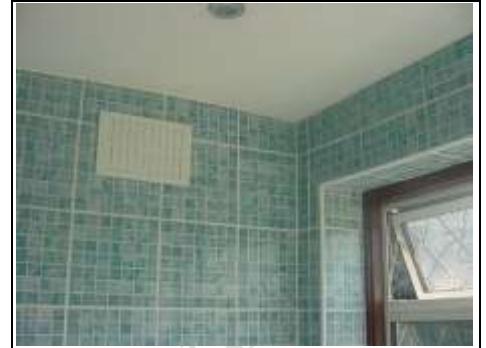
Large humidity controlled extract fan required in bathrooms and kitchen

ACTION REQUIRED: We would recommend humidity controlled extract fans be added to kitchens and bathrooms.

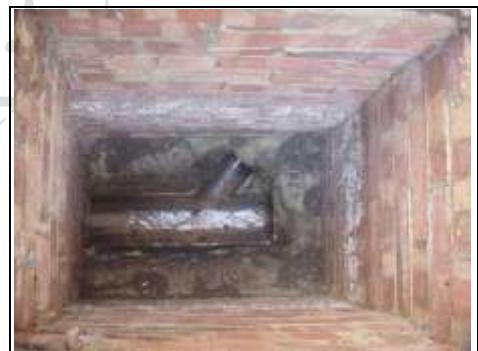
Manhole (middle right)

From what we could see it is brick built and has some deterioration.
