ENGINEERS REPORT / SPECIFIC DEFECTS

Relating to Cracking to the Rear of the Property

**Ground Floor Apartment within a Large
Early Victorian Property in London**

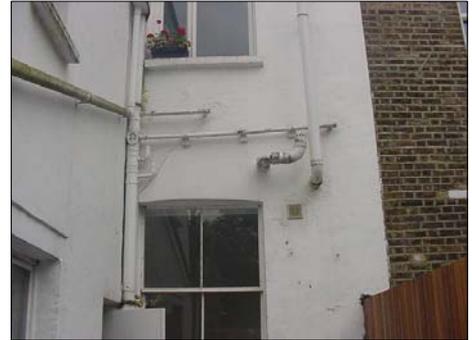
Diagonal cracking to left hand side of window

1. Externally to the subject property diagonal cracking of approximately one and a half metres ranging from 1mm to 8mm with a depth range of approximately 10mm – 40mm, the majority of which is in the 10mm – 15mm range, indicating that the minority of the crack is also into the brickwork. The cracking looks to have been repaired previously.

ACTION REQUIRED: We would recommend that the render is opened up in this area to check the type and condition of the lintel.

If this is a timber lintel depending upon its condition it may be necessary to replace it.

If it is a brick soldier course lintel that has slipped then it needs to be secured in place, i.e. packing or a supporting metal lintel.

Whilst opening up the render you should also check to see if the cracks transfer through the bricks. We found when checking the depth of the raking crack that the majority of it was render thickness, with approximately a quarter of it going deeper than we would expect; indicating the possibility of some brickwork damage.

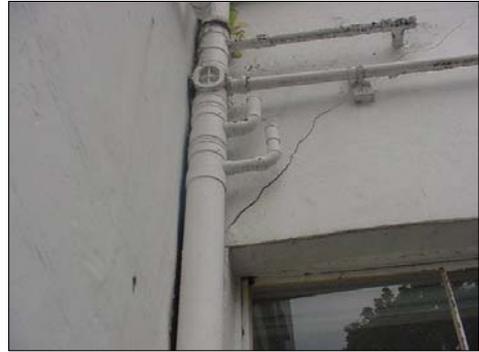
2. We noted hairline cracking over the adjacent kitchen window that looks to have been repaired previously.

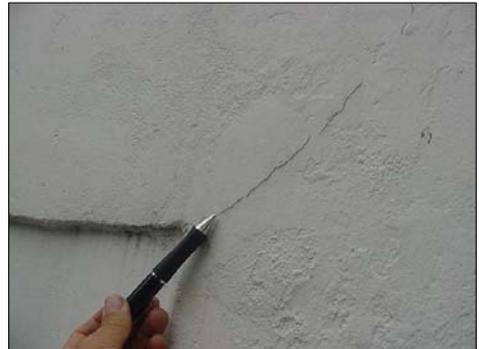
3. Externally we noted that the soil and vent pipes showed signs that they are leaking quite badly with a vegetation growth, which are immediately next to the widest part of the crack, which we feel will be causing additional problems with the freeze / thaw cycle.

In our discussions with the owner she advised that the gutters had been replaced. We would assume that deterioration had been caused to the render and possibly the brickwork before this by the discharging of rainwater down the face of the property.

The soil and vent pipes and the rainwater pipes need to be made watertight.

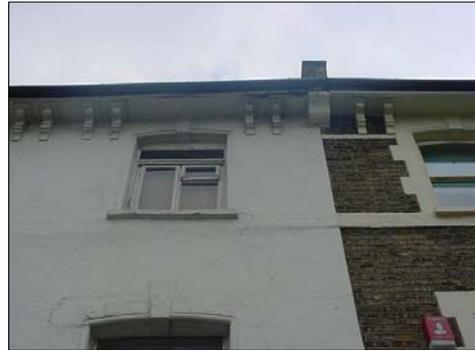
6. We also reviewed the front of the property, which is also rendered and we noticed a defective soffit and fascia indicating possibly that the guttering is still leaking in this area.

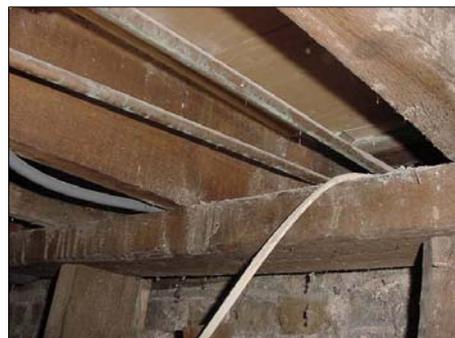
9. We did access the cellar area; the majority of the ceiling was clad but we were able to see a small selection of floor joists within an access hatch within the cellar. What we could see looked in reasonable condition.

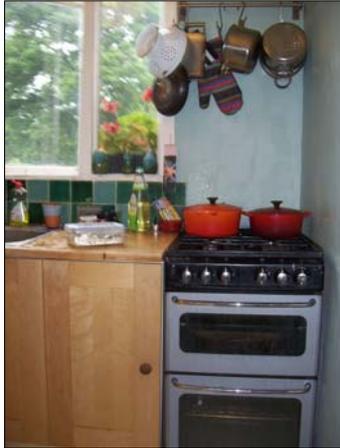
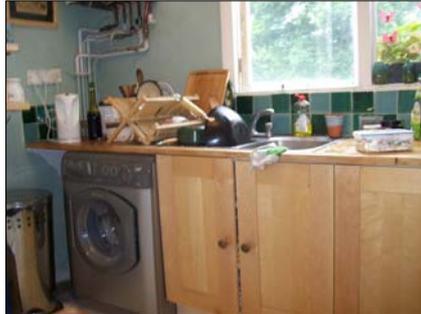
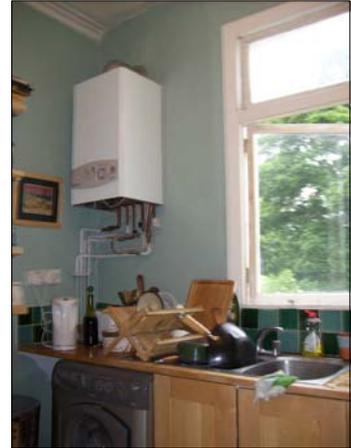
10. We have been forwarded these three photos of the first floor apartment by the client. From our inspection of the photos they do not show any signs of internal cracking, even though cracking can be seen externally.

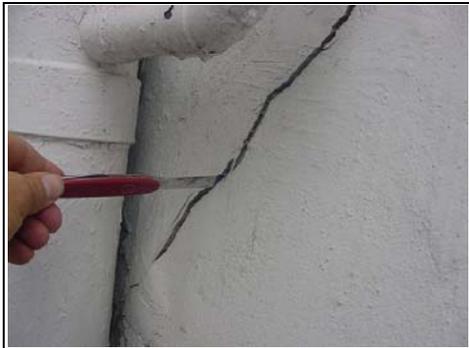
Checking depth of crack -
Bottom of crack

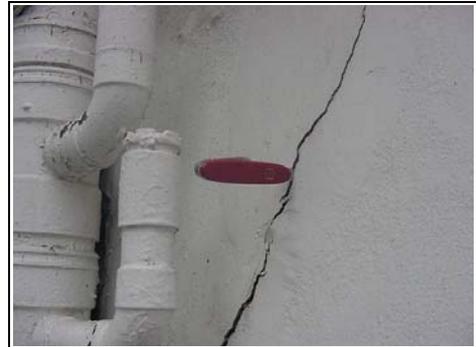
Checking depth of crack -
Lower middle section

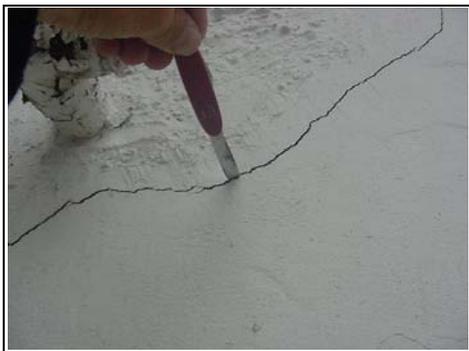
Checking depth of crack -
Upper middle section

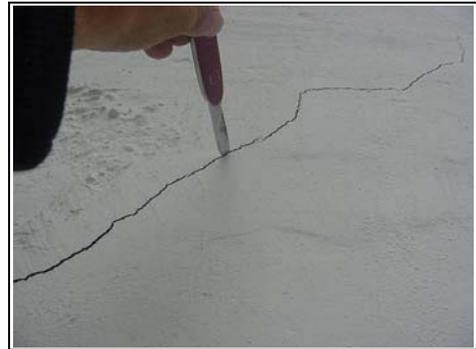
Checking depth of crack –
Top section

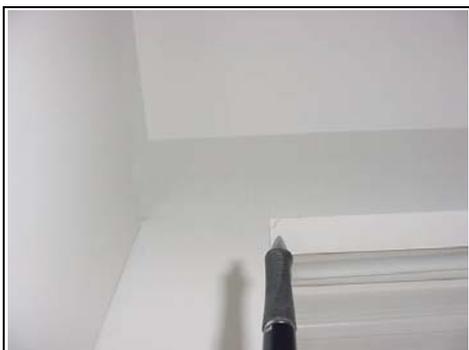
Bedroom – Minor hairline crack
due to drying out of internal
finishing material

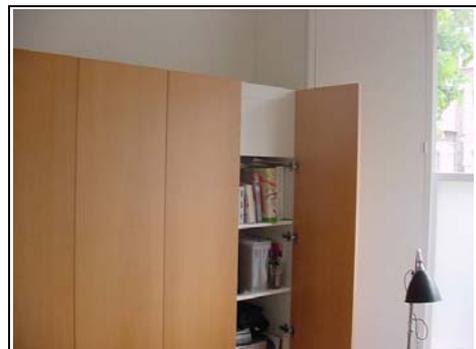
Adjacent cupboard is lined, so we
did not have access to the wall
structure.
