SPECIFIC DEFECTS REPORT

Relating to Cracking to the Plasterwork Due to Dampness

Victorian Terraced Property in London

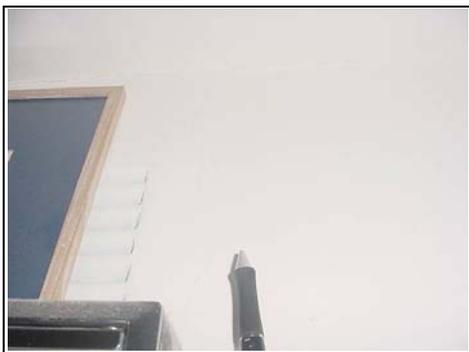
An example of the hairline cracking to the rear wall of the bathroom

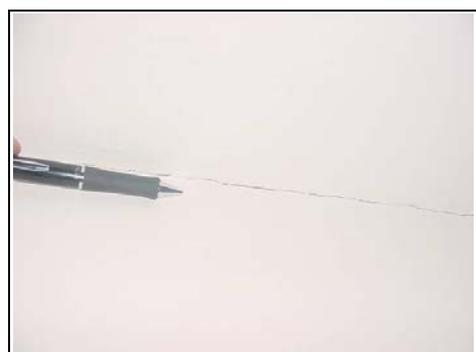
An example of the hairline cracking to the right hand wall of the Kitchen

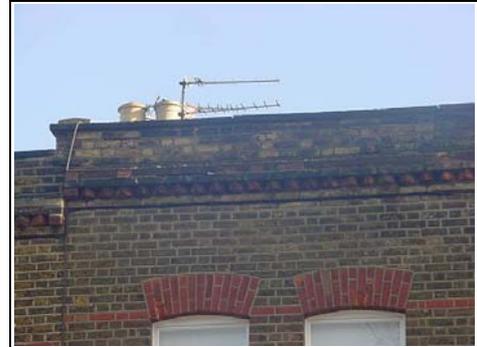
Dampness is getting into the property from a variety of sources for example, the butterfly roof area. The parapet wall needs repointing, possibly having a coping stone added to stop water getting in from the top and we also noted some slates displaced to the butterfly roof, particularly to the perimeter which need bedding into mortar. There is also some repointing required to the rear flat roof flashing.

Defective Parapet Wall to the front of the property which is allowing dampness in to the front wall.

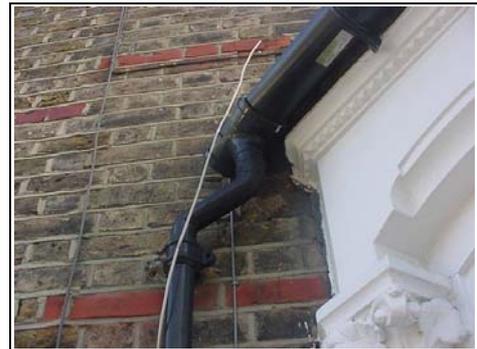
Smaller downpipe to the bay window (which could get blocked and lead to water discharging down the wall in this area which causes additional dampness

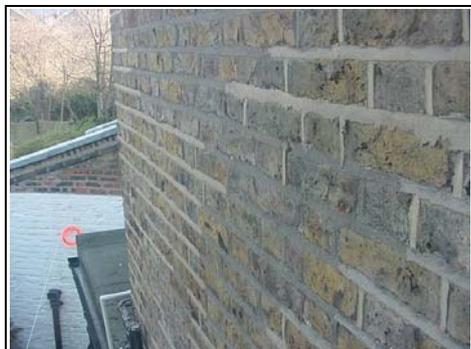
There are signs that this area has been repointed which is probably due to the gutter overflowing above (this was viewed from the rear bedroom)

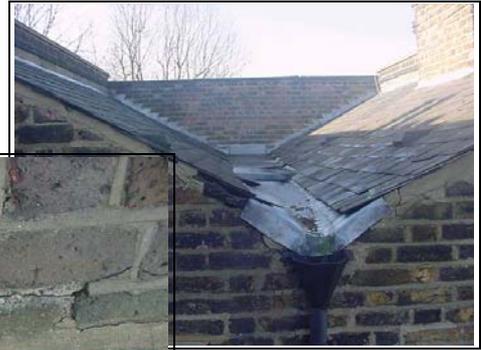
View of your butterfly roof with the missing mortar to either side of the valley gutter

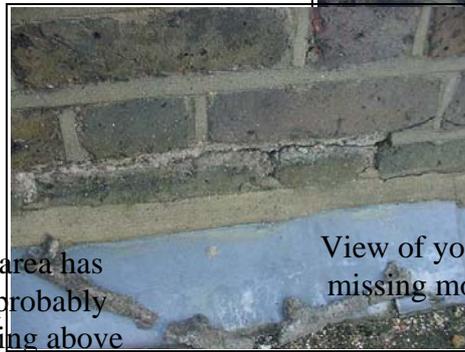
The cement mortar coming away to the flashing of the flat roof

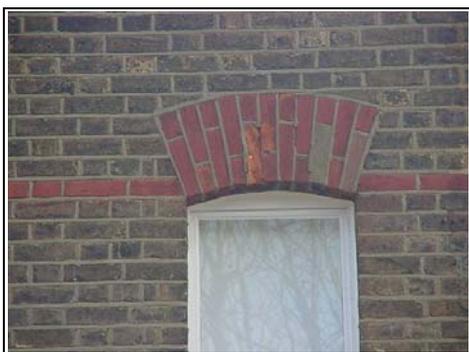
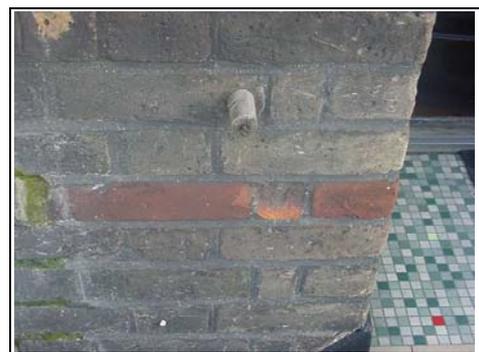
The Walls are no longer breathable as they were originally constructed due to them being repointed in a cement mortar externally and internally having a modern plaster, together with having the original slate damp proof course (assumed) and an inserted damp proof course (assumed). Any moisture which gets into the wall will have difficulty in getting out again. This is resulting in spalling to the face of the brickwork, particularly the softer red bricks.

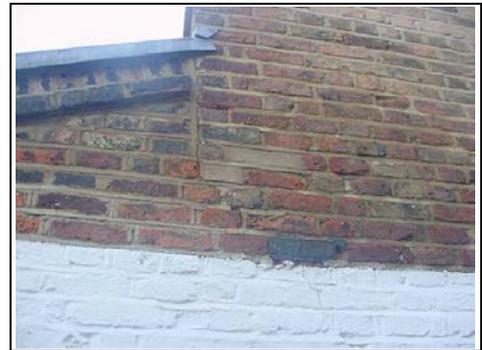
The cracking to your neighbour's property could indicate that there is a leak on the drainage route which is relatively common in this age of property. The movement which is visible to their property indicates that there may be shrinkable clay in the area. Above this percentage it expands causing what is known as heave although this in itself turns to dust causing what is known as settlement.

Your neighbour's wall with a crack where it has been extended

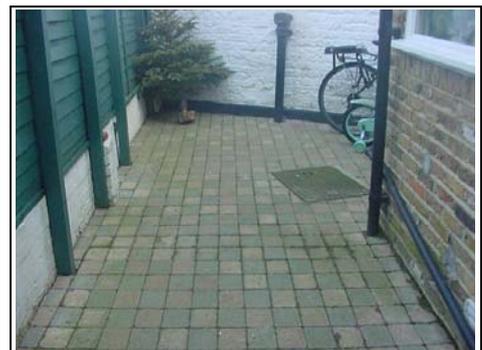
The man hole to the right hand side being along the route which we feel the drains will take

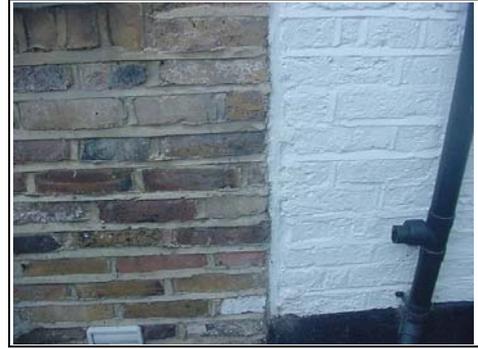
We also noticed that there is a straight joint between the original property and the new property (shown in the photograph) which indicates a modern brick laying system has been used rather than the traditional tooth and bonding system which in our experience tends to allow more movement.

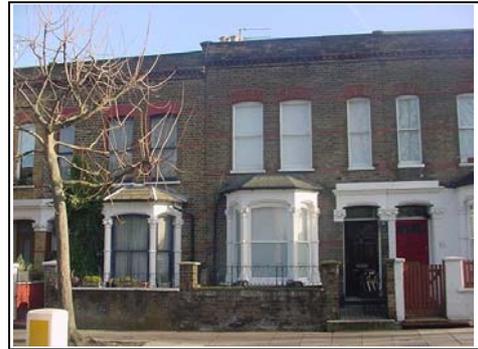
We also noted to the front of the property that originally it was built with a straight joint on the left hand side. This means there can be some additional movement to what we would traditionally see in terraced property.

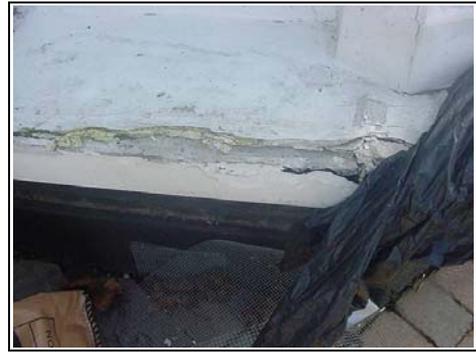
It appears that a repair has been carried out in years gone by to the window sill which involved applying an additional coat over the top on the original sill. This has now failed due to lack of bonding agent (or reinforcements). It is very difficult to advise on a repair method until we see the extent of the condition of the original sill.

De-lamination of Bay Window Sill
