SPECIFIC DEFECTS REPORT

Relating to Wall Dampness

Modern Apartment in Southend

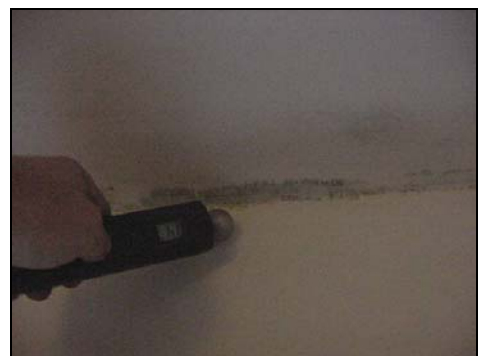
Mould

The property has extensive mould to the external walls (only visible to the top of the main bedroom wall at the time of our inspection) and the shower curtain.

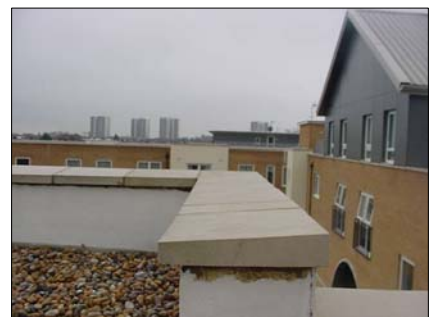
Coping Stone

We note that mastic has been used to cover the joints on the coping stone of the parapet wall and also to form a drip on the inner lip of the coping stone. We consider this to be a temporary solution, if indeed it does solve the problem.

ACTION REQUIRED: Builder to replace all coping stones or over clad them. We would also recommend a lead flashing is placed on the inner wall to stop dampness ingress.

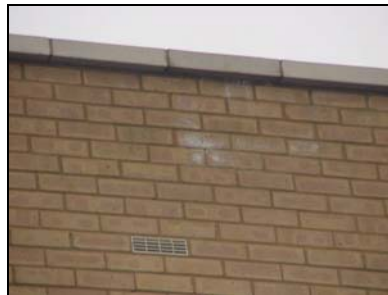
Efflorescence was noted to the brickwork. Efflorescence gets its name from concentrated salt deposits forming a crystalline layer which some say look like small flowers.

Efflorescence. Also note the weep holes to the lintels above the windows

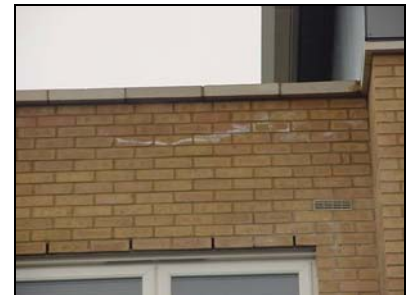
Adjoining properties
Efflorescence

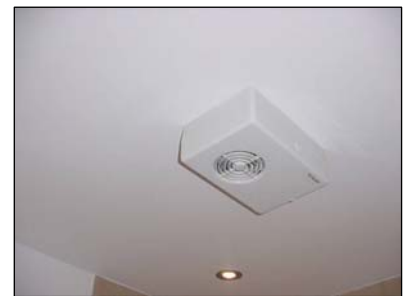
Extract fan
Need to identify where the extract fan discharges to

Throughout the property we would recommend increased ventilation, for example the extract in the bathroom could be increased to 150mm. We would also check that the extracts are extracting to the exterior of the property; there were no obvious signs of where they ventilate to.
