# RESIDENTIAL BUILDING SURVEY

Dorset

## **INTRODUCTION**

Firstly, may we thank you for your instructions; we have now undertaken a Building Survey (formerly known as a Structural Survey) of the aforementioned property.

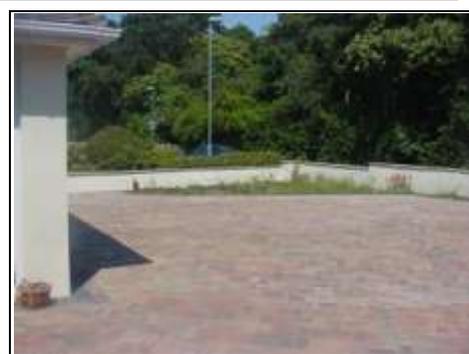
Car Parking Area

### 2) **Car Parking Area runs towards the Property and will cause dampness**

The car parking area runs towards the house and therefore when it rains we would expect the rain to do the same. We would expect a running gully or French Drain to run along the entirety of the house. We can see that one has been put in front of the garage although we cannot confirm if this is connected to a drain or not.

**ACTION REQUIRED:** Our preferred method would be a French Drain. Without this there will be damage, deterioration and dampness to the base of the render over time.

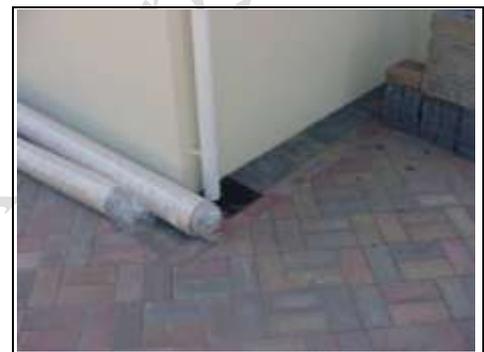
We were unable to see a Damp Proof Course and we also noted that the render doesn't have a bell mouth at the base which is a traditional detail to help stop damp or drips from above the windows. Whilst these may be considered old fashioned they have for many years helped stop dampness getting into a property. We much prefer a bell mouth detail to the base of the property although we do accept that a window drip perhaps is not as important today with plastic windows. This together with the off road car parking area which looks as if it is running towards the house, leads us to believe that there is likely to be dampness in the front elevation in years to come, unless a running gully or French drain is added as recommended above.

Lack of Bell Mouth Detail to base of Render

**ACTION REQUIRED:** Add a running gully / French drain.

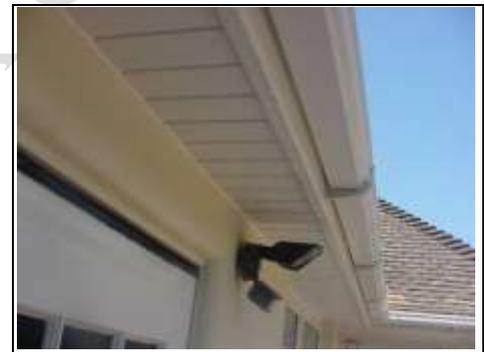
The fascias and soffits rather than being replaced have overclad the original timber. This is normally carried out where the timber is in poor condition. Unfortunately it can exasperate the problem as the fascias and soffits are now encased without any ventilation.

Over cladding on Fascia and soffits

This can be problematic as it can lead to wet rot and dry rot in the fascias and soffits. Over cladding is normally carried out as a more economical solution.

**ACTION REQUIRED:** In the long term we would recommend that this fascia and soffit is removed (you will also have to remove the gutters) and replace with a fascia and soffits either in timber or solid plastic.

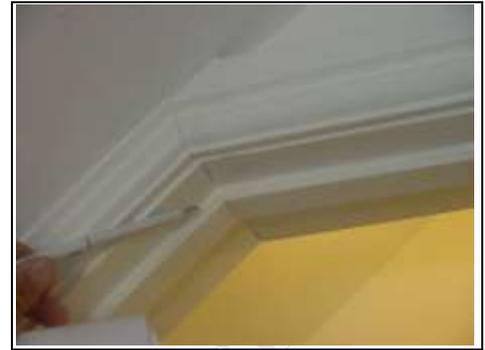
In any property which has been built from a mixture of construction such as this, where you have the original construction which has been added to a modern construction and particularly where a steel frame has been added, it changes in how the roof structure weight applies to the building. You have to expect some movement and as such there is likely to be some cracking, particularly in joints of plasterboard walls and ceilings and corners. We would add interestingly that the house walls didn't look to have any expansion joints in them to allow for such movement, these may be well hidden.

Opening up of architraves around the doors

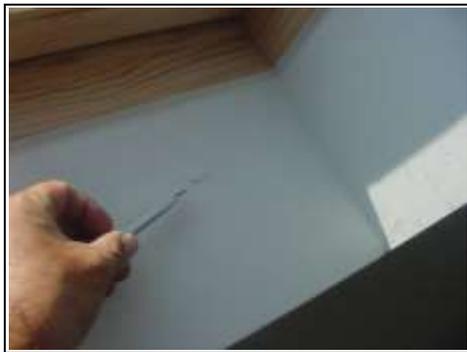
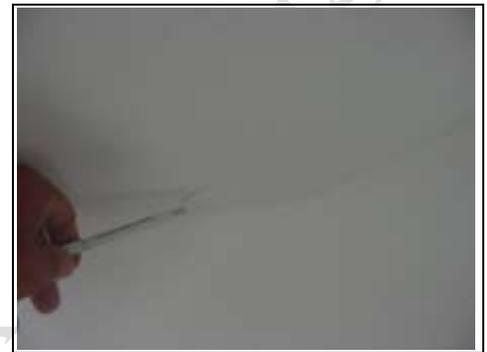
We noticed, particularly around the landing area / roof lights, that there is an amount of popping of plaster. This normally occurs when the incorrect nails have been used or that they have been bedded into the plaster incorrectly. This unfortunately can give a "spotty dog" type of affect to the plaster even when you are repairing it.

Popping of the Plaster

**ACTION REQUIRED:** We would therefore recommend that you obtain some sort of guarantee from the owner/developer.

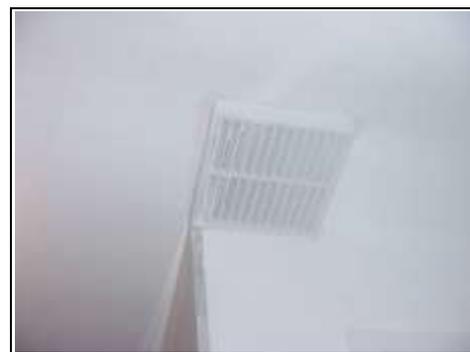
During the course of our inspection we could not get the extract system working within the bathrooms. The owner of the property came to show us how they worked and also could not get them working. We demonstrated the lack of extraction by holding sheets of paper against the extract fans. As the bathrooms and shower rooms are internal it is essential that they work otherwise you will increase the movement/cracking and possibly the popping that we discussed earlier to the plasterboard. The owner advised that the building control officer had managed to get them working but we would say that he hasn't and as such we would recommend the following:

We were unable to get the extracts to work within the bathrooms

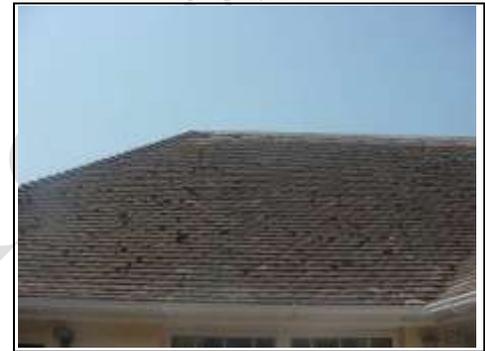
Hidden flat roof

**ACTION REQUIRED:** Please see our comments within the Executive Summary requiring an access hatch to be added by the present owner/developer so the roof can be viewed prior to purchasing the property.

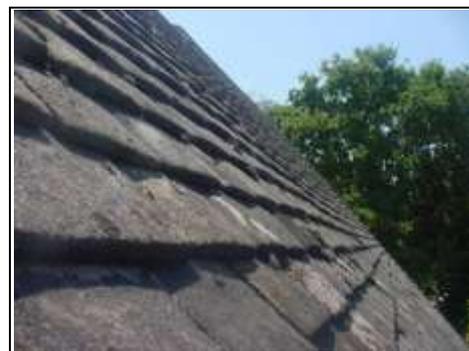
Concrete Tiles

The roof is pitched and clad in a small nibbed concrete tile. From what we could see the concrete tiles are lying level and true and look in reasonable condition.

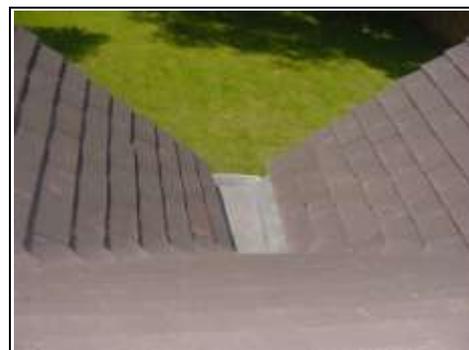
There is a valley gutter to the rear of the property where the two roofs join with a flat roof section in between. These are generally poor construction areas. With the surrounding trees and associated leaves and branches you will need to regularly clean this and ensure that it drains away rather than drains into the property.

Valley Gutter to the Rear. We think that this will block in years to come as it is a poor detail.

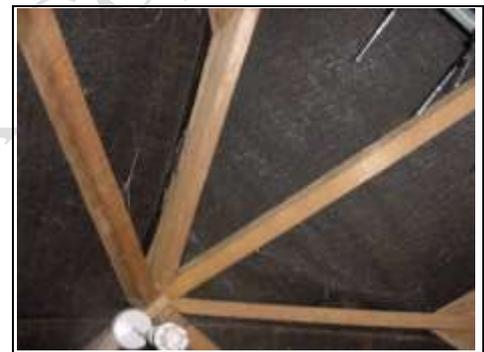
Underlayer

Our view inside the roof has been very limited. The areas that we could see to the front accessed via the front right hand bedroom cupboard had a hessian based Bitumen membrane which has been used since the 1940's thereby showing that the original roof tiles are probably still in place. If we looked at a modern roof we would expect to find a modern breathable underlayer which tends to be a white or grey colour which have been in use since 2002.

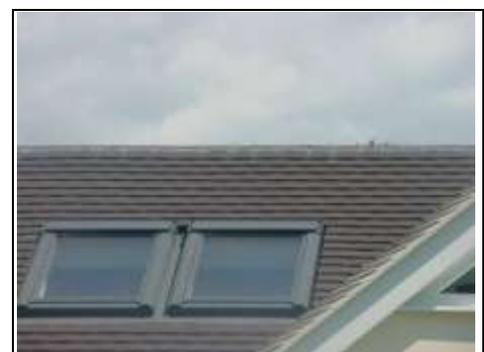
Roof Windows

We find that most roof windows leak sooner or later, or you get condensation!

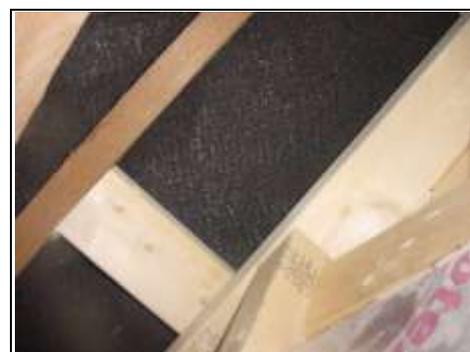
Roof timbers

Our examination was very limited by the configuration of the roof. What we could see was generally found to be in average condition considering its age.

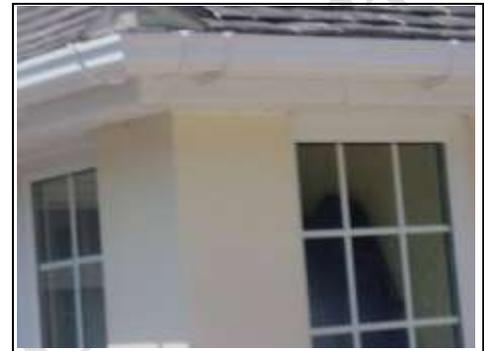
Gutters

From ground level the gutters and downpipes looked to be what is known as, profile plastic, which means the gutters and downpipes are shaped. They look as new, there is no pattern staining that we could see on the front and rear elevations. Obviously our view to the side was very limited.

**ACTION REQUIRED:** We would always recommend that the gutters and downpipes are cleaned out, the joints are checked and the alignment checked to ensure that the gutters fall towards the downpipes.

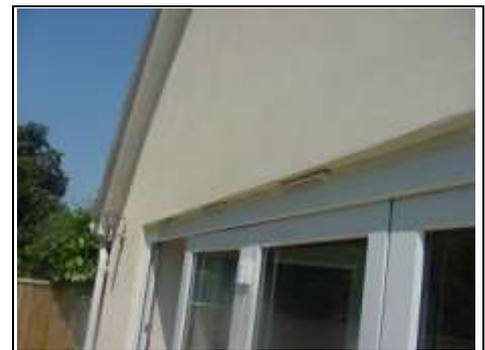
Render

The render is the external finish that has been painted over. We have carried out a tap test to the render at low level (literally hitting the render with the back of a hammer) to try to establish if there are any hollow areas and found it to be in average condition. It is, however, very important to keep the render in good decorative order as without this the render will deteriorate.

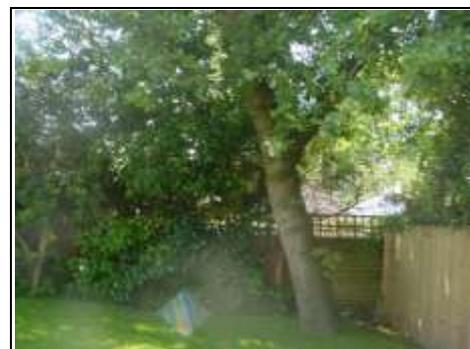
Mature Trees

There are some large trees fairly close to the property within what we would term as influencing distance of the property. Insurance companies are becoming more and more concerned about trees near properties. In this case we don't think the root system will be damaging the property and in theory the foundations should have allowed for this in the new extension.

**ACTION REQUIRED:** It is probably best to remember that trees need maintenance from time to time such as cutting back. Without this their root system may well grow to damage the property and/or the drains.

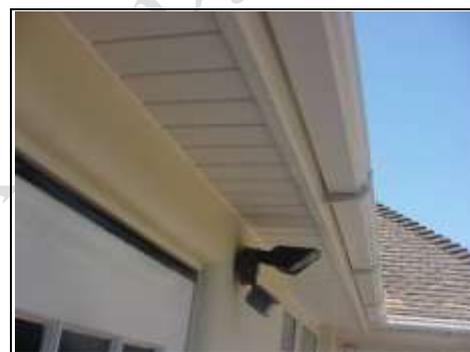
Please see our comments in the Executive Summary. We believe overcladding to be a poor quality system. The plastic is usually stuck on and as there is no ventilation in this area, rot can occur.

Fascias and Soffits are over clad

**ACTION REQUIRED:** Strip off the over cladding and check the condition of the timber beneath. Ideally you should replace completely and add a vent to the soffit and repair and redecorate as necessary.

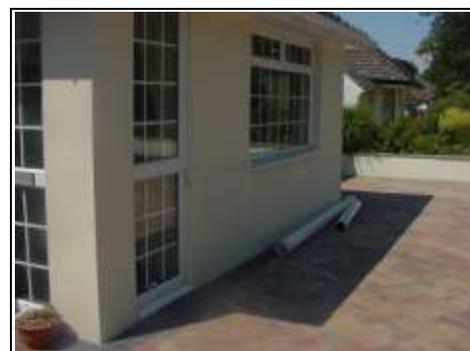
Windows and Doors

The property has plastic, double glazed windows and doors, which generally look to be of an average quality for the year made. We have made this comment because the older windows don't have any trickle vents but the more modern windows/sliding doors do and although they look quite similar at first glance they have very different characteristics and also very different places in the life of the windows. We were surprised that all the windows hadn't been replaced with a modern double glazed unit.

**ACTION REQUIRED:** Ask for guarantees with regards to all the replacement units. If they have all been replaced then we are surprised that they haven't all got trickle vents.

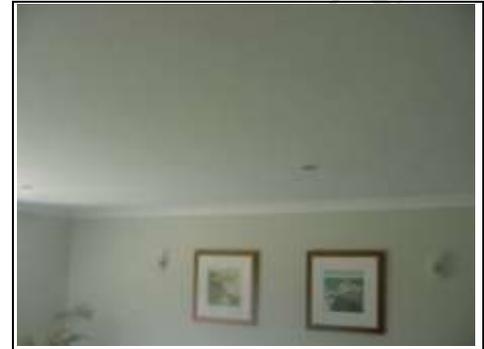
Ceiling

From our visual inspection of the ceilings and our general knowledge of this age and type of construction we believe that the ceilings are likely to be plasterboard (assumed). Please see our comments with regards to the popping that is occurring.

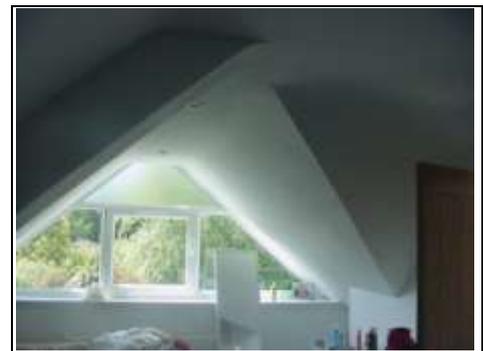
Drop beams (rather than flush beams) are visible throughout the property, these do infringe some areas.

Drop beam infringing on ceiling and room height

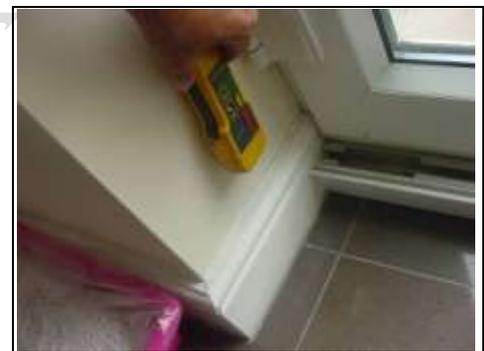
Checking for Rising Damp

A random visual inspection and tests with a moisture meter have been taken to the perimeter walls and some internal walls. Whilst we didn't find any readings we are concerned that the outside floor levels are similar to the inside floor levels without any French Drain or other way of getting the water away from the property.

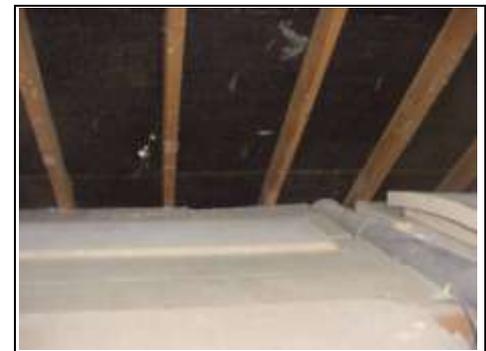
Roof Insulation

Some roof insulation was present although not to current Building Regulations requirements of 300mm. In the areas we could see we were surprised by the amount of insulation that was there considering it is an as new property.

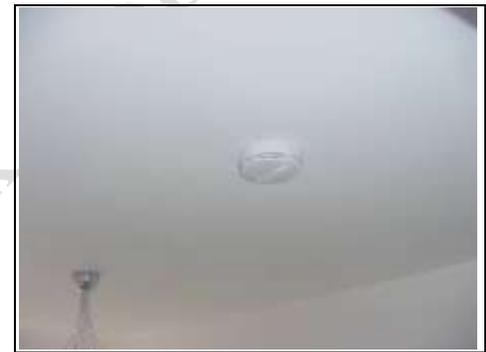
Some smoke detectors were noted. The current Building Regulations require that they be wired into the main power supply. Obviously in a property of this age this is difficult, as it would mean having surface mounted wires or cutting wiring into the plaster.

**ACTION REQUIRED:** We would recommend, for your own safety, that smoke detectors be installed.

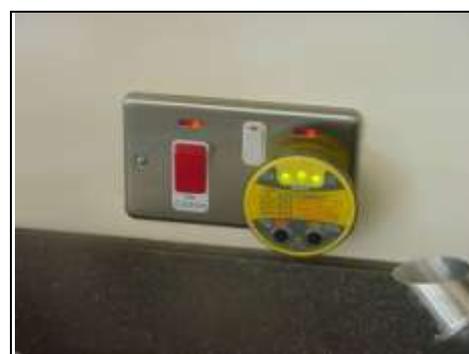
Earth Test

We carried out an earth test in the kitchen area to the socket point that is normally used for the kettle, this proved satisfactory.

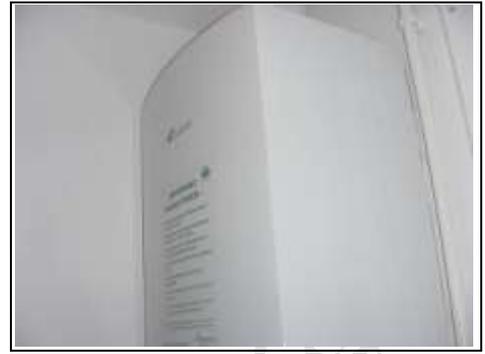
Boiler

Our limited inspection of the hot water and central heating system revealed no evidence to suggest any serious defects but we would nevertheless recommend that the system be tested and overhauled before exchange of contracts and that a regular maintenance contract be placed with an approved heating engineer.

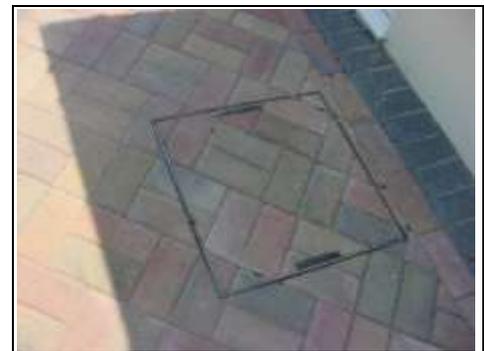
We have been unable to lift the manhole cover. Which is often the case with this type of inset man hole.

We were unable to lift the Manhole

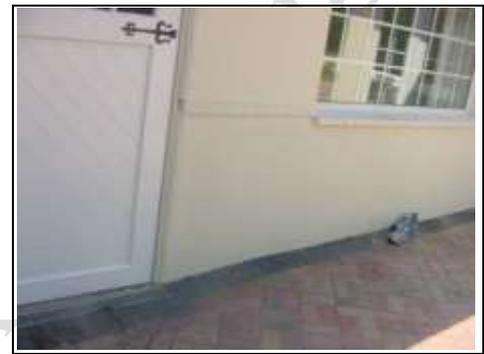
There is an integral garage. We were pleased to see a running gully in front of it, but as mentioned we are concerned that the car park rainwater will drain against the property which is not acceptable.

Garage (showing rain gully to the front)

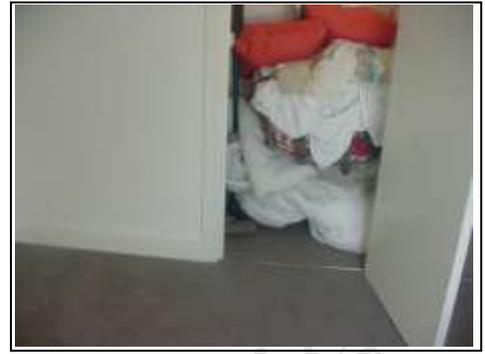
Unfortunately in this instance our inspection has been very limited due to us not opening up the floors, not having had access to the roof, some of the cupboards being full of stored items and due to the owner not wishing to fill out our question and answer sheet although he was quite open with our general questioning.

Some of the storage cupboards were full
