RESIDENTIAL BUILDING SURVEY

Buckinghamshire XXXXXXXX

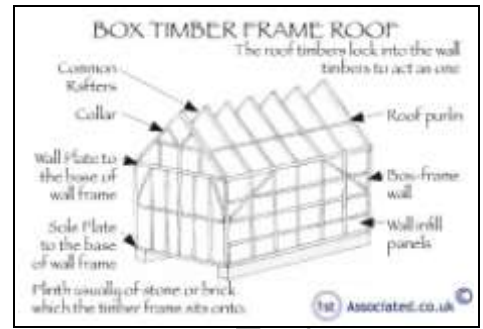
Box timber frame

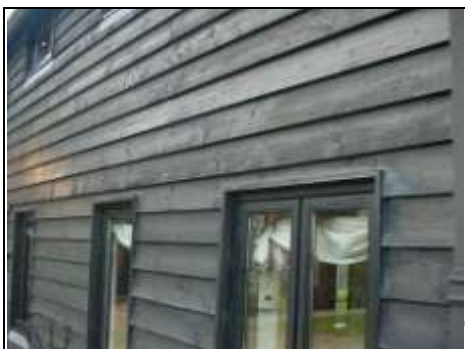
Weather boarding

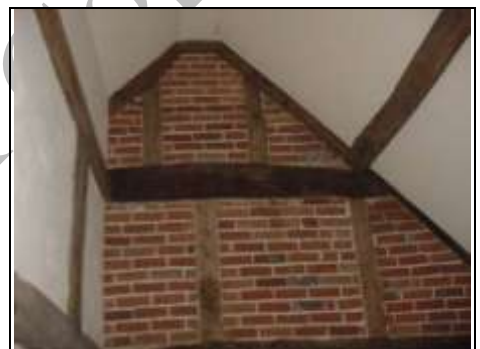
Hidden timber frame (within the walls) visible internally

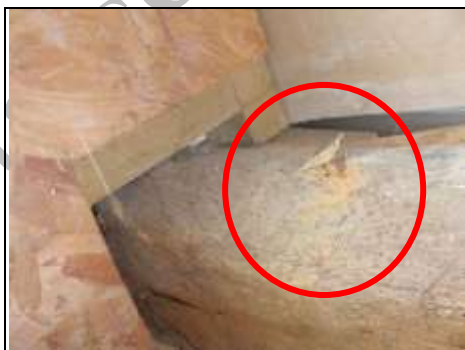
Where we can see the structural timbers we can see there has been woodworm. We also have concerns with regard to the condition of the roof timbers.

Signs of woodworm to purlin on right side of roof

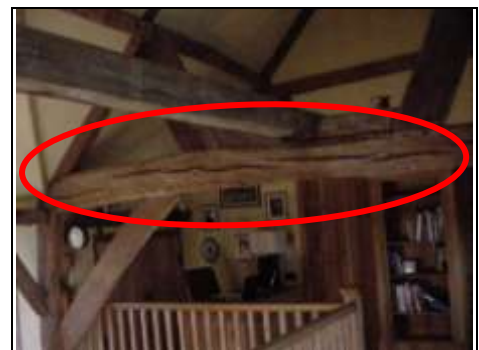
Gallery style landing, cracks in roof timbers

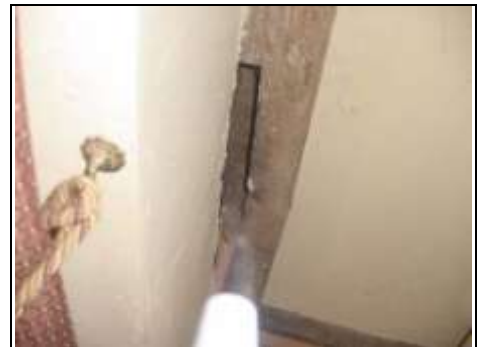
If you recall, we showed you how some of the triangulating members of the timbers have been removed;

We explained how in turn this could have an affect with regard to the lateral restraint of the whole property.

Top of stairs where the brace is missing

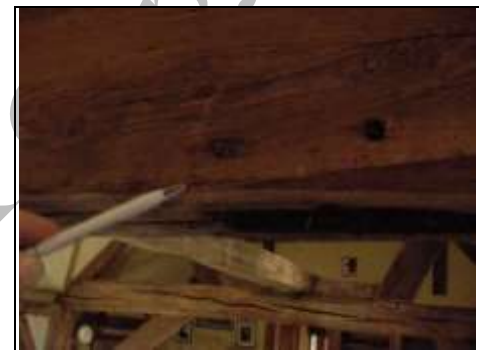
Two peg joints on beam where brace is missing

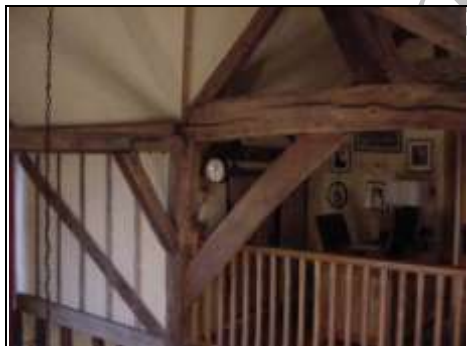
Brace between post (vertical timber) and beam (horizontal timber)

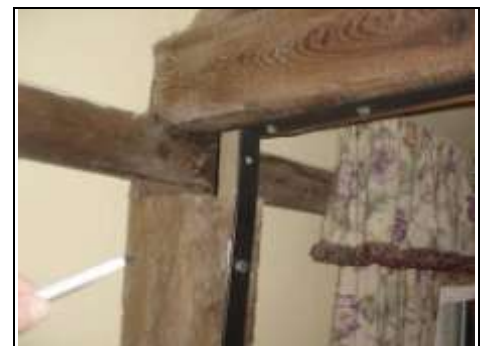
Indeed we can see some relatively new metalwork in the property. Our concern is this metalwork looks to be tying the structure together as opposed to giving structural support.

Metal work in master bedroom

ACTION REQUIRED: Your legal adviser needs to ask in writing for any information there is in relation to the metalwork.

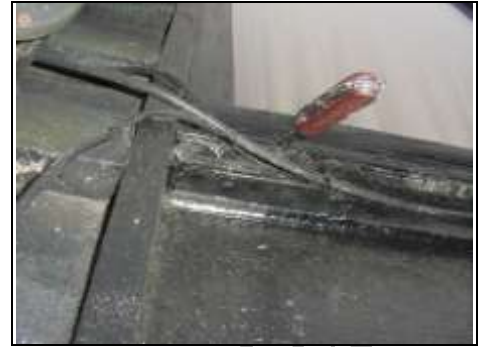
There is generally some wet rot to the windows and external timber, particularly to the main windows that replace the old threshing doors that we could push a penknife 2.5 cm (one inch) into.

Rot in timber windows where the front door used to be

ACTION REQUIRED: Prepare, repair and redecorate the timber.

ANTICIPATED COST: In the region of £2,500 to £5,000 (two thousand five hundred pounds to five thousand pounds) for repairs and redecoration. Please obtain quotations.

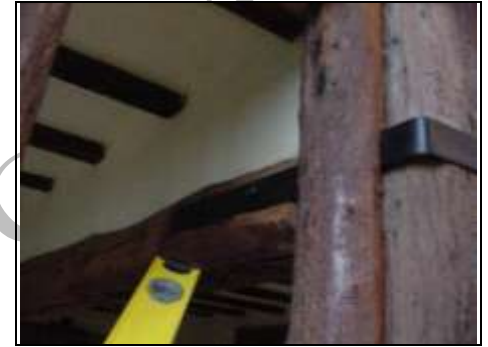
Bare timber visible in some areas

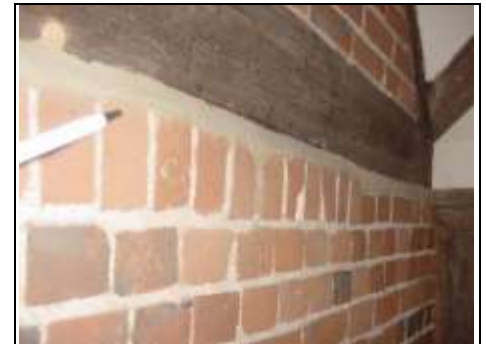
We would comment on the right hand side there seems to have been some repair work carried out to the party wall to the cement mortar which is a different colour to the lime mortar, which is not an appropriate repair.

If the lime mortar is moving this would concur with our thoughts that there is some movement in the property and certainly cement mortar will not last very long compared with lime mortar in this particular instance.

Repairs to party wall on right hand side

ACTION REQUIRED: Replace with lime mortar.

ANTICIPATED COST: A few hundred pounds; obtain quotes.

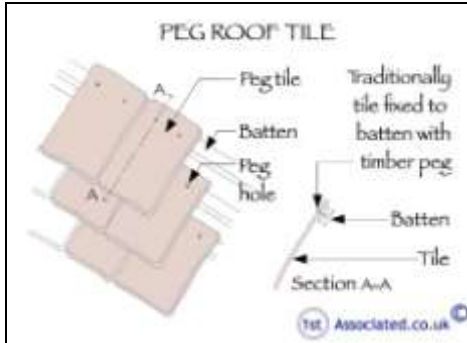
Peg roof tiles

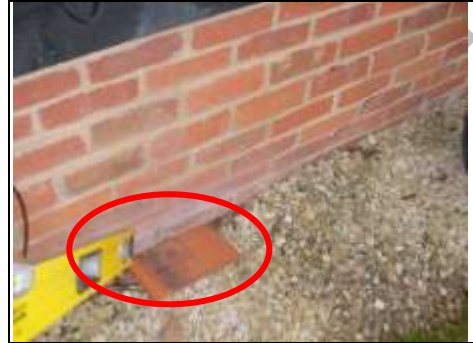
Peg tile

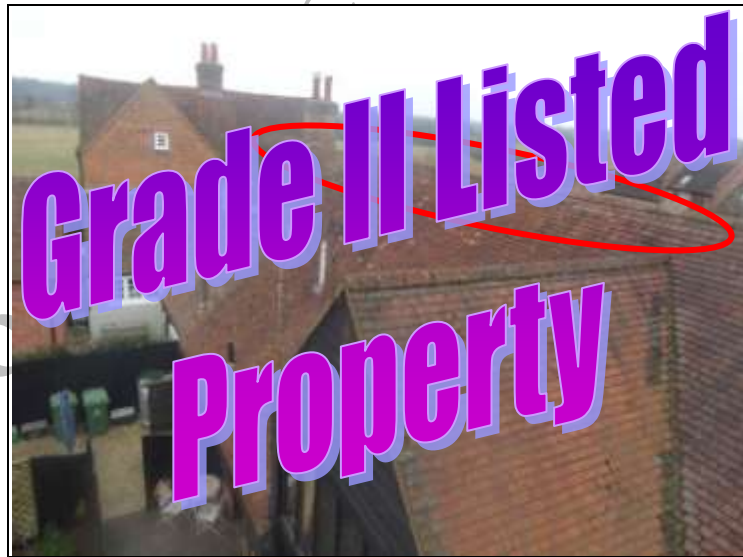
We noted gaps in the ridge tiles of the roof that need re-bedding.

Gaps in ridge tiles

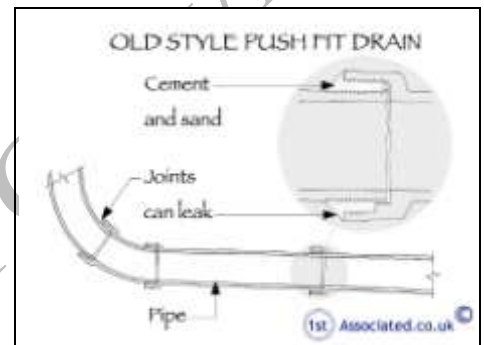
In older properties, such as this, drainage was often push fitted together rather than bonded together which means that they may leak over the years. Whilst we ran the tap for 15 minutes without any build up or blockages, the only way to be 100% certain of the condition of the drains is to have a closed circuit TV camera report.

Push fit drain
