COMMERCIAL BUILDING SURVEY

XXXXXXXXXXXX
XXXXXXXXXXXX

London

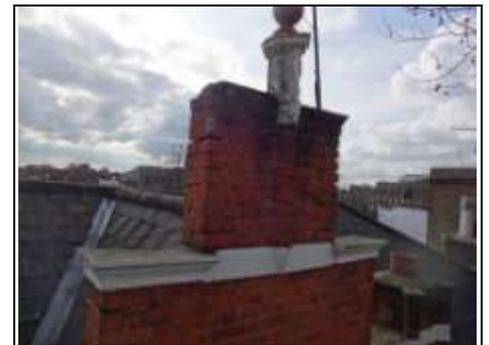
These are at high level and are formed in soft red brick. These are in a below average condition and from what we can see look as though they have not had any maintenance for some time.

Chimney to right with soft red brick deteriorating and weathered pointing
Aerial view – 360 photo

ACTION REQUIRED: Repair and repoint and possibly rebuild.

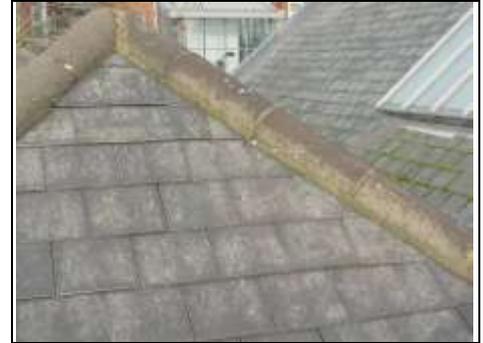
The main pitched roof has a mixture of quarried slate and manmade slates, possibly with asbestos mix. We can see some of the slates are starting to turn from a black colour to a white colour showing through, which can often mean an asbestos mix.

Whitening of slates

Our insurance company require us to advise we are not asbestos specialists and recommend you have an asbestos survey carried out by a specialist asbestos company on the entirety of the roof.

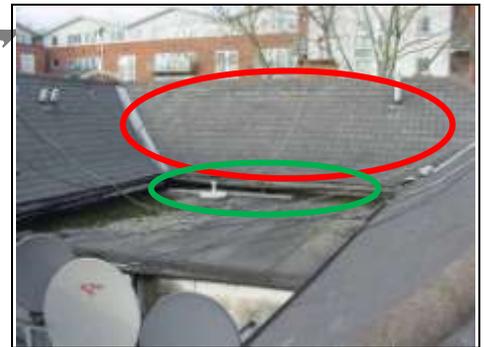
Dip in entire roof (red oval)
with Flashband repairs below (green oval)

ACTION REQUIRED: The whole roof needs to be overhauled and made watertight, replacing damaged slates and re-positioning slipped slates.

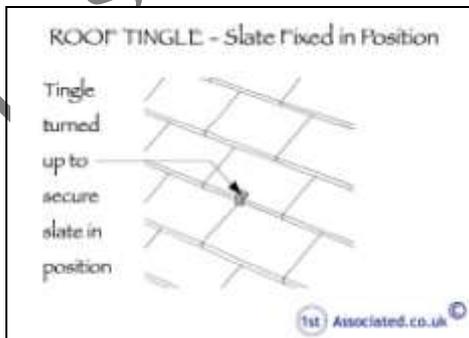
We can see areas of slipped slates, repaired slates and damaged slates, including lead tingles.

Lead tingles

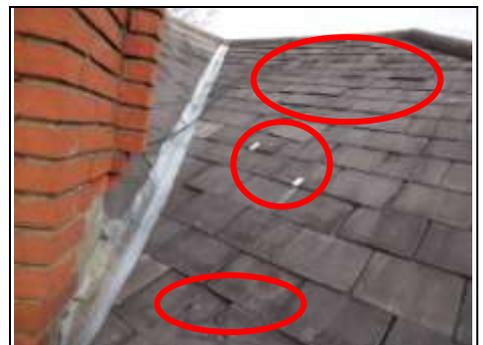
Old slates, with slipped, damaged slates and lead tingles
Aerial view – 360 photo

ANTICIPATED COST: In the region of £1,500 to £5,000 (one thousand five hundred pounds to five thousand pounds), assuming this work can be carried out off a tower scaffold; far more if not. Please obtain quotations.

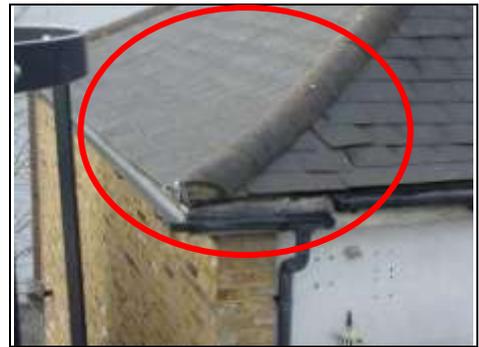
We can see to the rear right corner on Middle Row that the roof has been propped, therefore there are known about problems with this roof. We can also see roof structure problems externally, for example rear left side and other areas. Unfortunately there was no access into the left side of the roof.

Rear right corner where there is some movement and whitening of slates

ACTION REQUIRED: Form an access into the left side of the roof. We recommend you prop the roof timbers to both the left and right sides of the roof. Also investigate the dip in the roof.

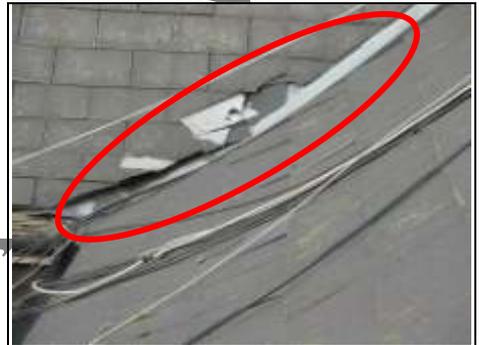
Problems with valley gutter

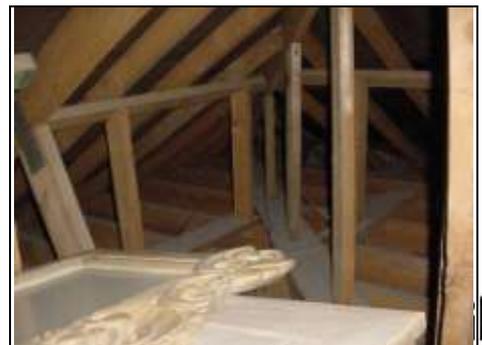
Props in roof space

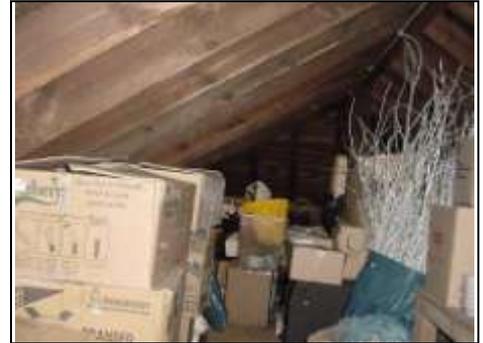
Our inspection was limited by the large amount of stored items within the roof.

Mass of stored items limited our view of the roof

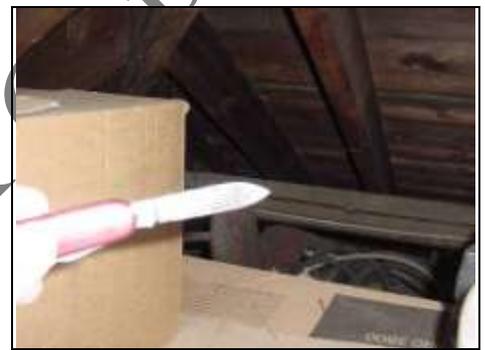
The right side of the roof was full of stored items at the time of our survey which limited our view to be able to see exactly what the problem was, but in our experience it is likely that the common rafters have failed/broken.

We were able to see some splits along the lines of the purlins.

Split in purlin

ANTICIPATED COST: In the region of £5,000 to £10,000 (five thousand to ten thousand pounds), but may be more; it is difficult to comment with such a limited view of the roof. Please obtain quotations.

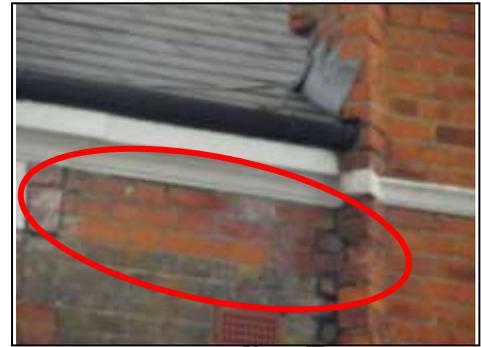
Some of the gutters are sit on gutters. They are leaking and causing efflorescence to the brickwork below.

Dampness in the form of efflorescence on brickwork from overflowing gutter

ACTION REQUIRED: General overhaul of gutters, ensuring the joints are not leaking and are clear and that the gutters go towards the downpipes. Thereafter, regular maintenance and checking of the gutters and downpipes.

ANTICIPATED COST: A few hundred pounds, assuming they are accessible from a ladder or tower scaffold. Please obtain quotes.

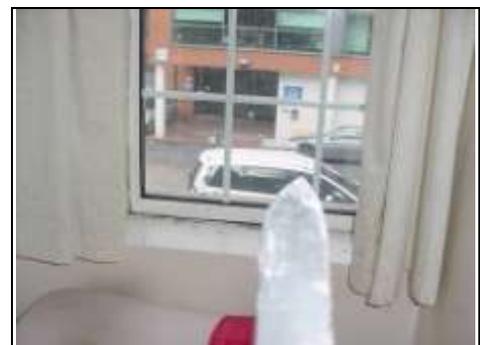
The windows to the first floor are plastic double glazed windows. They have been used and abused and some are literally coming off their hinges.

Window literally falling out

ACTION REQUIRED: We recommend new windows to the majority of the first floor.

ANTICIPATED COST: You can spend as much or as little as you want on windows. We would anticipate costs from £7,500 to £20,000 (seven thousand five hundred pounds to twenty thousand pounds). Make sure the windows have trickle vents to allow air circulation. Please obtain quotes.

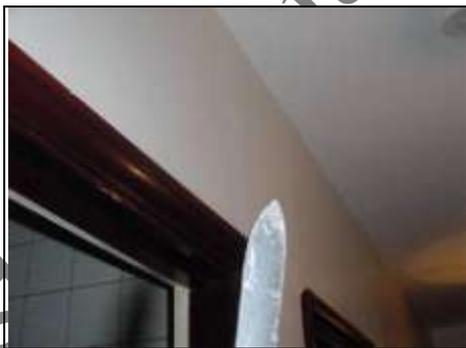
We can see there has been condensation to the first floor level which in turn has caused cracking to the plaster within the property and black mould (please see our article on black mould).

Hairline cracking in corridor to right side between first and second toilets

ACTION REQUIRED: The problem will effectively be resolved when these rooms are no longer used for bed and breakfast, washing, etc. You will need to repair any cosmetic defects to the plaster. As it is a modern plaster it may be replastering and redecorating.

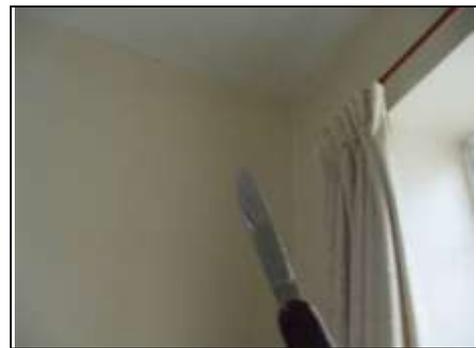
Hairline cracking in rear right bedroom

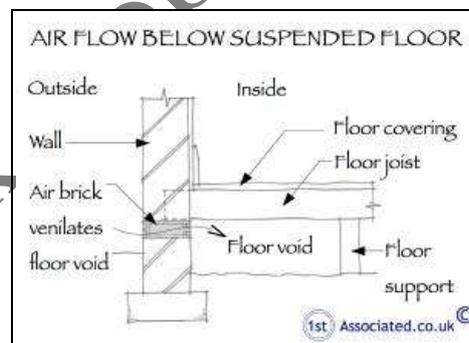
There is a suspended timber floor that we suspect has damp underneath it. It should have vents but we did not see any and we think this is why the floor is undulating.

Suspended timber frame

ACTION REQUIRED: Ideally open up the floor before you commit to purchase the property to establish its condition underneath.

ANTICIPATED COST: A few hundred pounds; please obtain quotes.

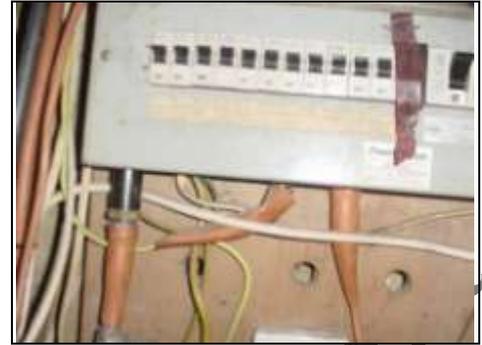
The fuseboards are from the xxxxxxxx. When we carried out our earth test it tripped the circuit indicating there are problems.

Older fuseboard

ACTION REQUIRED: Depending upon the extent of alterations you carry out we believe complete re-wiring is likely to be the best way forward.

We recommend an Institution of Engineering and Technology (IET) test and report to be carried out by an NICEIC registered and approved electrical contractor or equivalent.

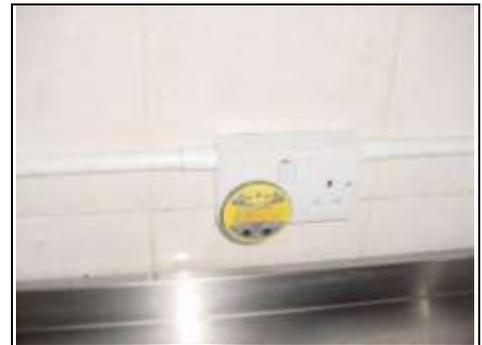
Earth test tripped both fuseboards

ANTICIPATED COST: £250 - £500 (two hundred and fifty pounds to five hundred pounds) for an IET test plus any work recommended. For re-wiring expect costs in the region of £5,000 to £10,000 (five thousand pounds to ten thousand pounds). Please obtain quotations.

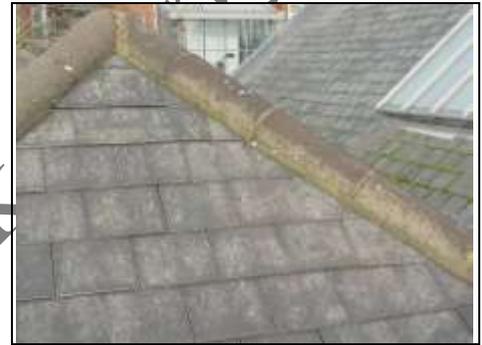
Whitening of slates

ACTION REQUIRED: You need to obtain an asbestos report from the existing owners or have one carried out yourself.

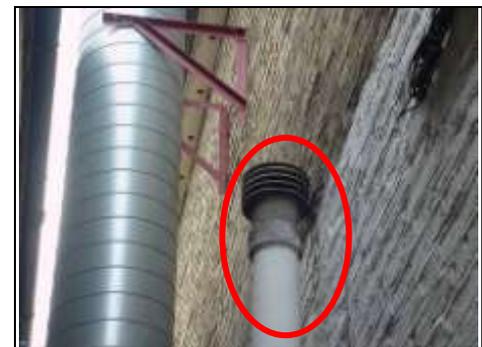
Flue may contain asbestos

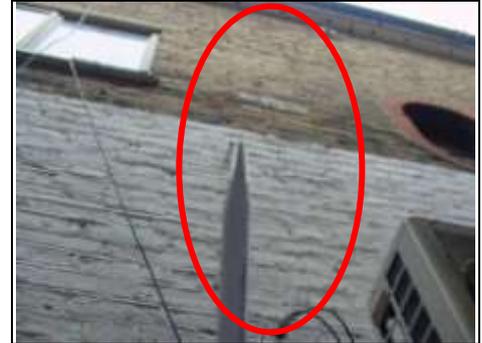
We can see cracked lines running vertically through the joint and brickwork to the left side of the property. It looks to have had repairs over the years which have re-opened up. This is approximately in line with the cellar and could relate to this or it could relate to the extra weight added on the original property by the extensions, or to the clay soil in the area and water table level problems.

High level vertical cracking to left hand wall in passageway

The movement may be acceptable, it may not, but it needs to be monitored and we cannot be 100% from a one-off inspection.

ACTION REQUIRED: Ideally we would recommend the existing owners take out an insurance claim, advising that the cracking has been noted by a structural surveyor (this should cost them nothing other than time to write the letter).

This usually means that the insurance company will carry out a monitoring exercise (the Building Research Establishment recommends monitoring any cracks for a minimum of one year) to establish if there is any progressive movement.

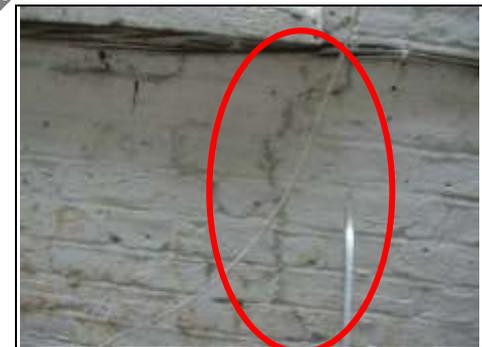
Vertical cracking to low level part of left hand wall

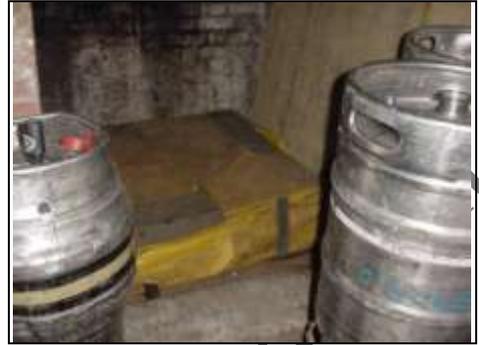
Cellar drop – said to have sump pump underneath

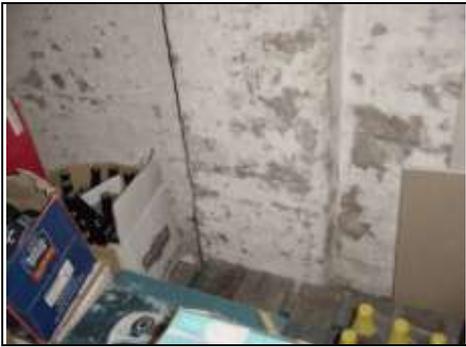
Dampness coming in through walls

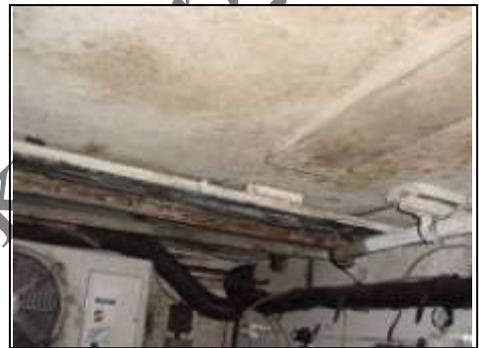
Mould to ceiling in cold store and rusting to supporting steels

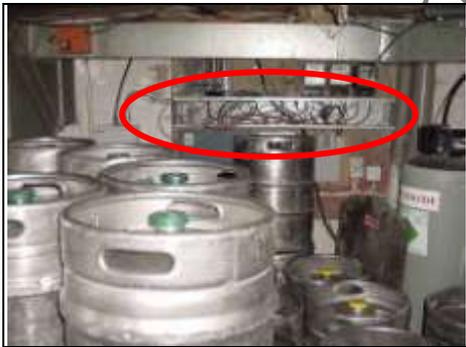
Cold store
Wiring needs tidying up

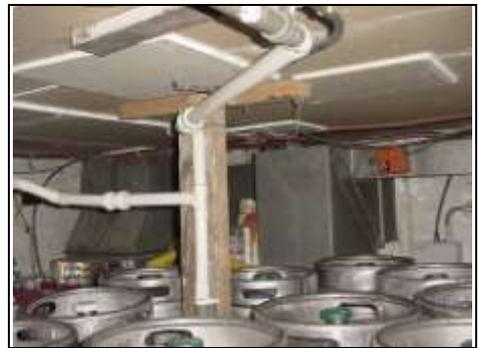
Drainage under bar needs supporting

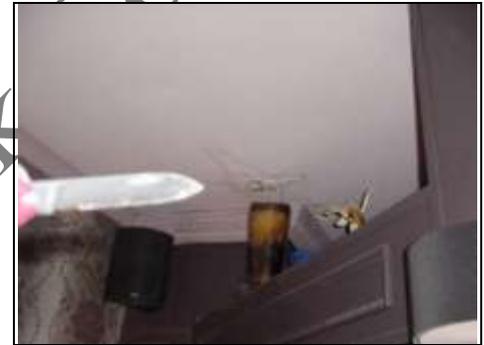
Leak from one of the shower rooms above

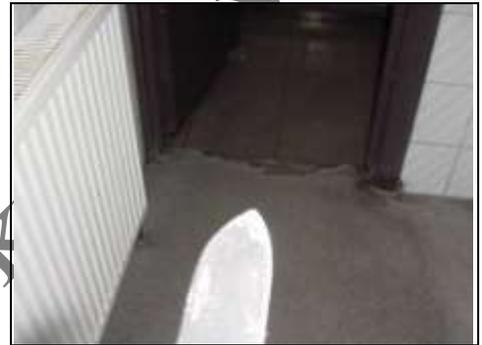
The Altro-safety flooring in the bar, catering kitchen and wash up area would not meet current environmental health standards as it is damaged, although we spoke to the Manager who advised they did not have any outstanding environmental health notices.

Worn safety floor

ACTION REQUIRED: We suggest you have a 'cup of tea' meeting with the Environmental Health Officer before you legally commit to purchase the property.

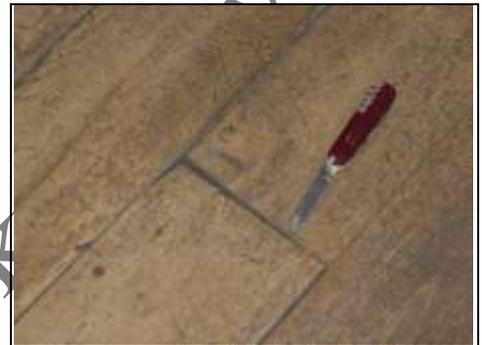
Bar boards screwed back down could relate to dampness and movement

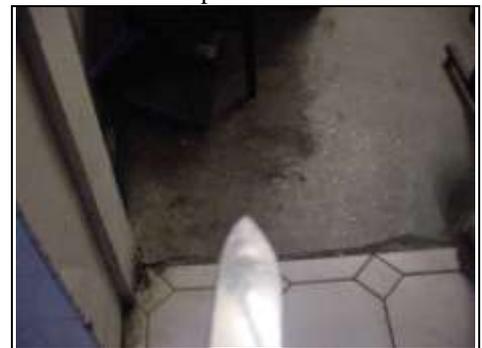
Damaged safety floor in kitchen

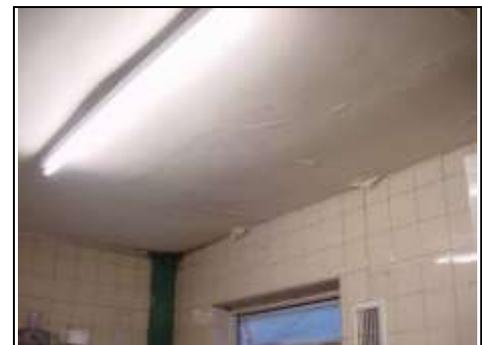
Dampness coming through from above in wash up area

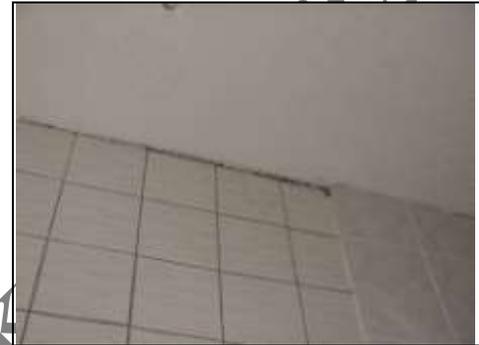
Room 1 – black mould
