SPECIFIC DEFECTS REPORT

Relating to Windows, Condensation and Black Mould

London

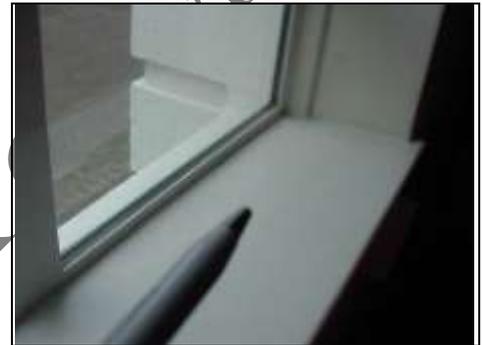
We believe by changing the windows the property has moved from older style single glazed metal xxxxxxxxxxxx, which in our experience tend to warp and deteriorate over the years and as such could be called leaky windows (we did not see these windows).

Condensation/water staining on the window sill

These have been replaced with xxxxxxxxxxxx range windows without trickle vents which are much more airtight and as such, perform very differently in the building.

1. Confirmation whether xxxxxxxxxxxxxx considered the windows to be installed.
2. Confirmation whether xxxxxxxxxxxxxx recommended trickle vents or not in this situation.
