Example Survey Victorian Residential Building Survey

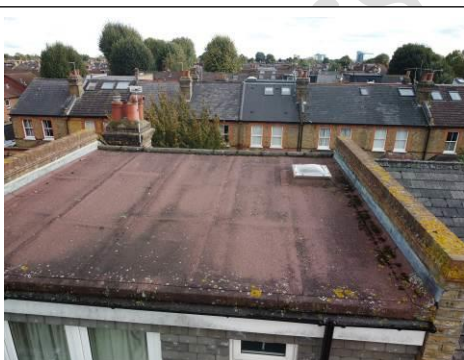
There seems to be leaks to the parapet walls, both left and right side, and also to the roof window which has a felt flashing which is not ideal, we much prefer to see lead. The left parapet wall and the roof window are highlighted in blue.

High level flat roof and parapet walls

ANTICIPATED COST: All of these are quite costly and for a capping or new coping stone we would expect costs in the region of £5,000 - £10,000 plus access scaffolding or access via the roof window that we discuss below; please obtain quotations before you legally commit to purchase the property.

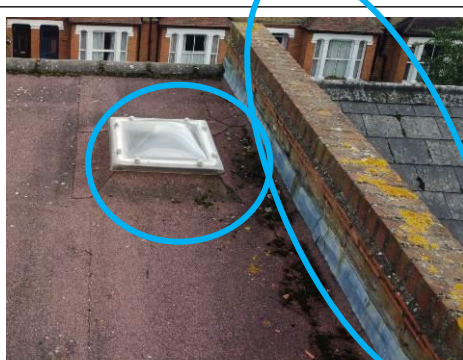
Left parapet wall and roof window leaking

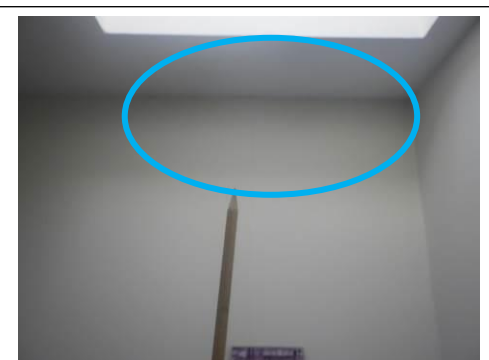
Water mark - leak from roof window ?

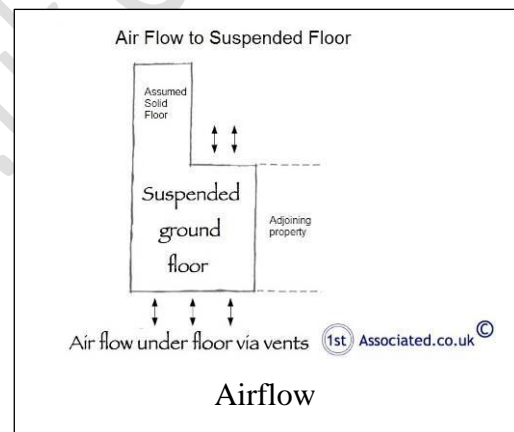
Another contributing factor to the dampness could be the suspended timber floor and the air vents. The air vents are to help airflow underneath the timber floor to help reduce the possibility of wet rot, dry rot and wood destroying insects.

To the front and rear of the property there has been paving added. Unfortunately, this has resulted in the air vents now being low and we believe they may be acting as gutters and allowing water in;

ACTION REQUIRED: Normally we would recommend protecting the air vent however in this case in both instances we would recommend monitoring and if water is getting in we would recommend reducing the height of the ground / taking out the paving slabs to stop water getting in through the air vents.

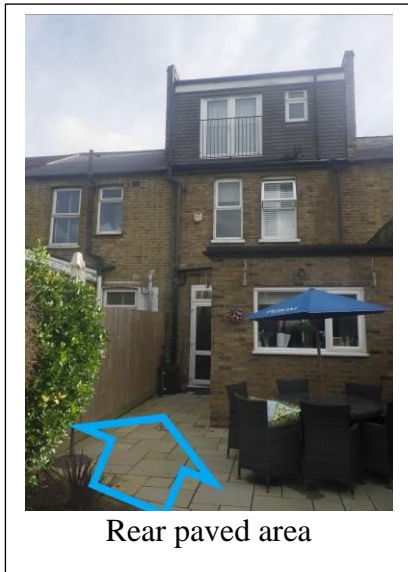
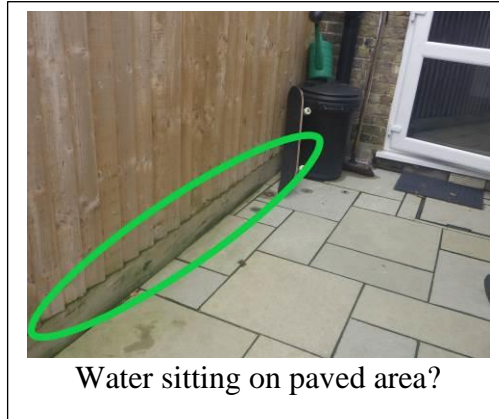
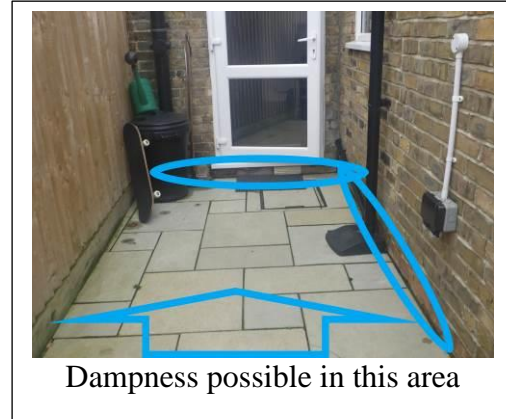
As already mentioned, there has been paving added to the rear which is quite popular however in this instance the paving looks to have been added on the existing ground level therefore reducing the height to the air vents and also to the damp proof membrane that we have already mentioned. It is very difficult to be certain on a dry day but it does look like the rear area is holding water and dampness is susceptible in this area and indeed we found dampness in our damp meter readings.

ACTION REQUIRED: The area needs to be monitored. If water is being held in this area then we would recommend a French drain and/or land drain diverts the water around the property and is discharged into a manhole (subject to obtaining approval) and/or a soakaway added (which will be additional cost).

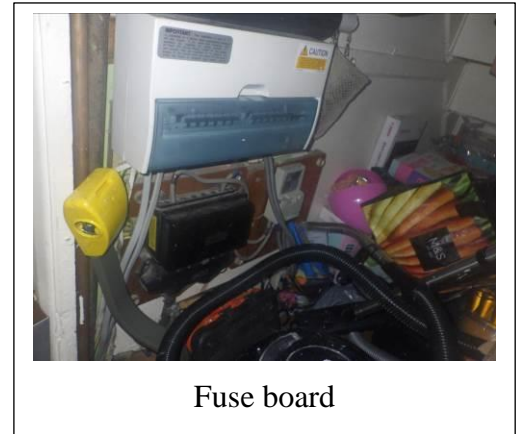
The fuse board is 1980's/1990's and better are now available. We would recommend upgrading the electrics unless the owners can confirm that it has been carried out recently.

ACTION REQUIRED: We recommend a new fuse board with a metal casing; modern standards require half hour to one hour fire resistant casing around a fuse board.

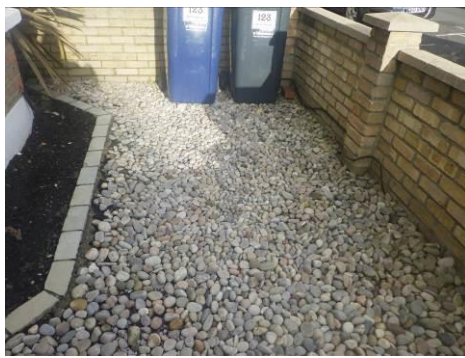
We ran the tap in the top floor shower room for fifteen minutes and found the water was slow to drain away however this could be due to the awkward external waste pipes that we sometimes have when properties have been extended like this.

Front manhole hidden under shingle

ACTION REQUIRED: We would prefer to be on the safe side and recommend a closed circuit TV camera report of the drains.

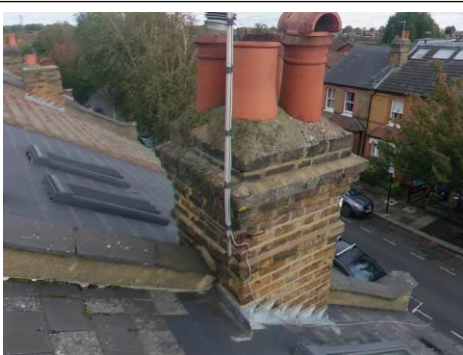
This chimney is brick finished with a lead flashing and four chimney pots. From what we could see from ground level it looked in below average condition considering its age, type and style. There is a water trap behind the chimney which looks to have been repaired previously. Also, the flashing looks like it may be coming away.

Water trap behind chimney

We would expect costs in the region of a few hundred pounds if work can be carried out via a ladder and crawler boards assuming the problem is as simple as repairing the flashing; please obtain quotations before you legally commit to purchase the property.

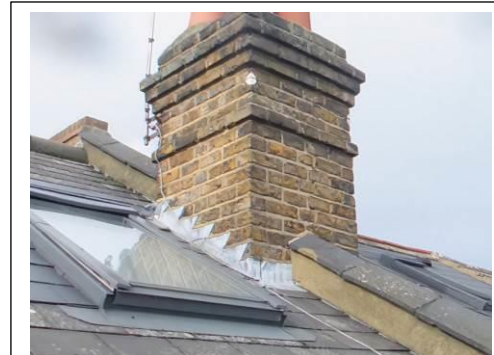
Problems to base of chimney

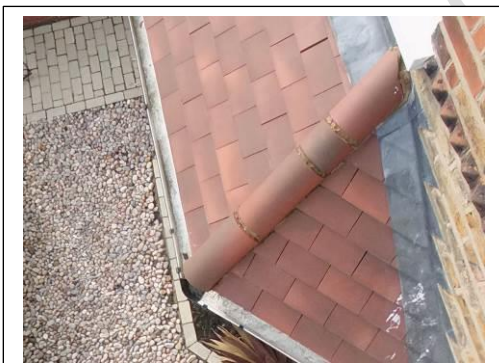
This roof is pitched and clad with slate. It has a lead flashing where it meets the main wall. We would comment it is in average condition considering its age, type and style. We were pleased to see a stepped flashing which we consider better than a straight flashing.

Front bay roof

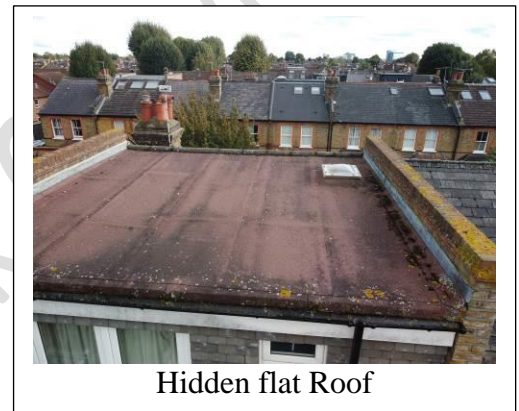
The flat roof is located to the rear and is covered with mineral felt. It is starting to weather where you can see the dark areas in our photograph which also often indicates where water sits. Where the mineral chipping has darkened you can get accelerated deterioration in these areas and they tend to warm up more during the summer months and possibly blister.

This flat roof is flat with minimal fall on it which may seem a strange comment but we would expect a flat roof to have a fall of about fifteen to twenty two degrees and this is why we would term this as a flat, flat roof.

ACTION REQUIRED: Please see the Executive Summary; we would recommend a safe roof access is added.

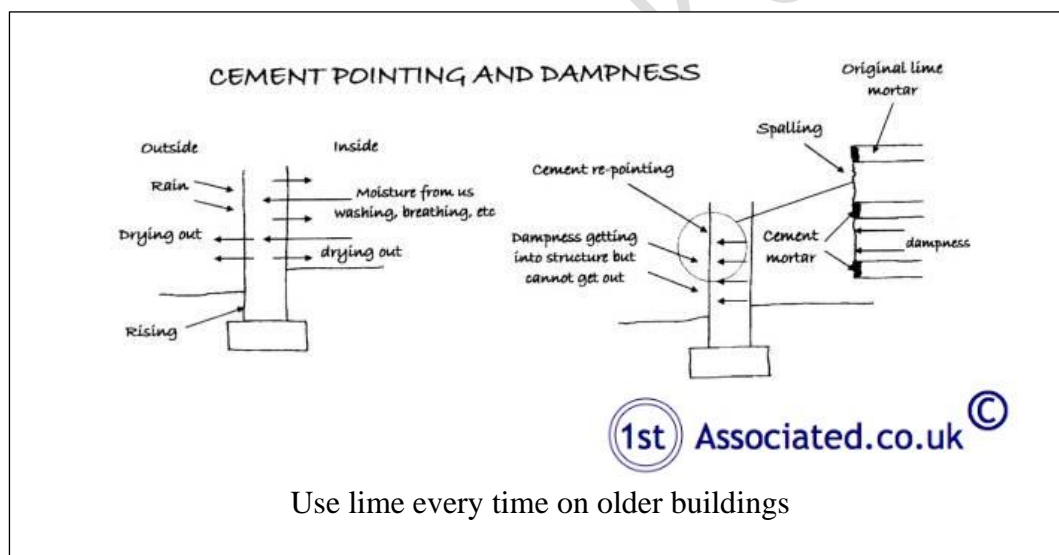
We would draw your attention to the cement mortar re-pointing that has been carried out on the exterior of the property that we feel is not appropriate to this building. Originally it will have been built with a lime-based mortar and this is what should be used for any re-pointing in the future.

The original lime mortar is a softer material which allows dampness to dissipate, whereas cement mortar is a harder material that does not allow the walls to 'breathe' and in turn causes dampness to come into the walls. The use of cement mortar causes deterioration to brickwork and does lead to the face of the bricks deteriorating, which in turn leads to dampness. This is a very important point.
