Timber Frame Example Residential Building Survey

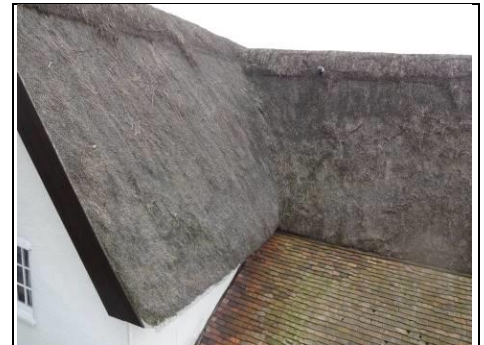
The thatch is nearing the end of its life. We believe that you will have to budget for a replacement thatch. With a listed property it is not just as simple as replacing the thatch, you need to obtain approval and consent. It will more than likely be considered a significant part of this building and as such it may well be closely scrutinised exactly what you are going to do. From what we can see within the roof we feel that unfortunately not only will the thatch need repair/replacement some of the timbers will need repair/replacing as well for example to the left hand side of the property from a limited view what we could see was not in particularly good condition.

Thatch in poor condition

ACTION REQUIRED: From what we have seen within the roof we feel that unfortunately not only will the thatch need replacing but some of the timbers will need replacing as well for example to the left hand side of the property. The owner advised that he had various quotes on the property to replace the thatch from memory ranging from £14,000 - £35,000. We have not seen these quotes and we have estimated our figure below, the quality of these quotes all the companies understanding if the building is listed or not. However, in addition you need to add work to the roof structure and also consultation work you need with the Conservation Officer.

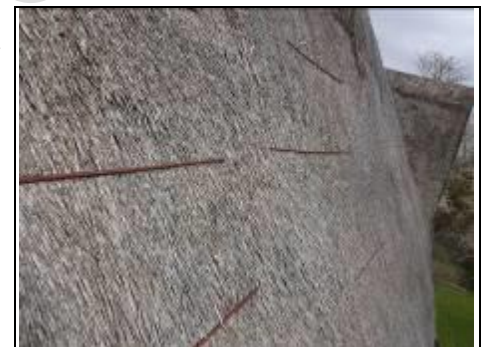
Stitch in time to thatch, rods added to hold thatch in place
~ Aerial View - 360 Photo ~

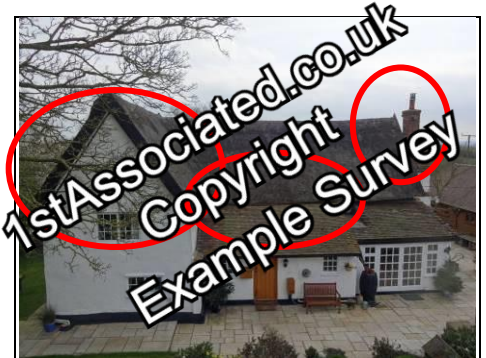
We have divided the roof structure into three areas, the left, middle and right side. We had reasonable access to the middle roof although much of it was covered with insulation, we had no access to the left roof and we could only view it from the middle roof as there was no direct access into it from what we could see. The right roof had a limited view due to both the insulation and lots of stored items although we did move some of them. From what we can see the roof structure has been replaced and repaired over the years.

Plan view of the three roof structures

ACTION REQUIRED: We would recommend that your solicitor specifically asks in writing is there any more information with regard to the metal plates/structural work which effectively are tying/holding the building together. Unfortunately, metal plates add a relative stiffness to what is traditionally a fairly soft building on a timber frame so they can in themselves cause problems if not designed appropriately.

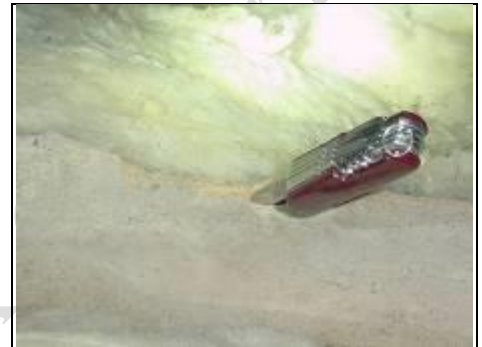
Over the years we have come across lots and lots of woodworm and we normally say any good old property tend to have some woodworm. Having said that most of the woodworm is no longer active and has died off many years ago and in addition to this although there may be holes rarely is it what we term as structurally significant? However, in this instance there does look to be active woodworm in the roof as well as old woodworm in the roof. Unfortunately, that where we tested it with a knife, our knife went directly into the timber and we would then consider that this maybe becoming structurally significant. By this we mean that the timber has been weakened by the woodworm.

Knife going completely into timber common rafter

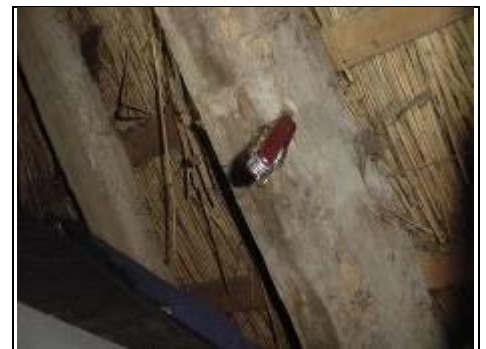
Unfortunately, the environment with insulation being added can improve the woodworm and encourage to breath from what we understand. There is a fair amount of insulation in the roof; all of this will have to be removed to properly view the roof to assess the damage to the timbers. We do feel that some of it is what we would term as a structurally significant in nature although there is of course woodworm in the roof that is not structurally significant. We found woodworm to the centre roof and we believe it also to the left roof.

Woodworm and soft rot

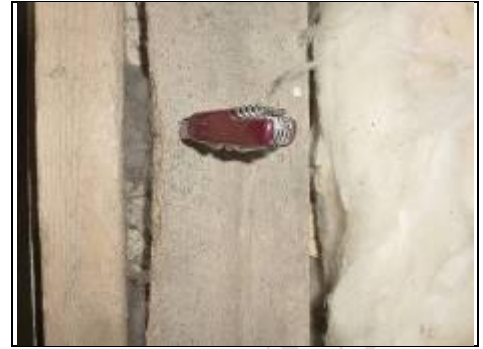
Woodworm

ACTION REQUIRED: If you have immediate plans to re-thatch the property then the whole of the roof structure could be looked at, at that point. If not, a much closer examination of the roof with the insulation removed needs to take place. However, from what we have viewed so far we would expect approximately ten to twenty percent of the roof to have been affected with woodworm to the point where we put a knife into it relatively easily/has potential to be structurally significant.

ANTICIPATED COST: We would recommend setting aside £2,500 - £7,500. The reason why the figure is relatively large is we do think there is a likelihood that there are problems with the roof structure. There is an element of estimation on what we are commenting on as we have not had access to the left side of the roof, we would be able to comment further if direct access to the left side of the roof was formed and if insulation was removed. We do feel we have to warn and advise about the worst case scenario; please obtain quotations.

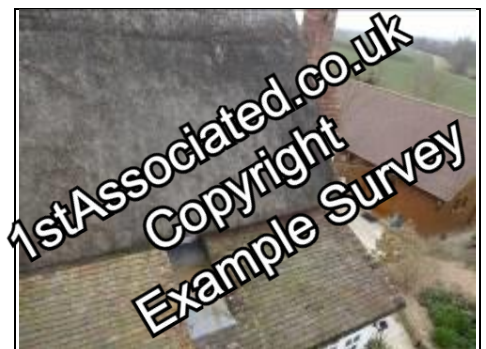
The property has a relatively shallow roof and as such water can sit on it and we noted that the tiles are starting to spall. We would recommend that work is carried out in this area.

We have also found that wind driven rain can get in this style of roof if it is not repaired.

Displaced tiles and in need of repair

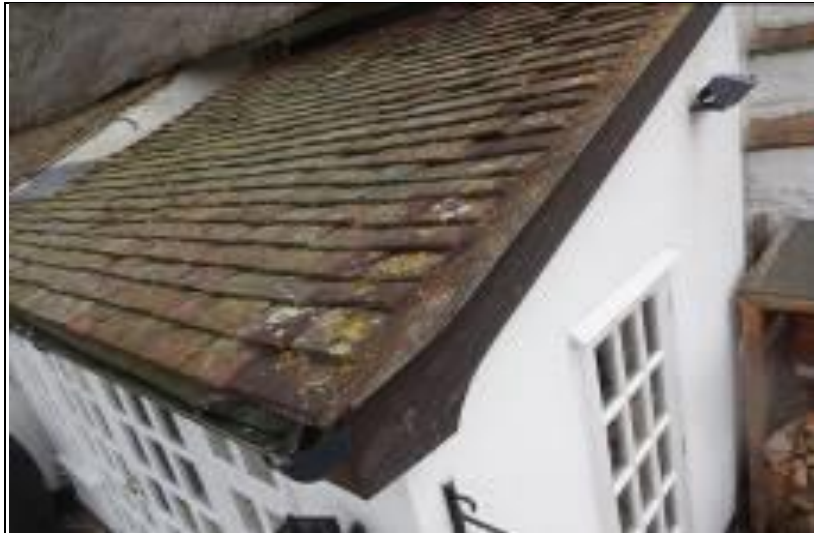
Spalling to tiles
~ Aerial View - 360 Photo ~

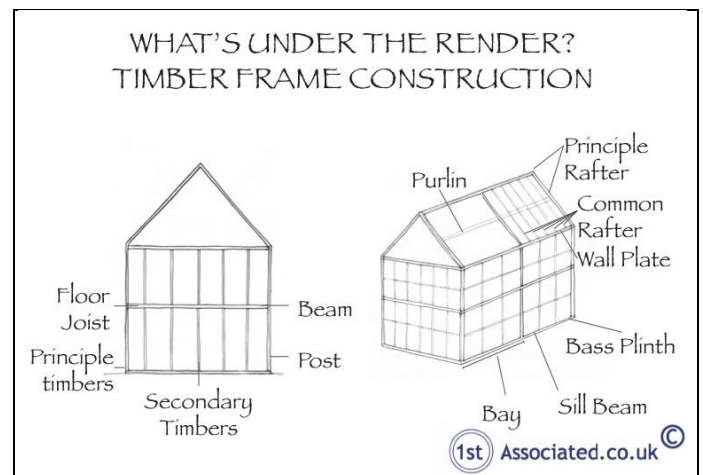
This is likely to have originally been a traditional timber frame building with primary structures and additional secondary structures then infill panels between which can be seen in the adjoining sketch. Infill panels normally start out and then over the years are replaced.

What's under the render?

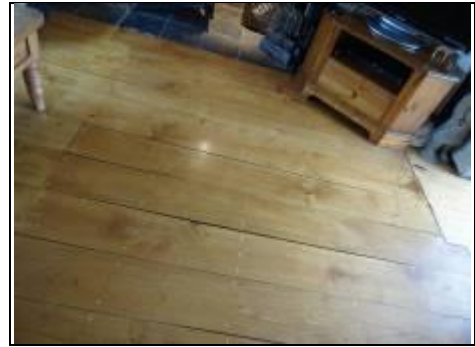
Replacement of original floorboards

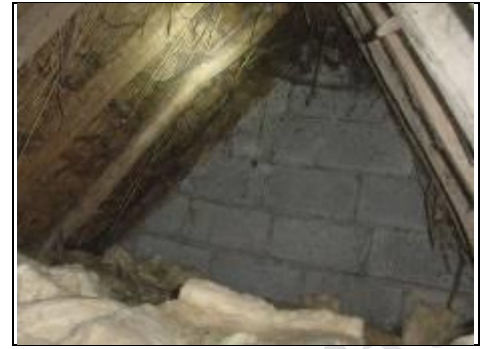
Having said all of that, the areas where we could see the inside of the structure we could see blockwork. Blockwork would have been typically used in the 1960's/1970's so we suspect there has been a lot of replacement work here.

Blockwork

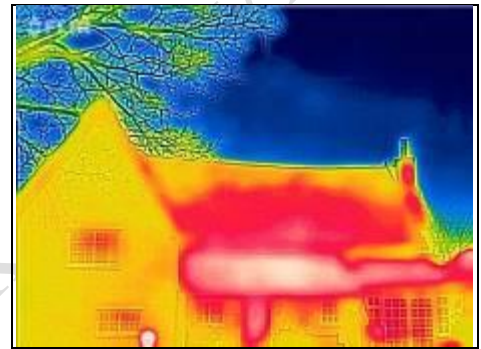
In addition to this we have also thermal imaged the property to see if this gives us any further clues and our evidence shows relatively low heat loss from the wall structure indicating that there is considerable replacement of the walls. Without opening up the walls we cannot confirm this but we do believe the thermal imaging information and the visual information in the roof give a good indication that over fifty percent of the walls have been replaced.

Thermal image showing heat coming out of thatch and tiles but not through what we believed was timber frame building

ACTION REQUIRED: We recommend opening up:

1. The left roof area and allow proper access to re-gain. The owner has specifically asked in writing by your legal adviser when they are aware of any rebuilding of the walls.
2. We recommend areas of render is removed so you can see the existing structure. We would add that unfortunately it is difficult to be conclusive if the usual indicators are not consistent.

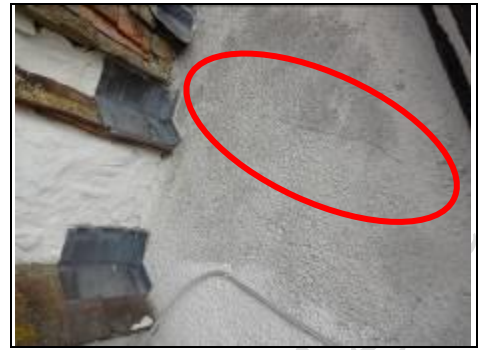
There is hairline cracking visible to some of the internal walls where the wall and ceiling joists meet and there is also hairline cracking to the gable end of the property. You do have to remember that the whole of this property has been repainted in the last few years hiding any usual indications. Again, these cracks are indicating sideways movement left to right.

Hairline cracking to right gable
~ Aerial View - 360 Photo ~

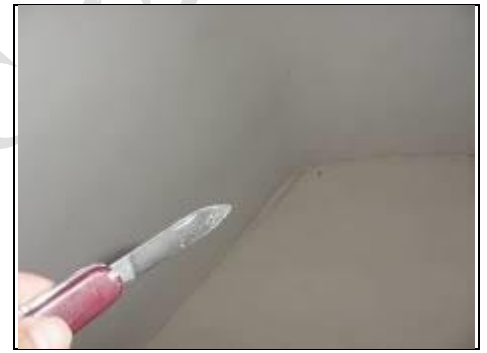
Cracking in far right bedroom

ACTION REQUIRED: Ideally we would recommend the existing owners take out an insurance claim, advising that the cracking has been noted by a structural surveyor (this should cost them nothing other than time to write the letter). This usually means that the insurance company will carry out a monitoring exercise (the Building Research Establishment recommend monitoring any cracks for a minimum of one year) to establish if there is any progressive movement. Your future liability will be limited to the cost of the excess on the insurance providing the insurance company is happy for you to take over the insurance claim.

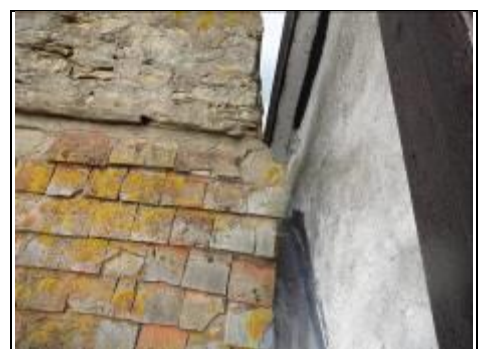
In various areas we found dampness coming in through the stonework for example and we can also see sulphate where there is orange/brownish staining where the soot is being drawn through.

Damp on gable wall
~ Aerial View - 360 Photo ~

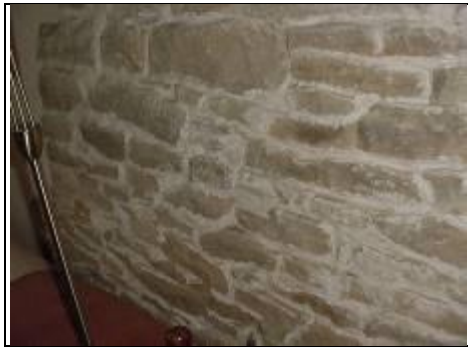
Dampness coming through and various repairs

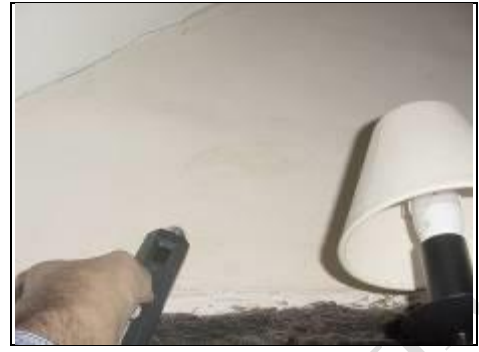
Dampness coming through plaster in right bedroom

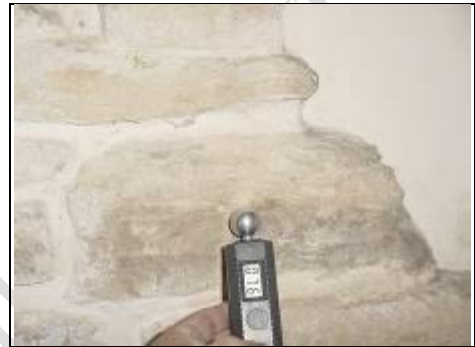
Dampness in stone

ACTION REQUIRED: We would recommend the adding of a French drain around the property. Currently there are paving slabs around the property which unfortunately discharge water against the building.

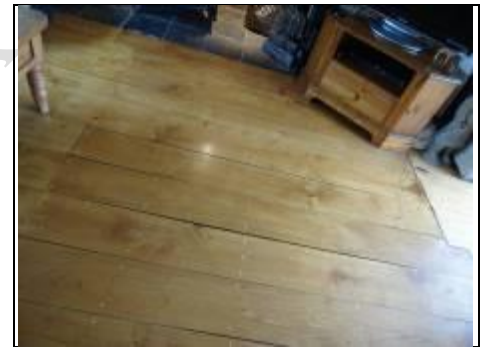
We are advised there is a timber floor in the lounge area which is typically a suspended timber floor. We cannot see anywhere where this has been vented which in a building such as this can lead to wet rot, dry rot deterioration.

We were advised original floorboards were sanded and reshaped

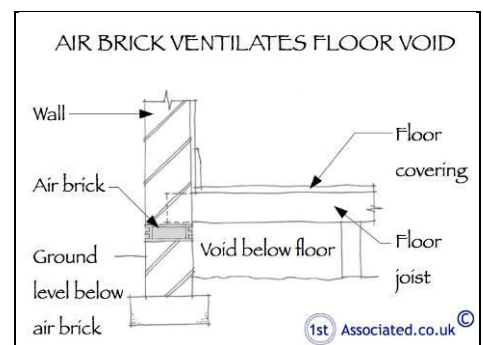
Suspended timber floor

ACTION REQUIRED: Add vents. We would also recommend opening up a section of the floor. The owner advised that the timbers used in this area were the original timbers but in our experience they would not have been that size or that cleanly cut. He did then comment that he had had them sanded, planed and then put back.

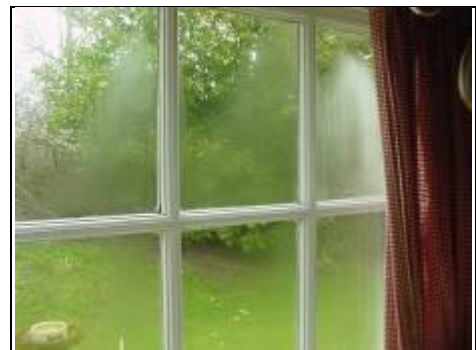
Condensation to windows in kitchen

ACTION REQUIRED: We would recommend large humidity controlled extract fans are added to the kitchen, the bathroom and any areas that are used for drying clothes internally during winter months (we would assume that clothes will be dried externally during the warmer months). By large extract fans we mean 150mm.

ANTICIPATED COST: We would anticipate costs between £250 - £500 per extract fan depending upon the wiring required. We always recommend quotes are obtained before work is agreed/commenced.

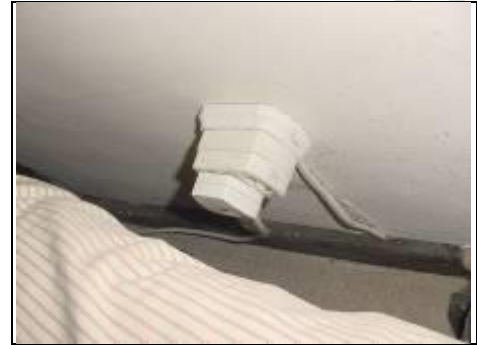
Electrics dated

ACTION REQUIRED: We recommend an Institution of Engineering and Technology (IET) test and report to be carried out by an NICEIC registered and approved electrical contractor or equivalent.

ANTICIPATED COST: £250 - £500 plus any work recommended; please obtain quotations.

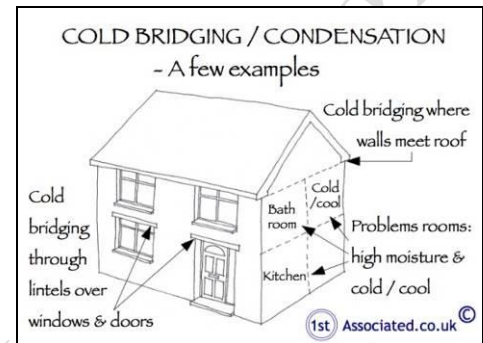
Due to the mixture of materials used we believe there may well be a possibility of cold bridging in the property. Unfortunately, without opening it up it is difficult to confirm. Cold bridging leads to black mould internally unless you control and manage the humidity. In some buildings you do just have to consider this a characteristic of the property.

Cold bridging is caused by a colder element in the structure allowing coldness to pass through the structure much quicker when warm moist air is present in the property, often caused by things like having a shower or a bath, cooking or washing, particularly if you are drying washing on the radiators. This is also caused by the general climate which results in condensation on the element.

Cold bridging/thermal bridging

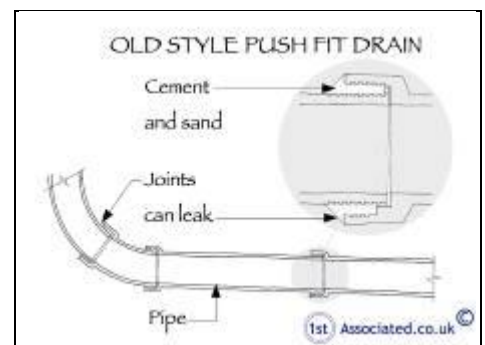
In older properties, such as this, drainage was often push fitted together rather than bonded together which means that they may leak over the years. Whilst we ran the tap for 15 minutes without any build up or blockages the only way to be 100% certain of the condition of the drains is to have a closed circuit TV camera report.

Push fit drain

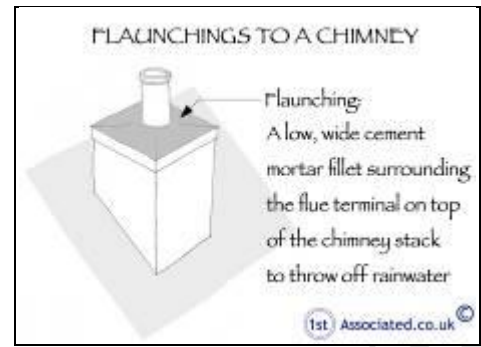
Flaunching

ACTION REQUIRED: The whole of the chimney would benefit from appropriate repair work as we can see there has been inappropriate repair work using cement mortar. We can also see that the lead work detailing could be improved to reduce the amount of water getting into the right gable end. From our experience we don't think this will ever be completely dry but it could be we feel improved. We can also see that the render that adjoins the chimney would benefit from being pre-paired, repaired and redecorated.

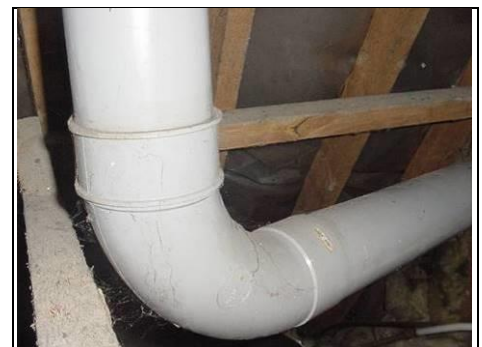
Plastic pipe within roof

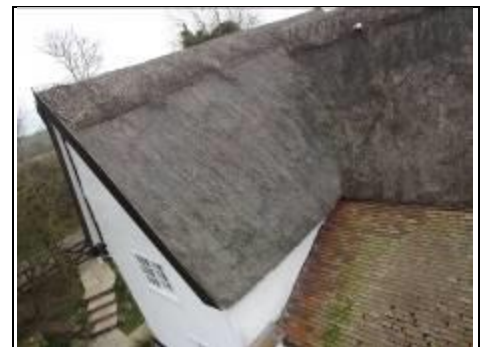
The roof is pitched and thatched with what we believe to be long straw, although it does need samples taking and analysis. From ground level, this looks in below average condition considering the roofs age type and style. We can also see that the roof structure needs work. The owner did advise during our question and answer session that they had carried out some work about five or ten years ago (he could not recall) and he does have quotations for the thatch but do remember with a listed building it is not just about what you want to do; it is also about what the listed building/conservation officer is happy with.

Thatch ridge disintegrating and dampness within thatch
~ Aerial View - 360 Photo ~

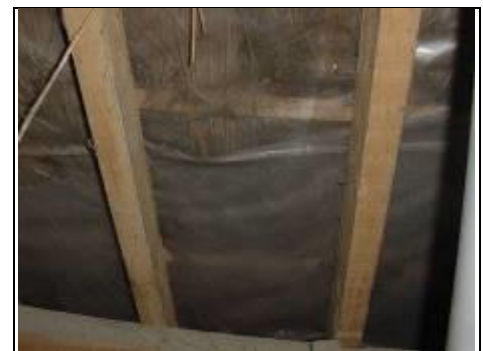
We did not expect to see a protective underlayer under the thatch however we can see some areas where a plastic sheet has been used which we thought was unusual and indicates that part of the thatch has been repaired more recently. We spoke to the owners about this in our question and answers session and they could not recall any specific repairs to the thatch in their time at the property.

This photo shows the common rafters (the ones that form the pitch of the roof) and the dark area between is the underlayer.

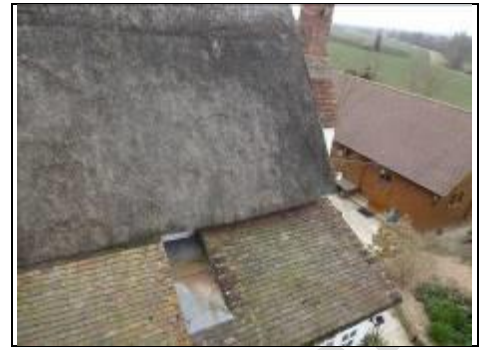
We noted the tiled roofs to the front of the property are relatively shallow and are starting to spall. We would recommend that work is carried out to this area. There is a lead valley to the roof which also needs to be checked when the roof is re-tiled.

Displaced tiles and in need of repair

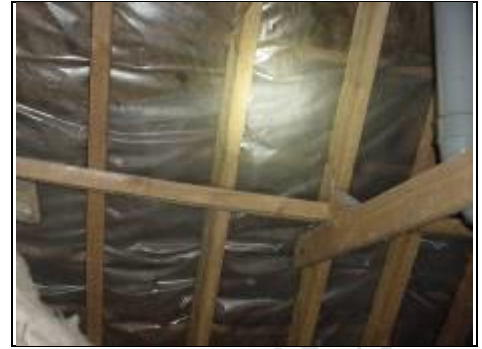
Thin purlins

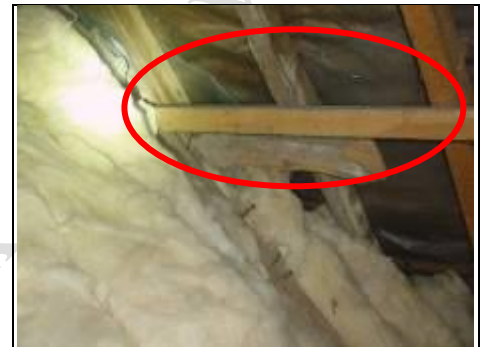
Purlin missing replaced with very thin purlin
Plastic sheeting

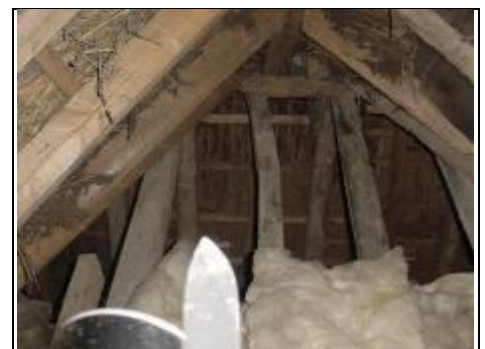
Deterioration/twisting to timbers in left roof

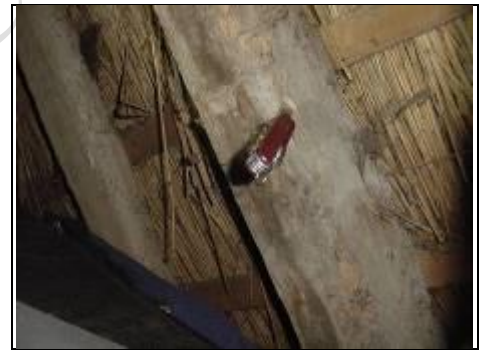
Woodworm and soft rot

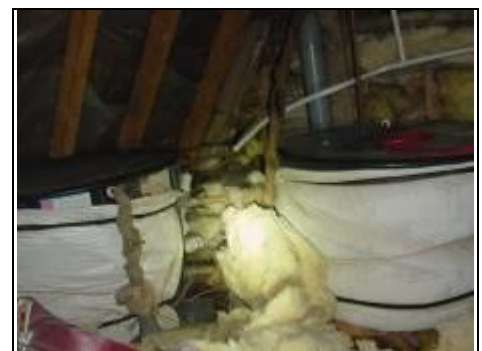
Water tanks in middle roof

We would always recommend that water tanks be drained down and cleared of any debris etc. (we have seen dead birds and other unmentionable things in these tanks). As you are often cleaning your teeth with this water it is best that it is as clean as possible!

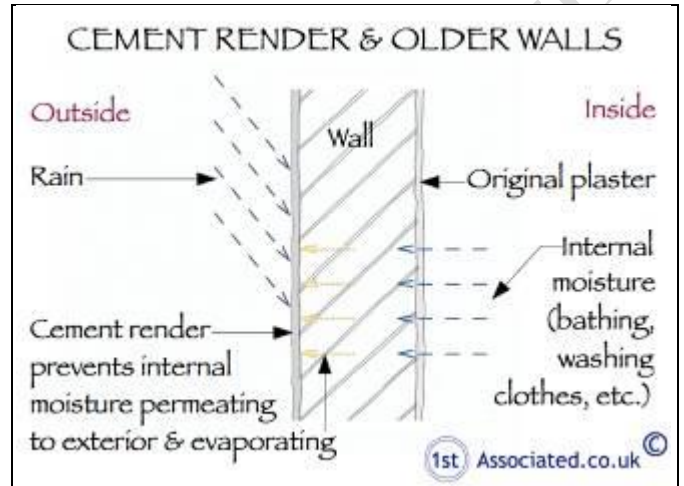
The question that we always ask of these is how much damage the cement render is doing to the timber frame. We do believe in this instance that there is movement in the property and a considerable lean on it so it is well worth carrying out investigations.

Cement render

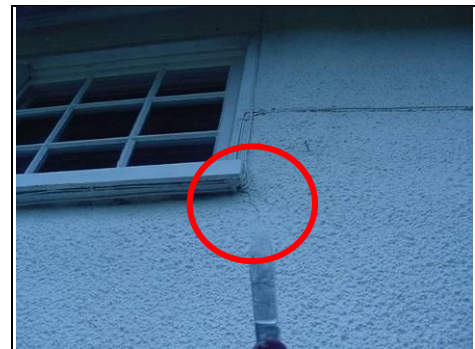
Cracking

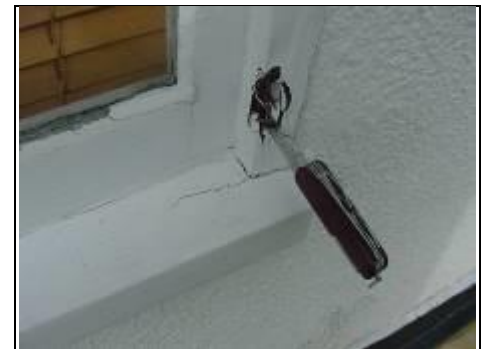
Knife test in rotten window

ANTICIPATED COST: In the region of £750 - £1,000; quotations required.

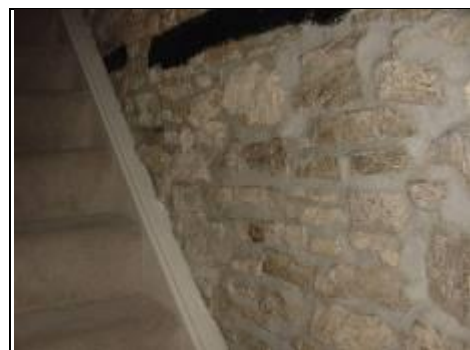
Cement repairs to stonework on side of staircase

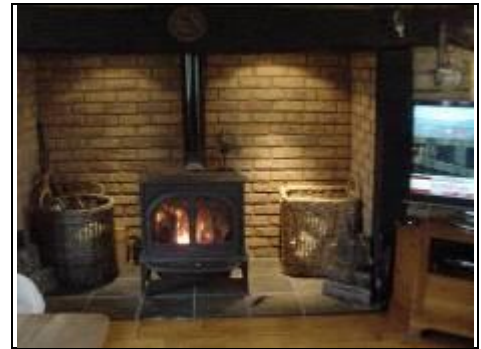
At the time of the survey the chimney was in use and burning brightly. We spoke to the owners about this and they advised that they had lined the inside of the chimney with brickwork which we would be surprised if the Conservation Officer was keen on this and they may well when reviewing the whole property when they look at the thatched work and comment on this. Generally, it would be argued we feel that a stone chimney should have a stone inner. As with lots of things in this property further investigation needs to take place.

Inglenook fireplace

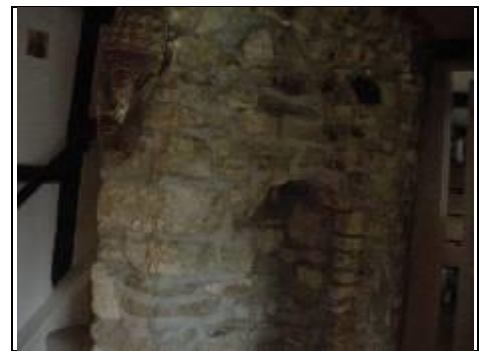
There also looks to be a central chimney built in stonework and one found within the roof. With further investigate it may well be what is known as a smoke hood which is one of the earlier chimneys which would be another historic element in the building.

Old chimney?

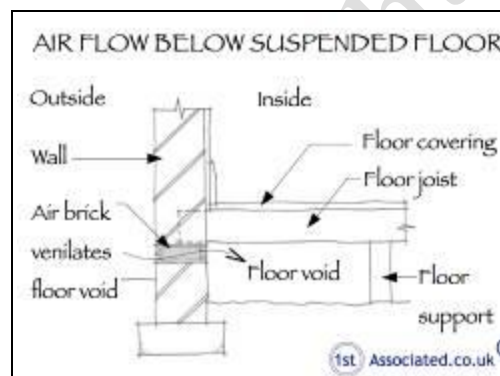
Over the years this has been replaced with various different floors including a suspended timber floor to the lounge area. We were advised the original boards were lifted and re-laid. We think the original boards were unlikely to have been cut that well, lifted, sanded, varnished and re-laid. We also think it is unlikely the original boards would have been so well cut. Our concern is the lack of ventilation to this timber floor. The solid floors as far as we could see throughout the rest of the property these can draw in cold.

Suspended timber floor

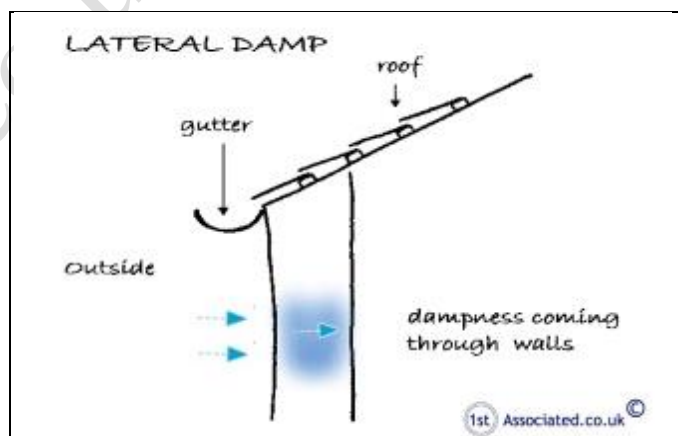
We used a resistance meter on the external walls. We have found significant dampness.

Lateral damp

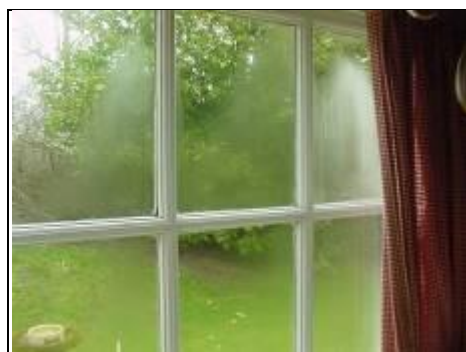
At the time of the inspection there were obvious signs of condensation to the windows in the kitchen and we generally find you do get condensation throughout a property like this even with the characteristic of the property. You do need to consider this will be something you have to live with if you do take this property on.

Condensation to windows in kitchen

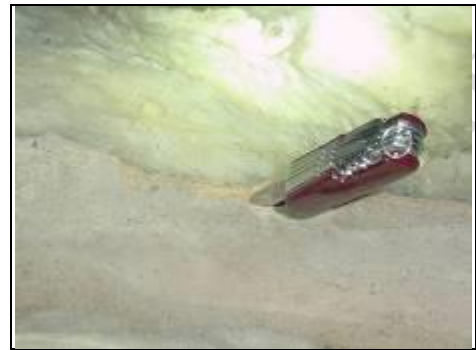
Woodworm/rot in timber in middle roof where it meets left roof

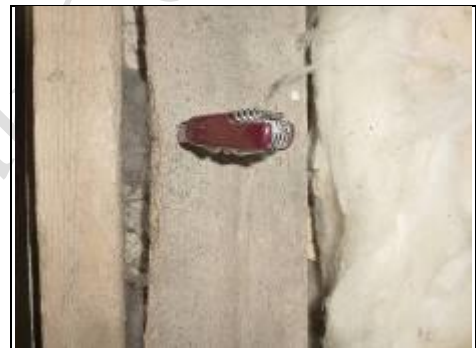
Woodworm

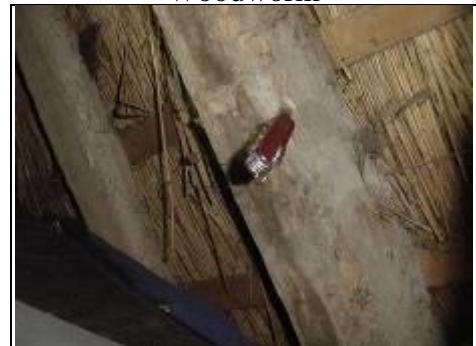
Woodworm and soft rot

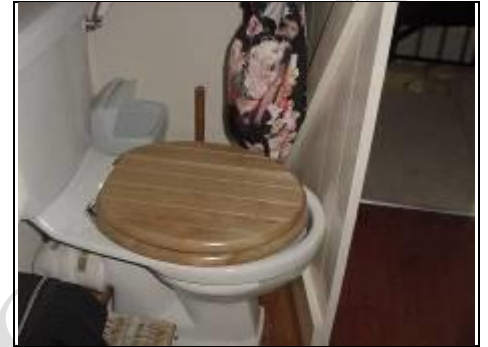
WC very close to door in bathroom
