Example Survey Victorian Residential Building Survey

GENERAL INTRODUCTION

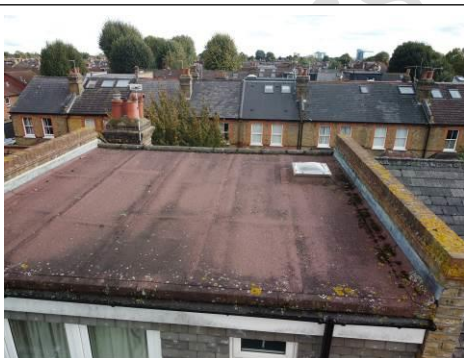
2.0) Hidden flat roof – parapet walls leaking?

There seems to be leaks to the parapet walls, both left and right side, and also to the roof window which has a felt flashing which is not ideal, we much prefer to see lead. The left parapet wall and the roof window are highlighted in blue.

High level flat roof and parapet walls

ANTICIPATED COST: All of these are quite costly and for a capping or new coping stone we would expect costs in the region of £5,000 - £10,000 plus access scaffolding or access via the roof window that we discuss below; please obtain quotations before you legally commit to purchase the property.

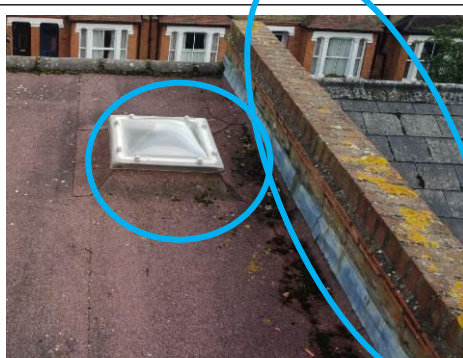
Left parapet wall and roof window leaking

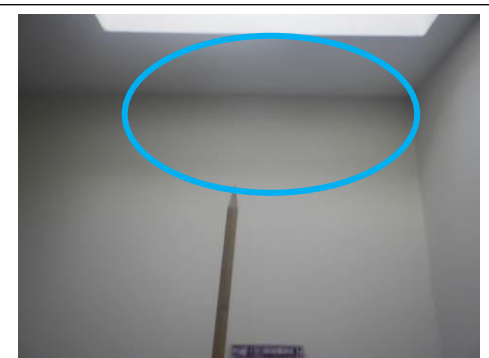
Water mark - leak from roof window ?

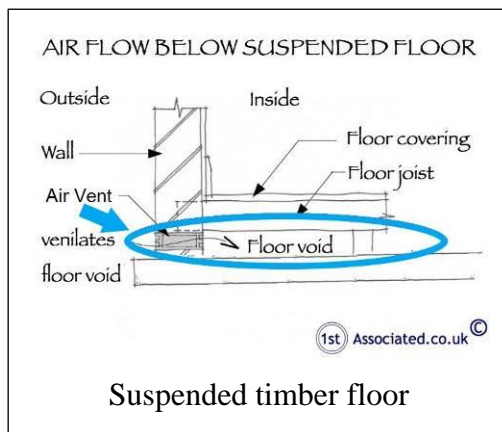
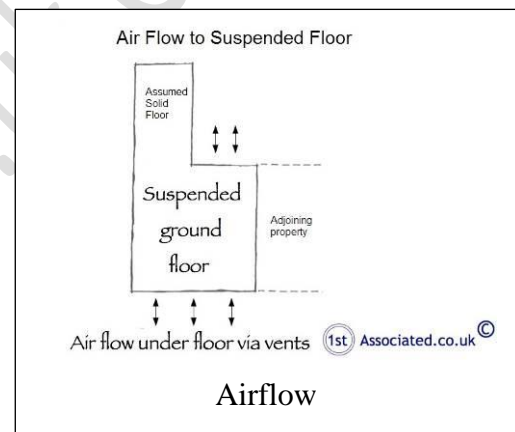
Another contributing factor to the dampness could be the suspended timber floor and the air vents. The air vents are to help airflow underneath the timber floor to help reduce the possibility of wet rot, dry rot and wood destroying insects.

To the front and rear of the property there has been paving added. Unfortunately, this has resulted in the air vents now being low and we believe they may be acting as gutters and allowing water in;

ACTION REQUIRED: Normally we would recommend protecting the air vent however in this case in both instances we would recommend monitoring and if water is getting in we would recommend reducing the height of the ground / taking out the paving slabs to stop water getting in through the air vents.

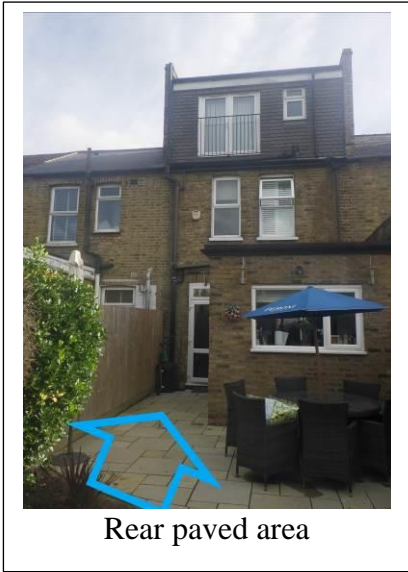
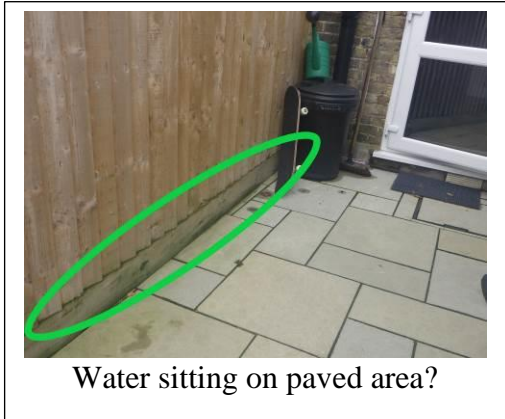
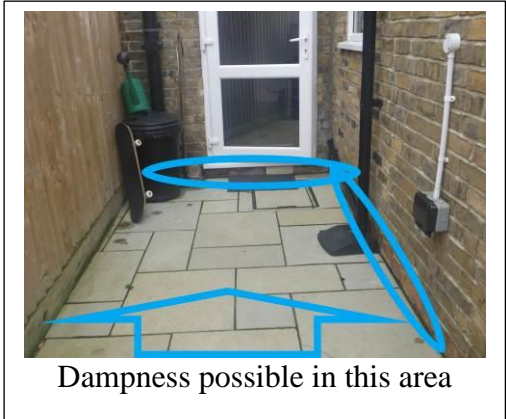
As already mentioned, there has been paving added to the rear which is quite popular however in this instance the paving looks to have been added on the existing ground level therefore reducing the height to the air vents and also to the damp proof membrane that we have already mentioned. It is very difficult to be certain on a dry day but it does look like the rear area is holding water and dampness is susceptible in this area and indeed we found dampness in our damp meter readings.

ACTION REQUIRED: The area needs to be monitored. If water is being held in this area then we would recommend a French drain and/or land drain diverts the water around the property and is discharged into a manhole (subject to obtaining approval) and/or a soakaway added (which will be additional cost).

ANTICIPATED COST: This work is likely to be costly and will involve removing quite a lot of the paving which is a shame however we cannot see any other way of doing it.

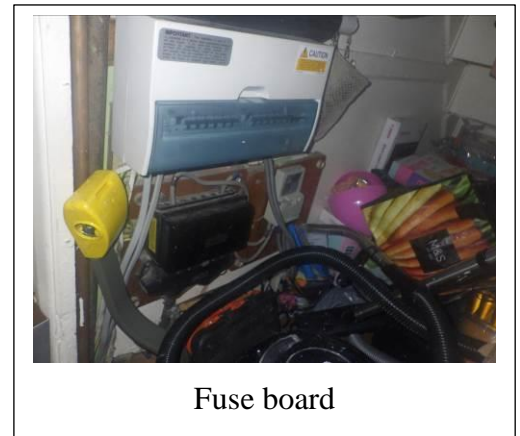
Fuse board

The fuse board is 1980's/1990's and better are now available. We would recommend upgrading the electrics unless the owners can confirm that it has been carried out recently.

ACTION REQUIRED: We recommend a new fuse board with a metal casing; modern standards require half hour to one hour fire resistant casing around a fuse board.

We recommend a test and report and we would also advise as the property is changing occupancy the Institution of Engineering and Technology (IET) also recommend a test and report and any recommendations should be carried out by a NICEIC registered, or equivalent, approved electrical contractor or similarly approved.

- 1) £250 - £500 for a test and report
- 2) £250 - £500 for a new fuse board
- 3) £500 - £1,000 for additional socket points and updating
- 4) Plus any further work recommended

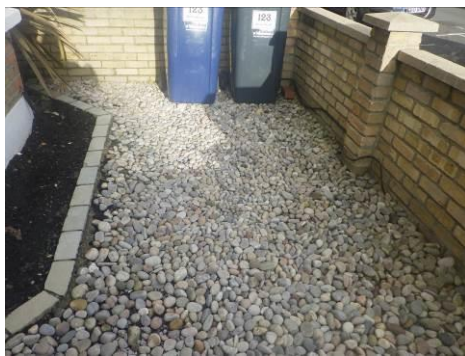
We ran the tap in the top floor shower room for fifteen minutes and found the water was slow to drain away however this could be due to the awkward external waste pipes that we sometimes have when properties have been extended like this.

Front manhole hidden under shingle

ACTION REQUIRED: We would prefer to be on the safe side and recommend a closed circuit TV camera report of the drains.

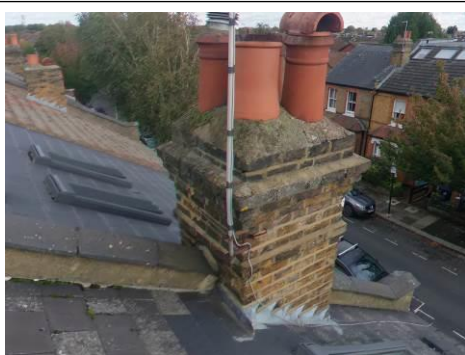
This chimney is brick finished with a lead flashing and four chimney pots. From what we could see from ground level it looked in below average condition considering its age, type and style. There is a water trap behind the chimney which looks to have been repaired previously. Also, the flashing looks like it may be coming away.

Water trap behind chimney

We would expect costs in the region of a few hundred pounds if work can be carried out via a ladder and crawler boards assuming the problem is as simple as repairing the flashing; please obtain quotations before you legally commit to purchase the property.

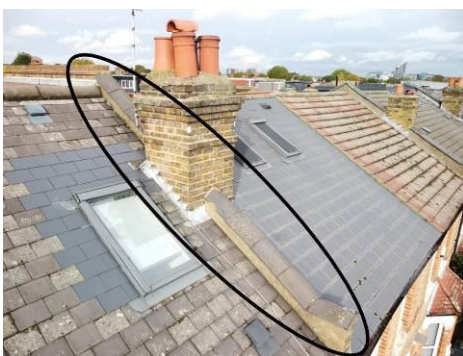
The flat roof parapet walls are built from brick with a visible lead flashing and a coping stone of brick which does allow dampness in over time. We would comment that generally they are in average condition considering their age, type and style with the exception of the rear left parapet wall which we believe is leaking.

Front right parapet wall

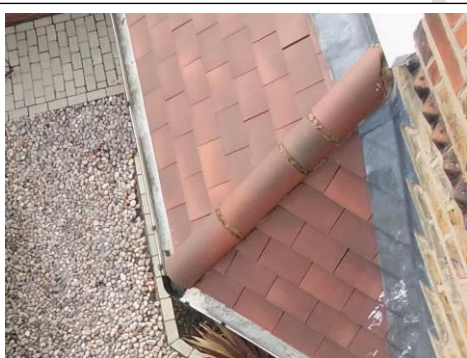
This roof is pitched and clad with slate. It has a lead flashing where it meets the main wall. We would comment it is in average condition considering its age, type and style. We were pleased to see a stepped flashing which we consider better than a straight flashing.

Front bay roof

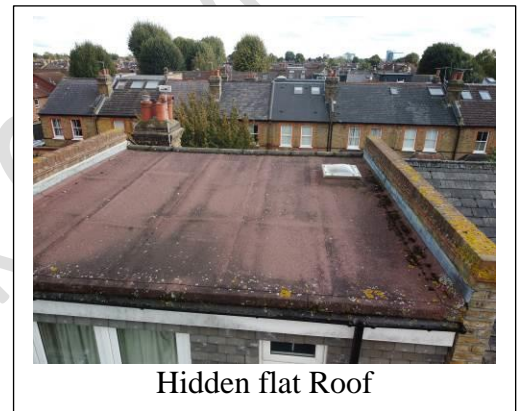
The flat roof is located to the rear and is covered with mineral felt. It is starting to weather where you can see the dark areas in our photograph which also often indicates where water sits. Where the mineral chipping has darkened you can get accelerated deterioration in these areas and they tend to warm up more during the summer months and possibly blister.

This flat roof is flat with minimal fall on it which may seem a strange comment but we would expect a flat roof to have a fall of about fifteen to twenty two degrees and this is why we would term this as a flat, flat roof.

ACTION REQUIRED: Please see the Executive Summary; we would recommend a safe roof access is added.

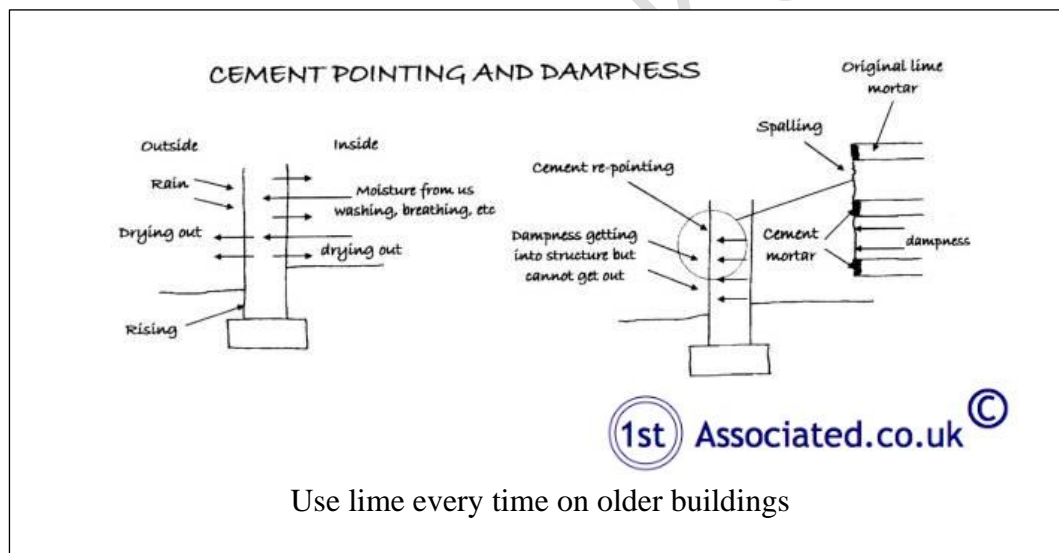
We would draw your attention to the cement mortar re-pointing that has been carried out on the exterior of the property that we feel is not appropriate to this building. Originally it will have been built with a lime-based mortar and this is what should be used for any re-pointing in the future.

The original lime mortar is a softer material which allows dampness to dissipate, whereas cement mortar is a harder material that does not allow the walls to 'breathe' and in turn causes dampness to come into the walls. The use of cement mortar causes deterioration to brickwork and does lead to the face of the bricks deteriorating, which in turn leads to dampness. This is a very important point.

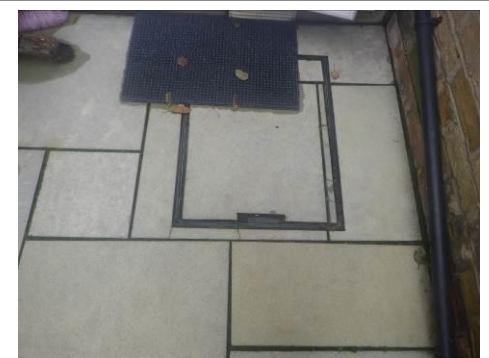
We were unable to lift the rear manhole as it was inset into the paving.

Rear manhole
