JOB REFERENCE: XXXXX

RESIDENTIAL BUILDING SURVEY

XXX
Roxton
Bedfordshire
MK44 XXX

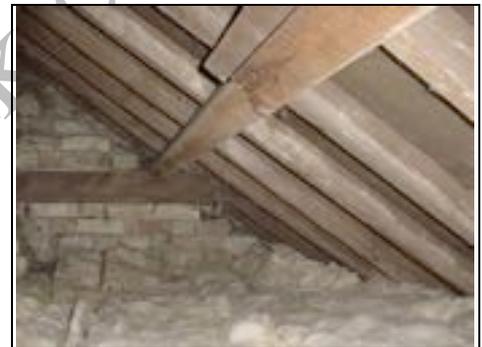
The original roof covering would have been slate. This has been replaced with a heavier concrete tile. Modern Building Regulations require a traditional structural support is provided where this takes place. We can't see any obvious additional support that has been added and equally we cannot see any significant movement in the timbers.

We did note that the purlins were running a long length without getting support.

Long purlin without support

ACTION REQUIRED: Your Legal Advisor to check and advise when the property was re-roofed and if Building Regulations permission was approved/obtained. We will advise further.

ANTICIPATED COST: Depending upon the findings of your legal advisor but to add propos is likely to be in the region of a few hundred pounds. please obtain quotations.

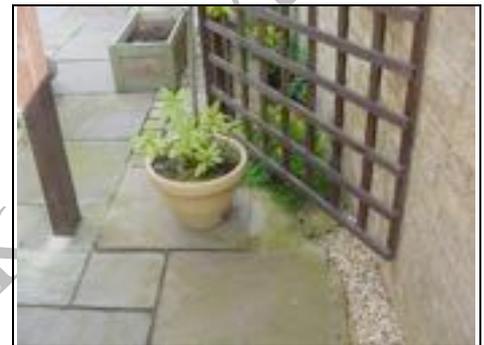
We are getting slightly high damp readings in the front right hand corner bedroom (all directions given as you face the front of the property). This could be due to the need for some repointing at high ground or it could be due to lack of air movement in the area due to the nearby tree.

Damp to the right hand side

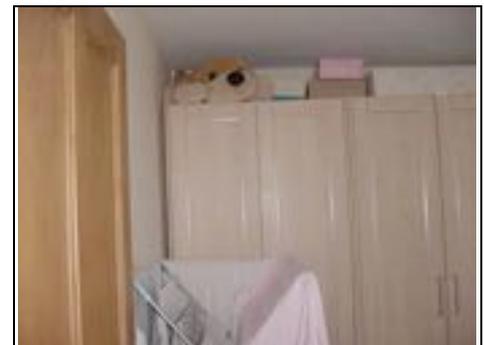
There may also be cold bridging occurring in the corner of the property as we noticed that washing was being dried here.

Washing drying in the right hand bedroom

ACTION REQUIRED: Improve the extraction to areas of high humidity with the installation of good large humidity controlled extract fans to the bathroom (we appreciate it has already got one but better are available) and the kitchen.

If the room is regularly used for the drying of clothes (it was being used at the time of the survey) and you intend to do the same then you need to make sure this room is well aired with a good large humidity controlled extract fan!

ANTICIPATED COST: We would anticipate costs between £150 - £250 per extract fan depending upon the wiring required. We always recommend quotes are obtained before work is agreed/commenced.

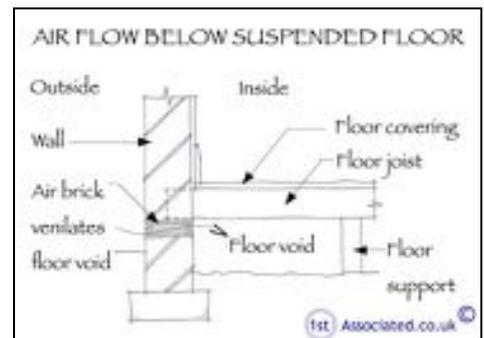
As discussed whilst at the property, there should be an airflow under the suspended timber floor. We can see the ground level has increased to the front of the property hiding some of the airbricks. These need to be exposed and cleared and checked they are venting; this is a relatively easy operation.

Suspended timber floor

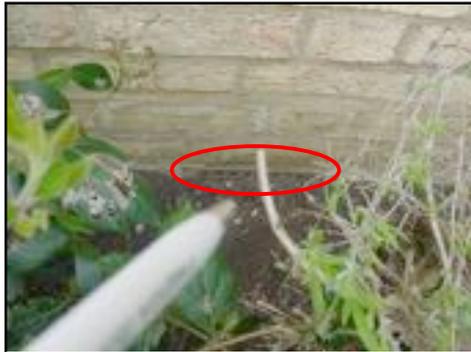
The difficulty comes with the rear airbricks where you need to have a ‘cup of tea’ meeting with both your neighbours (ideally before you commit to the purchase of the property) and advise them that there are high ground levels causing minor dampness into your property and probably causing dampness into the timber floor and that the ground needs to be lowered. This is probably possible in some areas, however there is also a garage to part of the property.

Hidden airbrick

ACTION REQUIRED: Ideally a French drain should be added to the rear of the property. As mentioned this is complicated by the garage to the rear which we have not seen inside. You do need to check this to see if there are airbricks within and if there is a concrete floor because a concrete floor will act like blotting paper against the property.

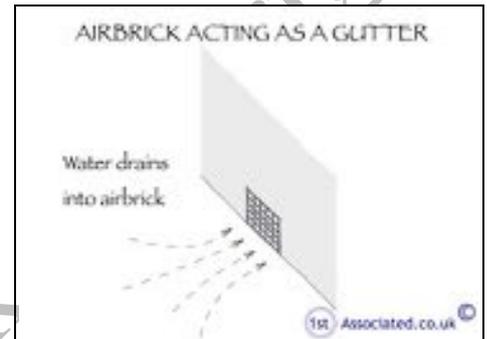
Airbrick acts as gutter

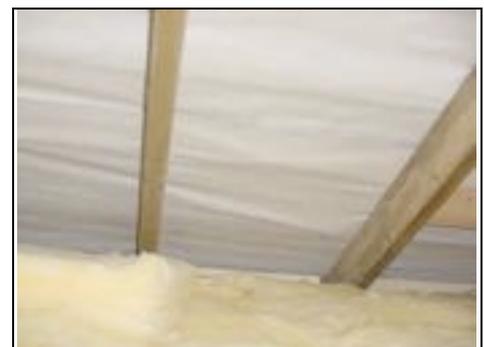
To the left hand side there is a modern breathable sarking felt. This type of sarking felt, as far as we are aware, has been used since 2002.

Modern breathable felt

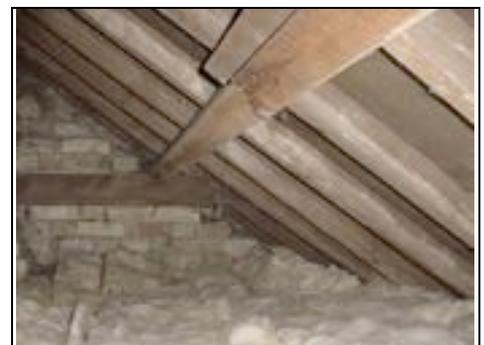
This type of roof structure has what is known as an 'A' Frame cut timber roof. This is a roof that is purpose made and hand built on site. Without the original design details we cannot categorically confirm that there are no defects; however it is in line with what we typically see with the exception that we would have expected more supports to the purlins particularly as there has been a concrete tile added.

Long length of purlins without support

ACTION REQUIRED: Please see our comments in the Executive Summary.

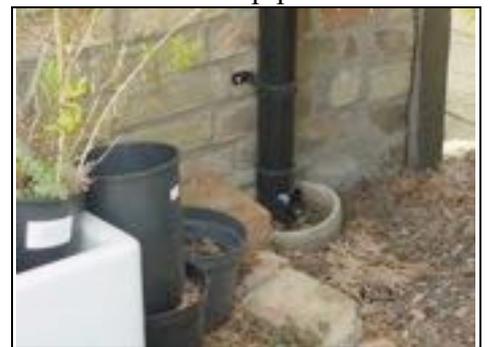
Downpipe

The property has plastic gutters and downpipes and are fairly typical of what we see; they are in average condition for their age, type and style.

ACTION REQUIRED: We would recommend you stand outside the property next time it rains heavily particularly to the rear of the property (obviously gaining permission from the neighbours first) and see how well the drains cope with the rainwater particularly looking at the guttering and the joints.

We also recommend that the gutters and downpipes are cleaned out, the joints are checked and the alignment checked to ensure that the gutters fall towards the downpipes.

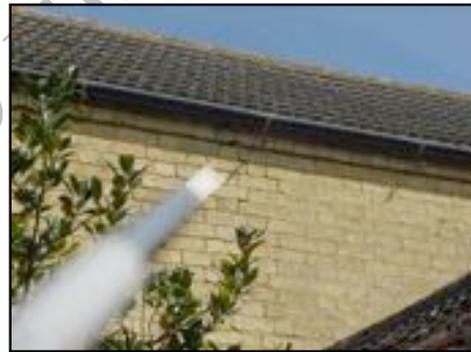
Weathered pointing

Generally Flemish Bond brickwork is liable to penetrating dampness internally, dependent upon the condition of the brickwork and the exposure to the weather. It is essential that external faces be kept in good condition. In this case the brickwork has some weathering.

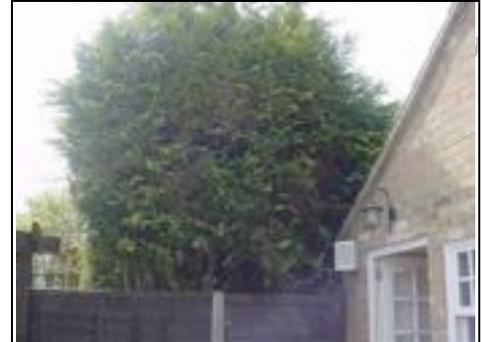
There are trees within what we would term as influencing distance but you do need to speak to your insurance company as they may have a different interpretation for insurance reasons.

The tree is located in next doors garden but is right next to your property

ACTION REQUIRED: Please see our comments in the Executive Summary.

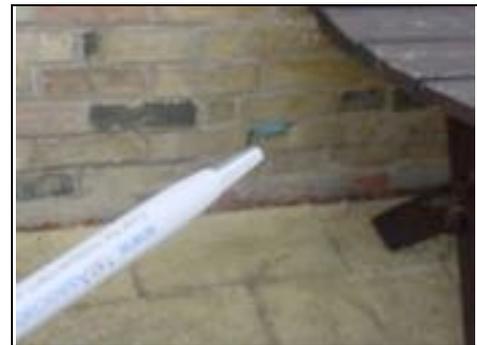
There is a metal electric damp proof course to the left hand side of the property. These were popular at one time. From the information we have read in relation to them, we generally find that they do not work. They are in the area of the boiler room which we should imagine is kept fairly warm and dry.

Metal electric damp proof course

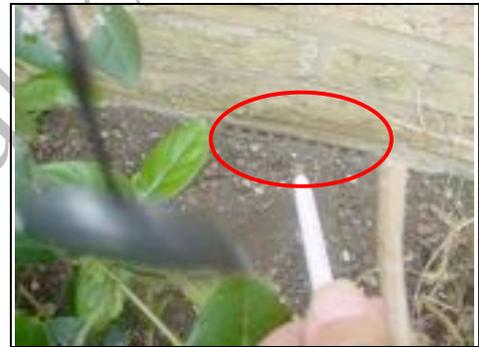
Air bricks are essential to have a through flow of air as this helps to reduce the chances of wet rot, dry rot and woodworm. In this case the airbricks are acting as gutters and certainly not venting the floor.

Air brick – ground level needs to be reduced

ACTION REQUIRED: Please see our comments in the Executive Summary.

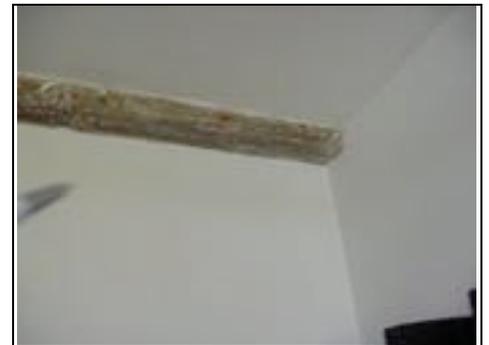
Timber in the lounge – is it real?

We are not one hundred percent certain but it seems it is a very unusual detail.

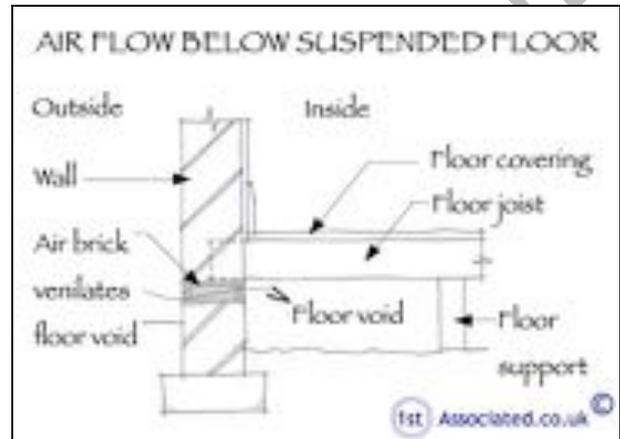
Suspended timber floor

There is a mixture of a suspended timber floor to the middle of the property and possibly the right side, which require air movement underneath to minimise wet rot, dry rot and woodworm. Our concern with regard to the airflow is that it will be difficult to get effective airbricks to the rear of the property due to the way the garage has been built against the building. In the Executive Summary we have mentioned about putting a French drain to the rear of the building. We would have a meeting with the neighbours and get permission before you legally commit to purchase.

ACTION REQUIRED: Please see our comments in the Executive Summary.

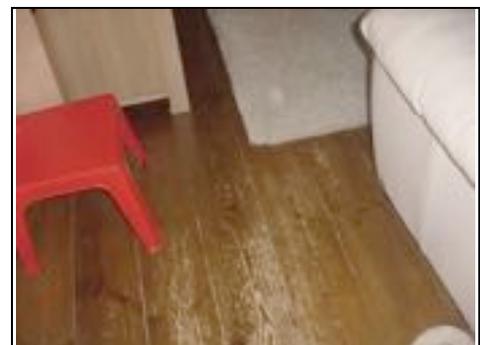
Marks to the floor in the lounge

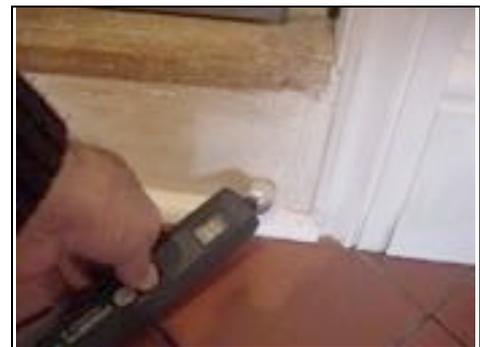
A visual inspection and tests with a moisture meter have been taken to the perimeter walls. In this particular case we have found significant rising damp to the right hand side of the property.

Testing for rising damp at the step in the construction between the kitchen and the main building.

ACTION REQUIRED: Please see the Executive Summary.

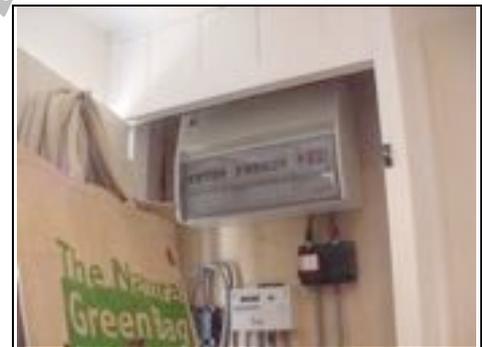
Fuse Board

The electric fuses and consumer units were located in the left hand side entrance area. The fuse board looked 1990's/2000's and better are now available. We are advised the electricians were tested in 2009; certificate required.

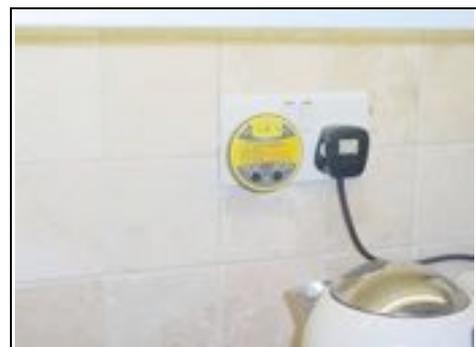
Earth test

We carried out an earth test in the kitchen area to the socket point that is normally used for the kettle, this proved satisfactory.

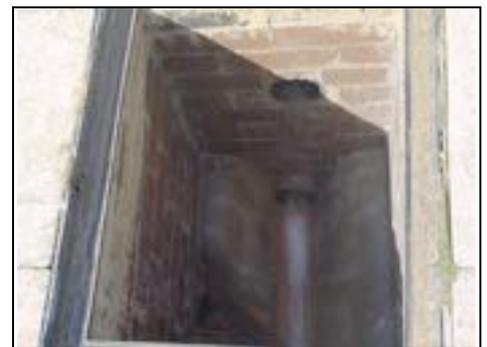
Front left hand manhole

We duly lifted the cover and found it to be free flowing at the time of our inspection.

From what we could see it is brick built.

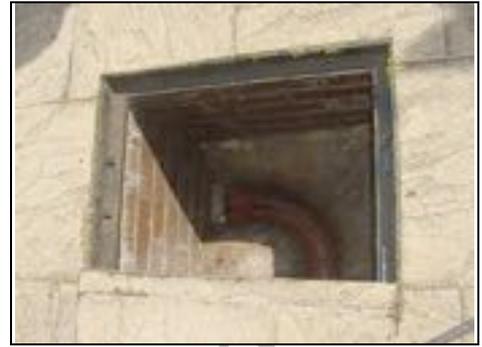
Rear left hand manhole

We duly lifted the cover and found it to be free flowing at the time of our inspection.

From what we could see it is brick built.

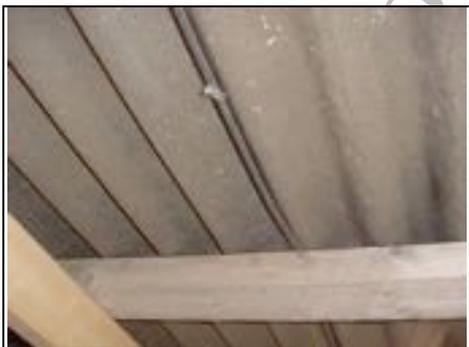
There is a substantial garage/workshop area. We were shown that it has electricity and an outside water supply. The current owner has put a lean-to type structure around it; we discussed the roofing of this with them and they said they had found problems with the corrugated roof that they had used and that it sagged and seemed to need a lot of support.

Roof to lean-to

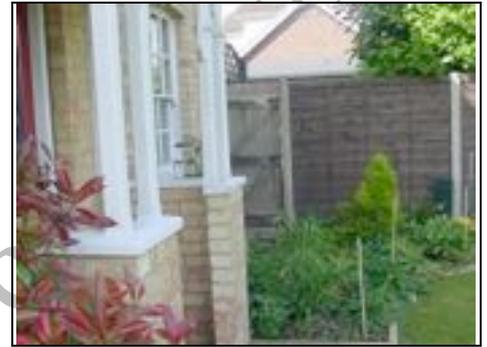
Access gate to next door property

ACTION REQUIRED: Your legal advisor needs to check that the access gate to next door property is not a right of way
