RESIDENTIAL BUILDING SURVEY

XXXXXXXXXXXXXXXXXX,

**London,
SW3 xxxx**

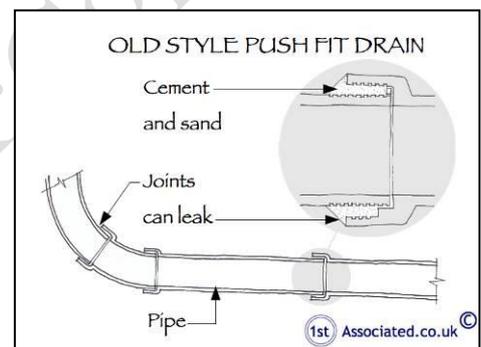
Please note our concerns with regard to the drainage and the tipping of waste materials down it and it being slow to drain away; there seems to be a minimum fall.

We would advise in older properties, such as this, drainage was often push fitted together rather than bonded together which means that they may leak over the years.

Push fit drain

Whilst we ran several of the taps for 15 minutes without any build up or blockages the only way to be 100% certain of the condition of the drains is to have a closed circuit TV camera report which we recommend.

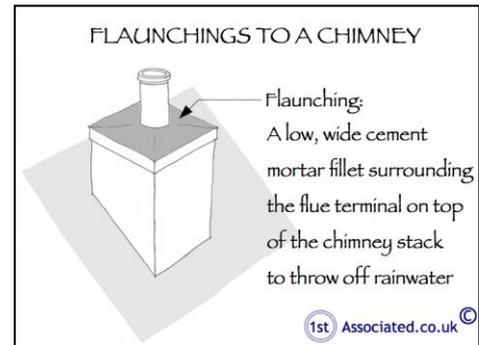
Unfortunately we were unable to see the top of the chimney fully, known as the flaunching. From what we could see of it the top has had what we would term as a poor quality repair.

Flaunchings

ACTION REQUIRED: Generally we would recommend removal of cement repairs and replacing with a lime based mortar and an increase in the flashing where the awkward detail is and repair spalling brickwork.

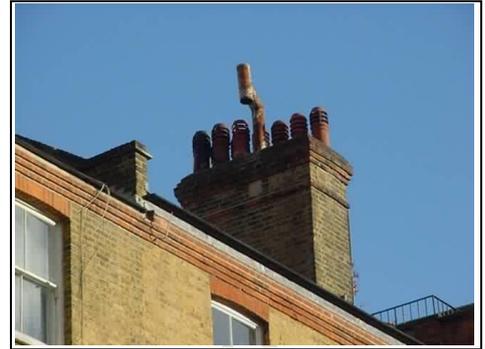
This chimney is brick built with numerous chimney pots and a lead flashing. This chimney also has problems with spalling brickwork.

We have not been able to have a close up inspection of this chimney so we would recommend a close up inspection takes place as well as repair work.

Rear left chimney

ACTION REQUIRED: We recommend a close up inspection takes place as well as removal of poor repair work in cement mortar and replace in a more appropriate mortar. Repair spalling brickwork.

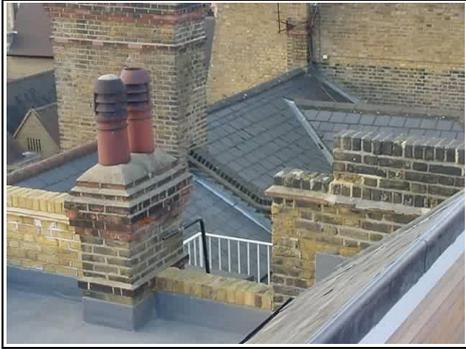
Middle rear right chimney

This chimney is brick built with two pots and a lead flashing. We would comment there is a crack to the haunching.

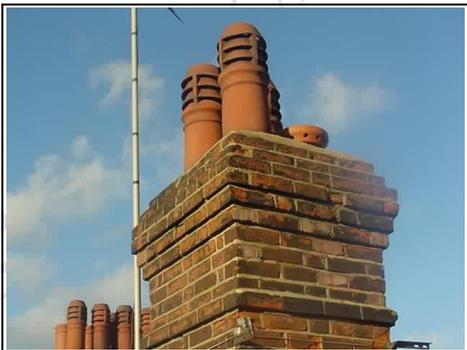
Front right hand chimney

This chimney is brick built with a lead flashing. We would comment the bricks are spalling.

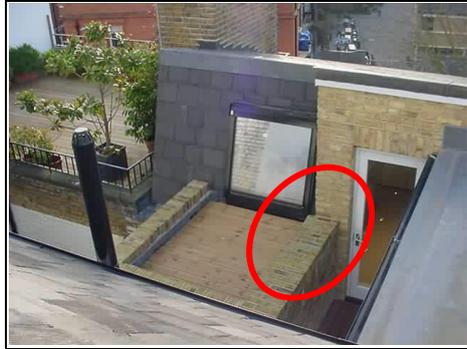
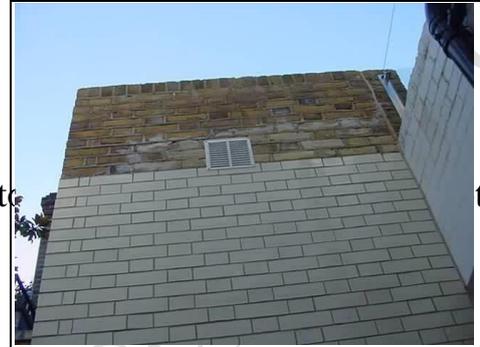
Recently built in brick as part of the project. Efflorescence visible. We do not believe that they are watertight although we can see some damp proof courses in some areas these may have not been lapped correctly.

Signs of dampness to central parapet walls

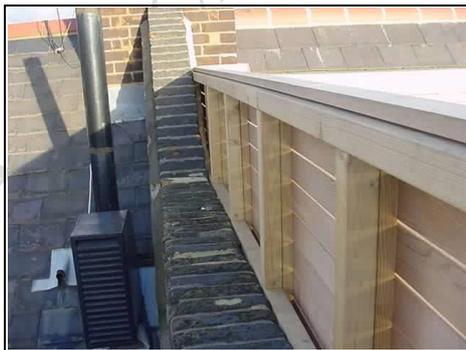
Right hand parapet wall

Additional brick built parapet wall. Some poor repointing has been carried out in cement mortar. No membrane as far as we can see to the wall and no repairs carried out before the cladding was added or we would say thought to the detailing.

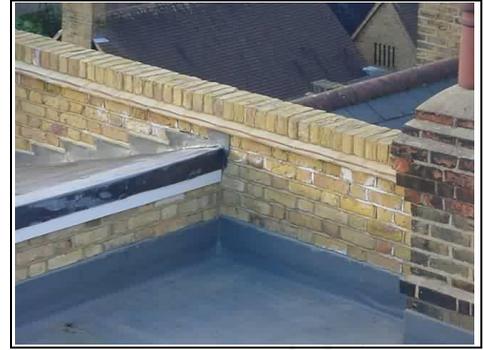
Rear right hand parapet wall

The rear right parapet wall is new. We can see efflorescence on it which does concern us as to whether it is watertight.

ACTION REQUIRED: Again monitor and carry out work to make watertight such as add a capping if required.

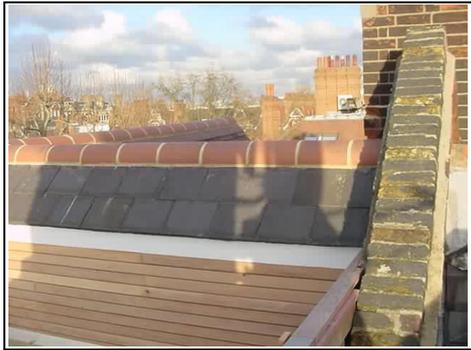
Small front slate roof

This is covered with slate tiles. It is poorly detailed and should have a guttering although this could be argued it is unsightly, equally pattern staining down the timber is unsightly.

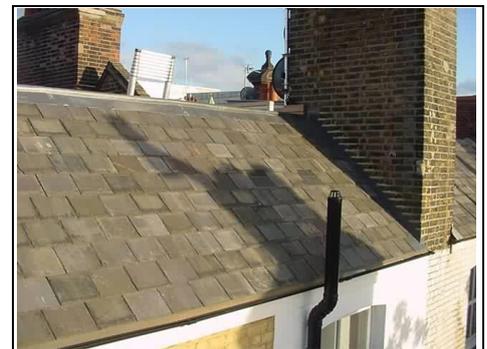
Small middle slate roof

This is covered with slate tiles. We believe the slates may discharge over the guttering during periods of moderate to heavy rainfall.

ACTION REQUIRED: This area needs to be monitored and guttering amended if surcharging (overflowing) the guttering.

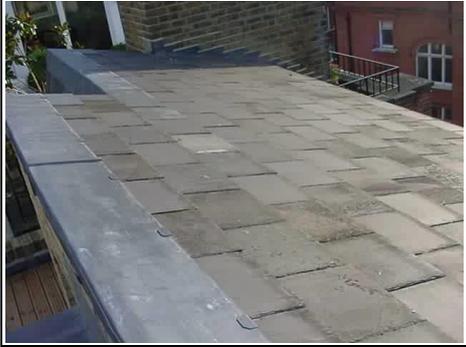
We noted an awkward detail to the left side and that there was no lead surround to the hopper head.

Rear slate roof

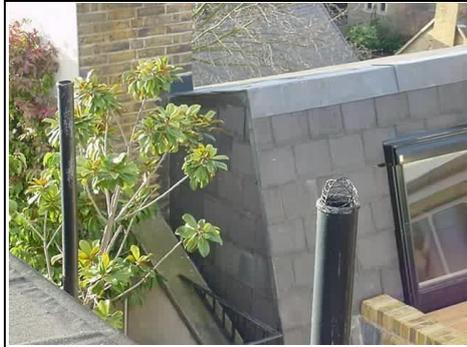
Awkward detail to left side

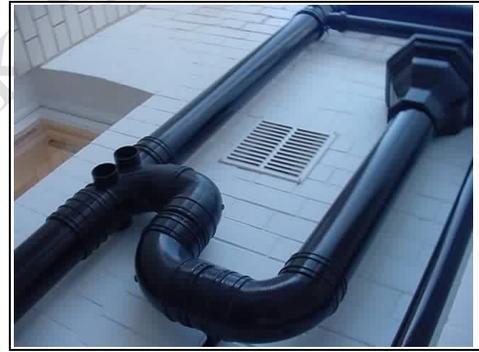
New plastic soil and vents pipes and guttering

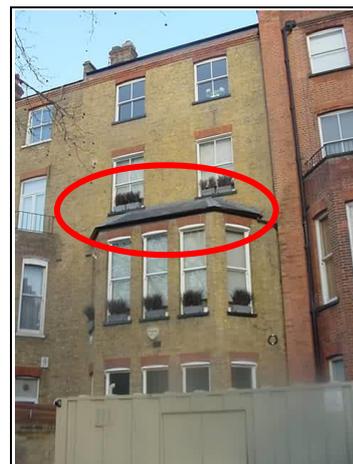
Before the 19th Century, the practice of building timbers into external walls was almost universal. These were known as bonding timbers. They are of course prone to rot as solid walls allow dampness through. Unfortunately, without opening up the structure, we are unable to confirm if this is the case particularly to the bay window areas.

Bay window to rear

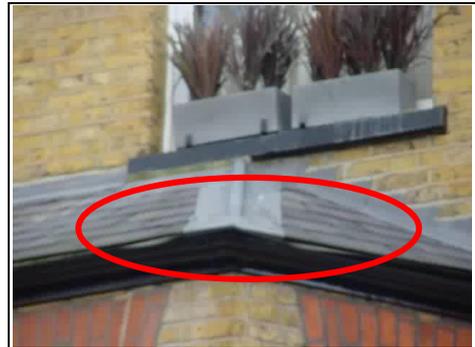
The fascias and soffits are timber. They are painted and we would comment they are in average condition for their age, type and style. There is no guttering to the fascia on the terrace; the contractor advised they didn't put one as it would look unsightly. This is something that has been raised in our snagging list as equally we believe the accelerated deterioration of the timber beneath and pattern staining will look unsightly.

Fascia to rear bay window

ACTION REQUIRED: See Snagging List.

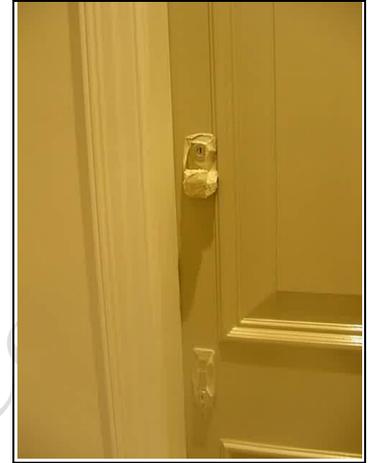
We assume all internal doors are as new. They were being painted at the time of our penultimate visit.

Door being painted

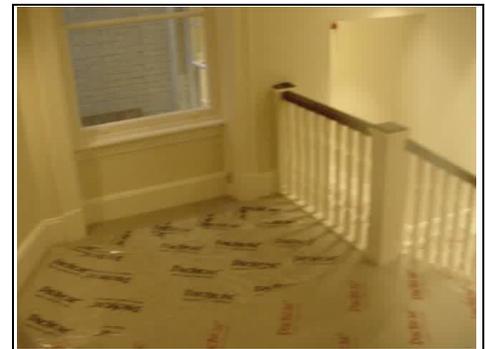
Materials were stored on the shared stairs during the course of our initial visits but later on the areas were cleared. They do need a final check for any contractor's damage that has taken place.

Shared stairs

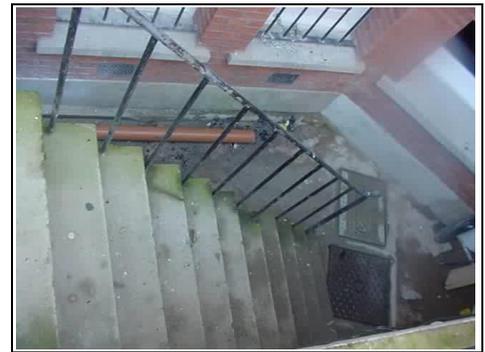
The railings were being painted but we noted there hadn't been any preparation treatment to the rusting areas. There is dampness at the top which we are advised by the contractor that they will be dealing with. There are broken steps; we would recommend these are replaced. We couldn't see any fall to the floor or a drain that would take the water away quickly. We also noticed that one of the windows hasn't got any bars on it.

Front external area

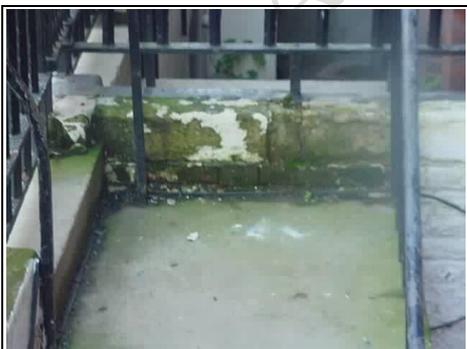
Dampness at top of external area

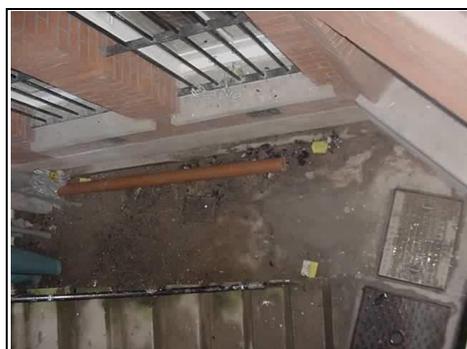
Lack of fall in area

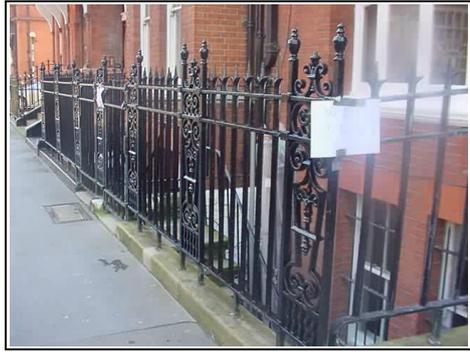
Railings to front

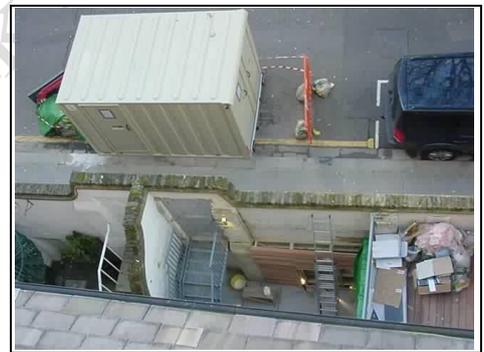
Construction still underway and building materials needed to be removed

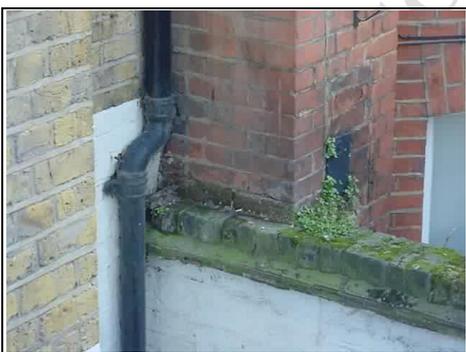
The staircase to the rear terraced area was awaiting redecoration at the time of our inspection. Our concern was that the top of the wall had a lot of moss and growth on it which we believe will allow dampness into it. In the kitchen/dining area that allows access to this area we could see water sitting on the floor. The decking on the area above it, we found gets slippery over time and not best suited to properties that are tenanted.

Moss and growth to top of wall

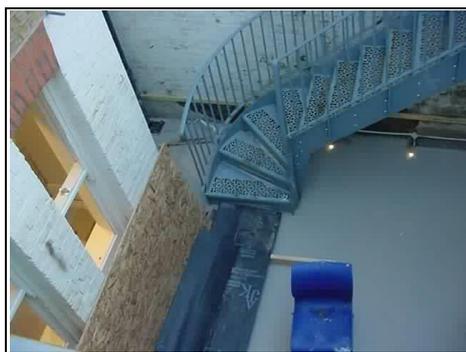
Stairs to rear terraced area

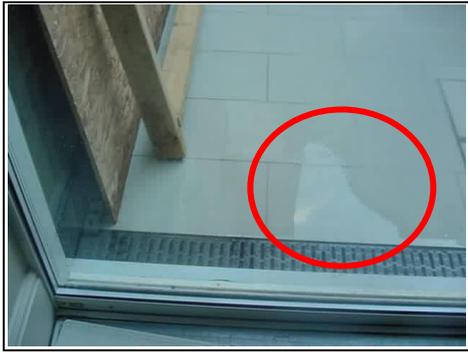
Water sitting out on paved area

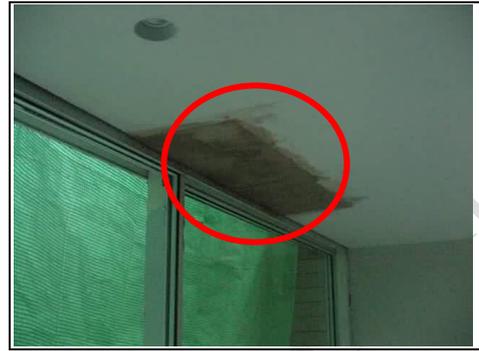
Repair carried out to ceiling
