RESIDENTIAL BUILDING SURVEY

Kent
CT6 xxx

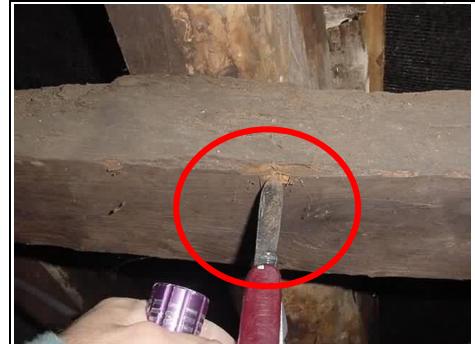
We found signs of frass, which are the chewed up remains of wood in the roof. We would have expected woodworm in a property of this age, unfortunately it appears that the woodworm may be active.

Woodworm frass

ACTION REQUIRED: Whilst we do not consider that the woodworm is structurally significant that is present it does need to be monitored. We generally recommend the environment is changed to an environment that woodworm are unhappy to live in. We would be happy to return in the Spring of 2015 to give a further opinion.

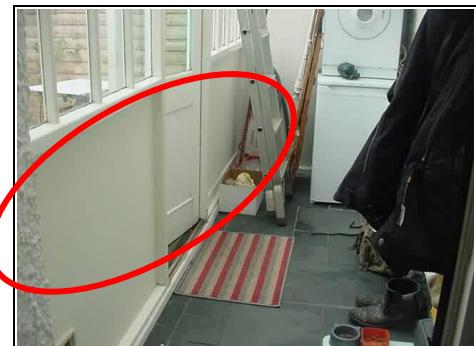
There is possible asbestos to the rear covered area (with polycarbonate roof).

Base of rear lean to area with possible Asbestos

ACTION REQUIRED: The only way to be a hundred per cent certain with regards to Asbestos in a property is to have an asbestos survey carried out by a specialist asbestos company.

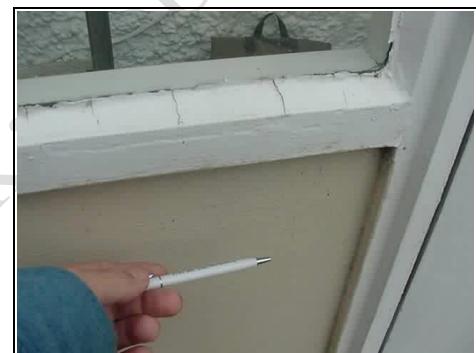
Possible asbestos to base

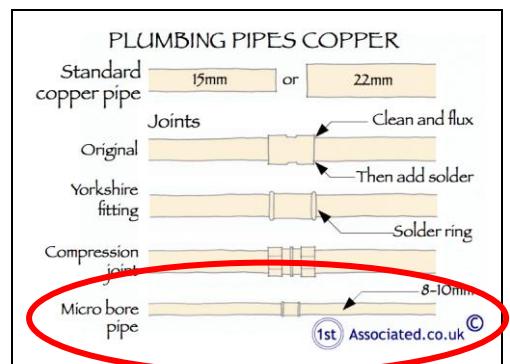
Plumbing pipework

ACTION REQUIRED: We would recommend that the micro-bore is replaced. We would also change any single panel radiators to double panel convection radiators.

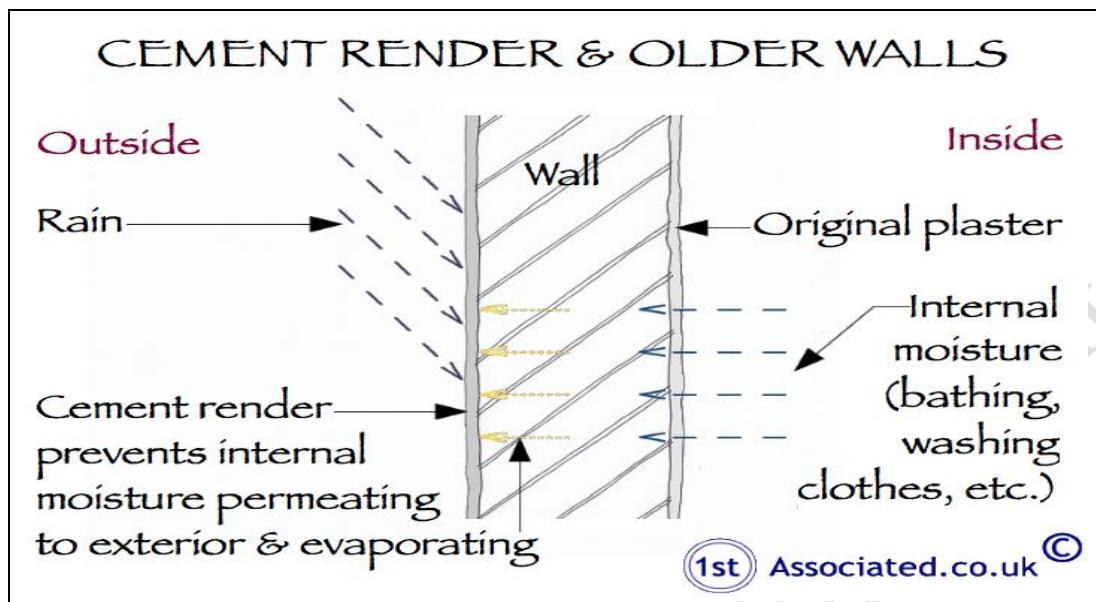
There is cracking in the render which can be caused by differential movement as you have a timber structure trying to move and it is being straight-jacketed with a cement render and modern gypsum plaster internally. In addition to this there may be other problems as indicated in the roof-spread item of this report.

Cracks in render

ACTION REQUIRED: Ideally all of the cement render needs to be removed and replaced with a lime render to allow the property to breathe.

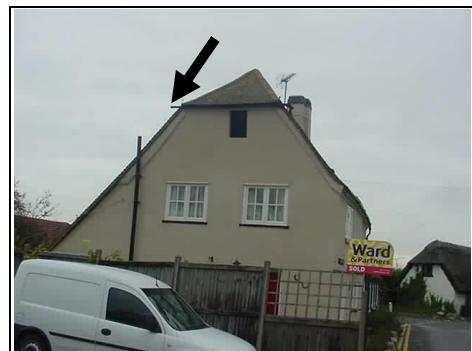
The original roof is likely to have been a clay Kent peg tile which then has been replaced with a heavier concrete tile which can cause roof spread. We could see hairline cracking in the cement render which is vertical indicating that the walls are moving out or down albeit relative minor.

We would also add that with cement even the most minor movement can result in cracking.

ACTION REQUIRED: There may be an option of the existing owner placing an insurance claim which you would then take over (approved by your legal advisors of course) with regard to the potential roof spread and then the insurance company could monitor for at least a year which is the recommended timescale. However this still would not get over the problem of having the cement render on the outside of the property.

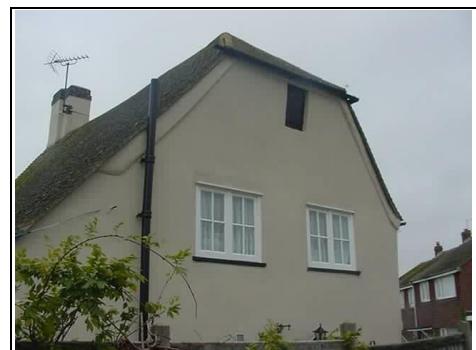
It can be seen that the gable end is out of vertical by approximately 15 degrees. We could also see within the roof that attempts have been made to tie the gable end in.

Gable end out of true

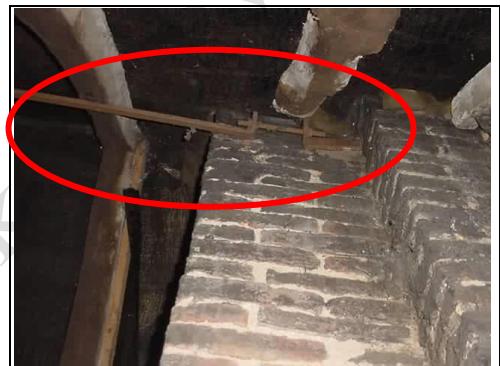
We could see some old iron bracing to the front of the property, which indicates there has been an attempt to tie-in the structure, which appears far older than the concrete small roof tiles that are likely to have been added in the 1970s.

Bracing running from front to rear

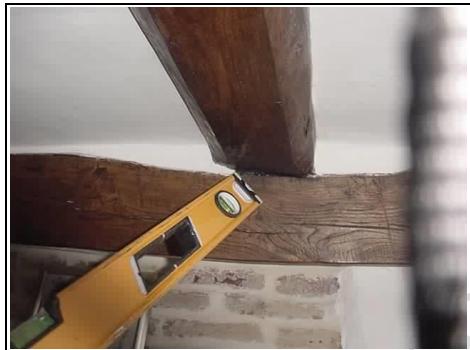
We could see a spine beam within the roof which is an essential beam that you need as the name implies which we could not see how this was tied in. There is also a beam which we could not see how it was tied in within the bedroom. These timbers may form part of the modernisation in years gone by.

Beam does not look to be tied
into the frame

ACTION REQUIRED: Open up the structure to check and confirm. We would be happy to return and comment further.

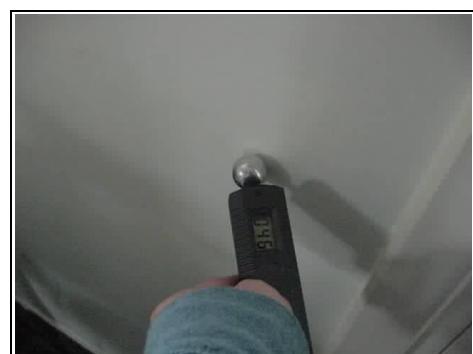
We have taken damp meter readings, which indicate that there is rising damp to the walls. We are not surprised with this given the modern material construction on an older property, which is stopping the property from breathing.

Damp meter reading indicating
rising damp

ACTION REQUIRED: Removal of cement render externally and cement/modern gypsum plaster internally and replace with lime based render and plaster which would then allow the property to breathe. Add bell mouth as this would help with the dampness.

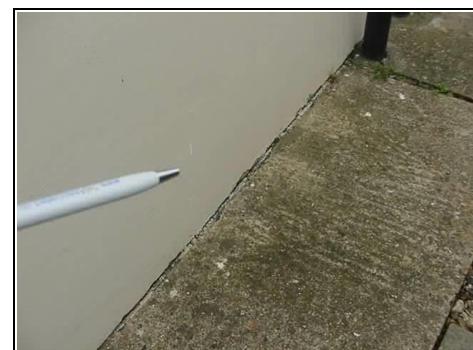
No bell mouth detail

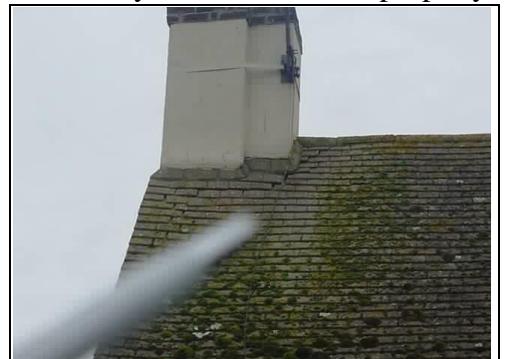
This chimney is render finished with a cement flashing and no chimney pots. From what we could see from ground level it looked in slightly below average condition considering its age, type and style due to the cement flashing.

Chimney viewed from rear

ACTION REQUIRED: Replace

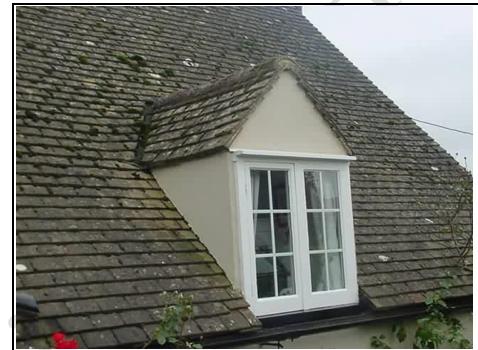
Dormer window

The dormer window roof is made from the same material as the main roof , the cheeks of the dormer are made in render and the windows are made in painted timber. Generally we could comment for their age, type and style they are in average condition. This is a new window – please see our comments in the Window Section regarding new windows and listed buildings.

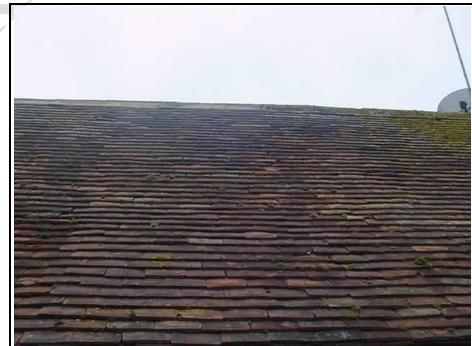
Main roof

The roof is pitched and clad with small concrete tiles and, from ground level, this looks in average condition considering the roofs age type and style other than we would not have put a concrete tile roof like this onto this age of property. There is moss gathering on the roof as there often is with concrete tile roofs which you need to sooner or later remove.

ACTION REQUIRED: Please see our comments regarding the roof in the Executive Summary. Carry out periodic inspections and maintenance of the roof, as required.

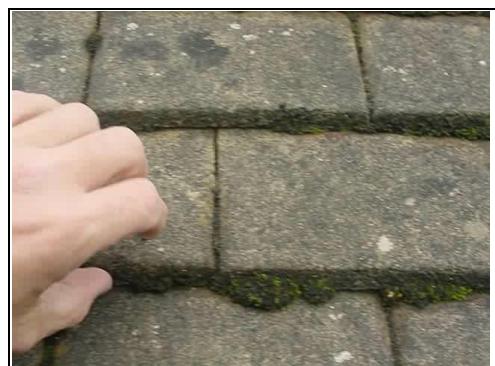
Moss gathering on roof tiles

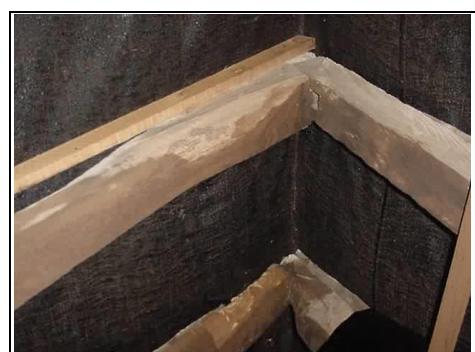
When we inspected the loft space we found a Hessian base Bitumen membrane. This type of membrane has been used since the 1960s. We generally found it to be in average condition, with damage in some areas, which is what we typically find.

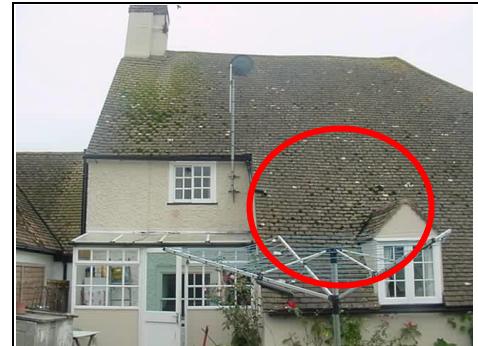
Rear cap slide roof

The roof is a cap slide roof with concrete tiles as the main roof. The cap slide is an extension of an existing roof which was fairly common in years gone by. This was added to allow the kitchen extension. We would add that it may be this cap slide roof and the extension that are limiting the movement in the building. Unfortunately it would take a years worth of monitoring as recommended by the Building Research Establishment to be certain of this.

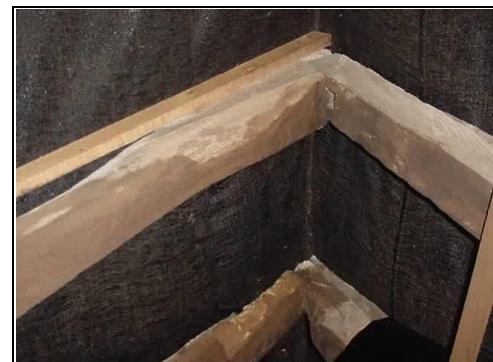
Coupled roof

- 1) The woodworm
- 2) We do not believe the roof is tied sufficiently with collars although obviously it has stood for many years.

The combination of factors such as the cement floor and the cement render to the walls mean that the building as a whole cannot move and cope with additional movement found in a timber framed property.

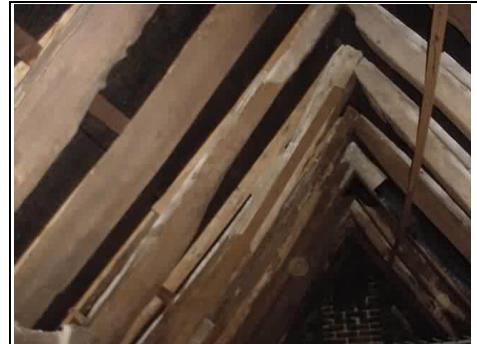
General view of roof

Our examination was limited by the general configuration of the roof, the insulation and stored items. What we could see was generally found to be in slightly below average condition considering its age. It is, however, feasible that there are problems in the roof that are hidden.

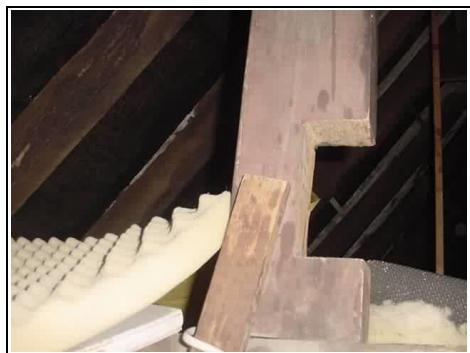
We could see that there have been repairs to the timbers which is quite common in older properties to have replacement timbers. Many of these have been re-used in other constructions. Or, the adding of additional timbers in what is known as back to backing, where timbers are strengthened by timbers being added back to back.

Re-used timber and
approximately half of it cut

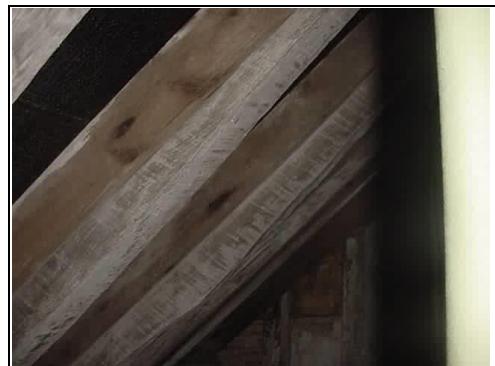
Close up of backing of timbers

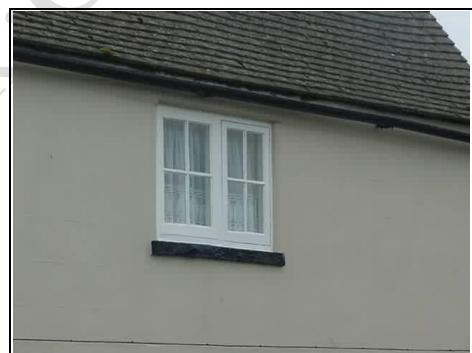
Guttering

The property has older cast iron gutters and downpipes. The condition is fairly typical of what we see; they are in average condition for their age, type and style. Cast iron of this age will need maintenance. If regularly maintained it lasts longer than plastic, in our experience.

ACTION REQUIRED: Clear moss. We would recommend you stand outside the property next time it rains heavily and see how well the drains cope with the rainwater particularly looking at the guttering and the joints.

We also recommend that the gutters and downpipes are cleaned out, the joints are checked and the alignment checked to ensure that the gutters fall towards the downpipes.

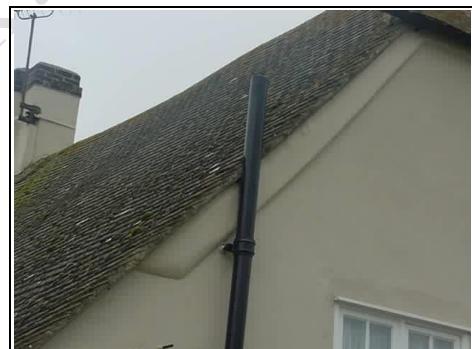
Soil and vent pipe to left of property

The property has two cast iron soil and vent pipes one used located to the left of the property which aligns with the bathroom and one unused located to the right of the property which does not align with anything in this property; we assume it may be used by next door. Cast iron of this age can crack and rust and needs regular maintenance.

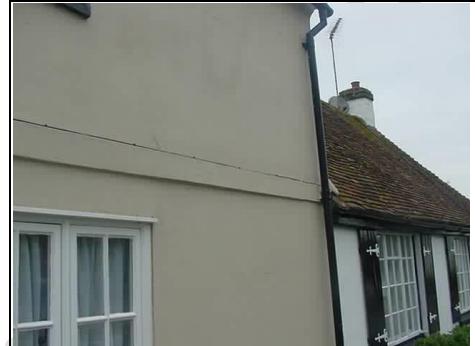
The walls are constructed using a traditional timber structure with painted smooth cement render.

Painted cement rendered walls covering timber frame

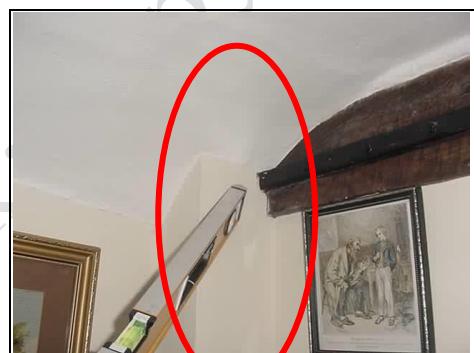
Bracing straps

We could see bracing straps. We would refer you to our comments with regards to collars in the Roof Section. All of these are to stop movement to the front and rear walls. This type of bracing we would suggest is pre-war however it may have been added as part of the refurbishment programme.

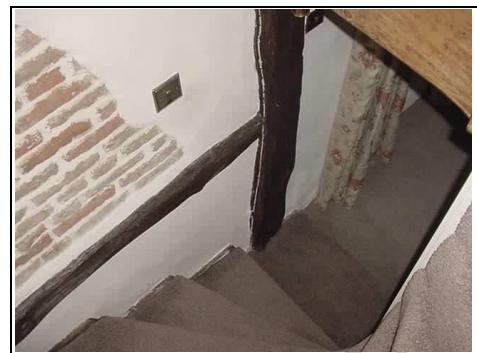
This timber did not fall in with the pattern of the structure and during our question and answer session the owner confirmed that he had added it. Unfortunately he had not remembered to mention it earlier until we pointed it out.

Fake timbers

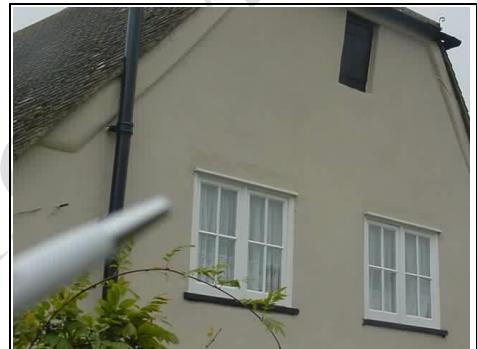
Render at gable end

We have carried out a tap test (literally hitting the render with the back of a hammer). We found it to be in average condition. The problem is it is a cement render.

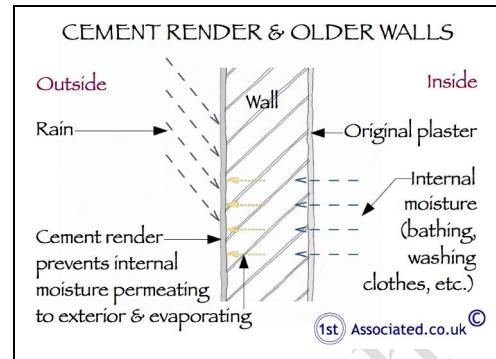
There is cracking in the render.

Cement render

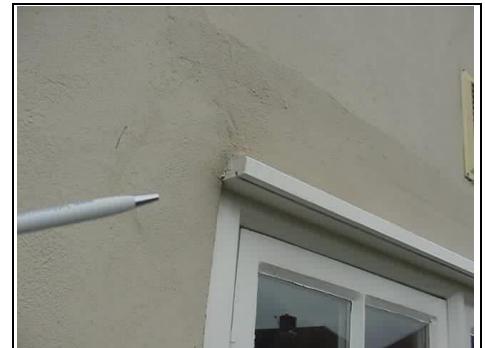
In this case we found a drip detail to the windows.

Drip detail to window

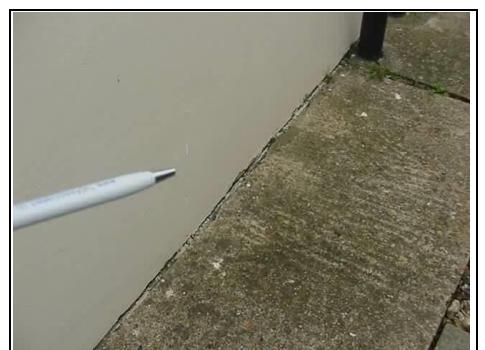
To the base of the render there was no bell mouth detail.

No bell mouth detail

ACTION REQUIRED: Add bell mouth as this would help with the dampness. Please see our comments in the Executive Summary.

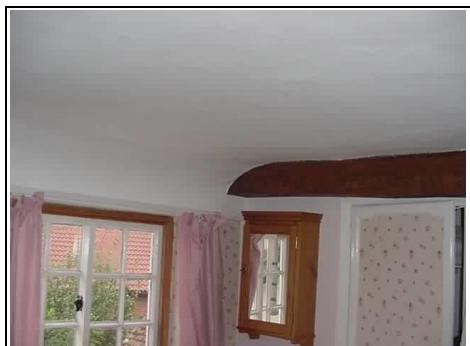
On the first floor there is a horizontal sliding sash window sometimes known as a York window which are particularly old windows and a nice feature.

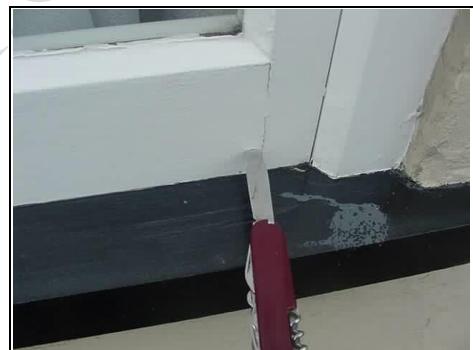
Knife test

We have tested the windows by pushing a knife into a random selection. We generally tend to do the lower windows as access is easier.

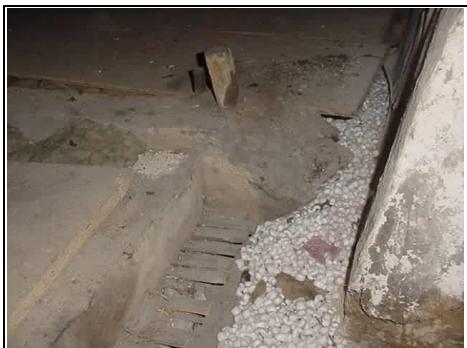
Spine beam that does not tie in

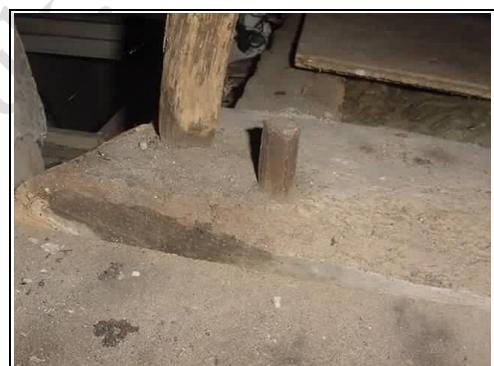
Peg fixing spine beam not tied in

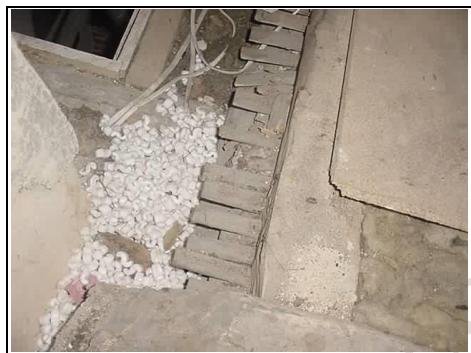
Lath in ceiling overclad

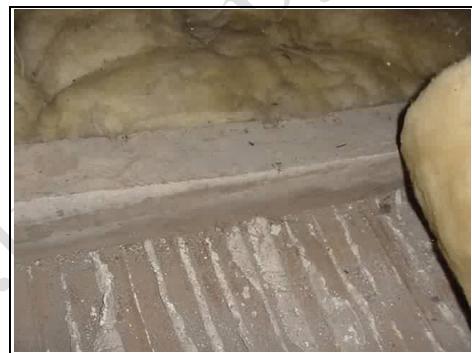
Where we could see the ceilings from the roof space we could see that they were lath and plaster. There is plasterboard/gypsum plaster to the newer areas such as the kitchen.

Lath and plaster ceiling

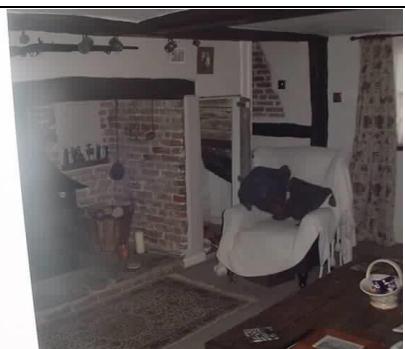
Inglenook fireplace

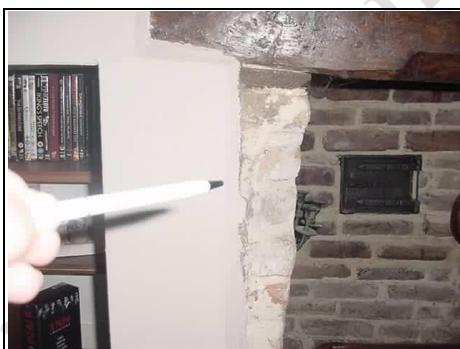
Mark on fireplace where knives were sharpened according to current owner

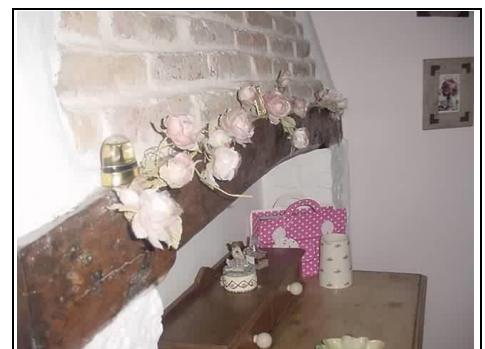
Fireplace in master bedroom

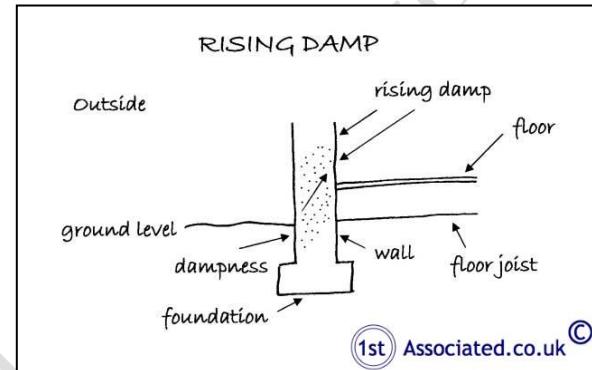
Rising damp

A visual inspection and tests with a moisture meter have been taken to the perimeter walls. In this particular case we have found significant rising damp.

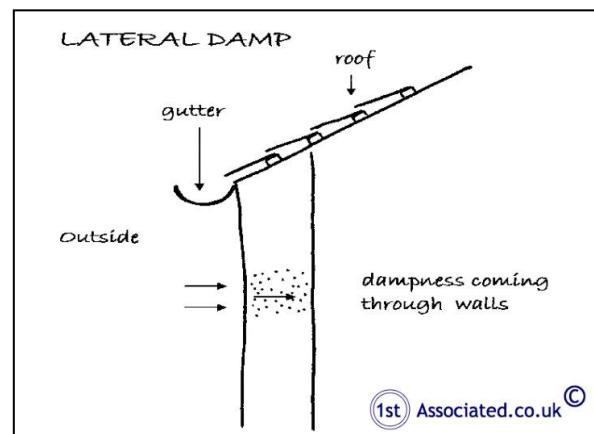
Lateral dampness

We used a resistance meter on the external walls. We have found dampness in line with what we typically see for this age, type and style of property.

ACTION REQUIRED: Please see our comments in the Executive Summary and in the Render Section.

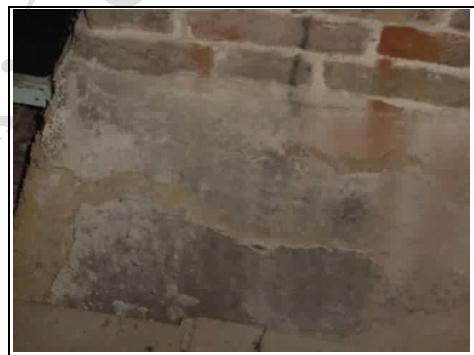
Damp plaster to chimney breast

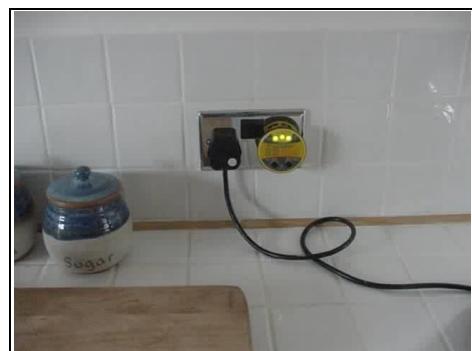
Earth Test

We carried out an earth test in the kitchen area to the socket point that is normally used for the kettle, this proved satisfactory.

ACTION REQUIRED: As the property is changing occupancy an Institute of Electrical Engineers (IEE) test and report is required, carried

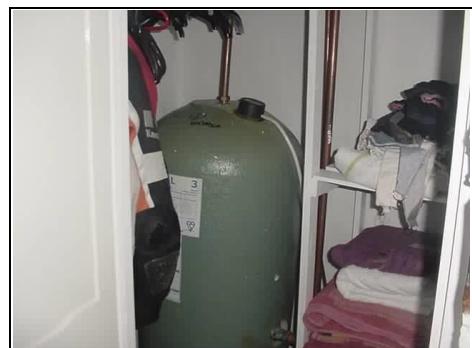
Hot water cylinder

There is a factory insulated hot water cylinder located within the bedroom cupboard. This cylinder will therefore have a good thermal efficiency, although not as good as the more modern hot water cylinders.

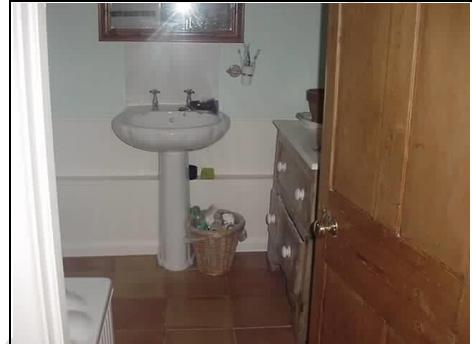
Bathroom

The property has a four piece bathroom suite, consisting of a bath, wash hand basin, shower and WC, which looks in average condition, subject to some day-to-day wear and tear, as one would expect.

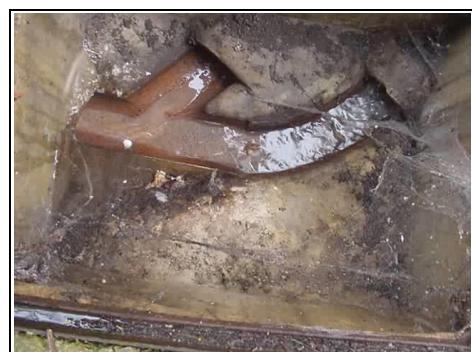
Manhole

We duly lifted the cover and found it to be free flowing at the time of our inspection.

From what we could see it is brick built.

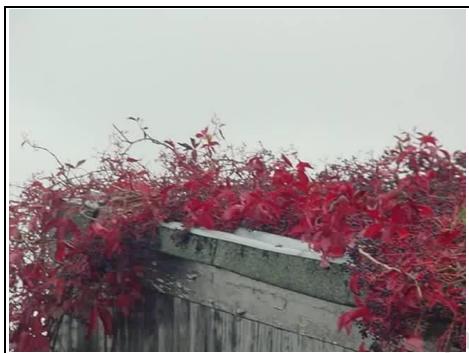
Overgrown plant on garage roof

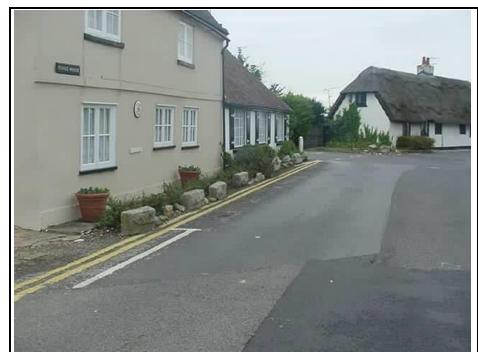
Front of the property sits close to the road
