JOB REFERENCE: XXXX

RESIDENTIAL BUILDING SURVEY

London

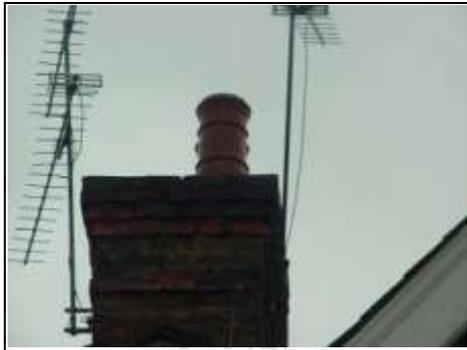
1.1) We could see that the front left hand chimney and also rear right hand chimney (all directions given as you face the property) requires work. To the front left hand chimney we believe re-pointing and possibly repair work to the flashings and to the rear right hand chimney we believe repairs are required to the flashings although we could not view the chimney properly.

Front left hand chimney

ACTION REQUIRED: Repair as necessary the chimneys to make water tight. We believe it is likely re-pointing and adding/amending flashings required.

ANTICIPATED COST: The main cost relates to the scaffolding required, we would anticipate costs for the chimneys to be in the region of £1,500 to £4,000; please obtain quotations. If this work is left deterioration will occur to the roof structure.

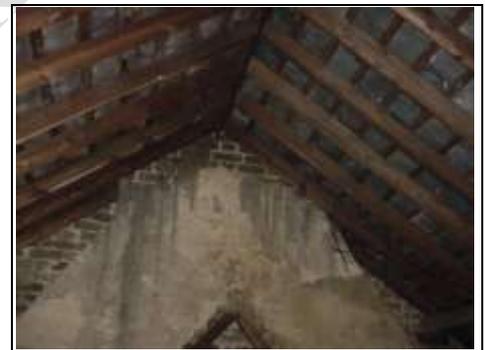
Dampness coming in around chimney to left hand side

In both cases when we were in the roof space we could see that rainwater was getting in; please see above photographs.

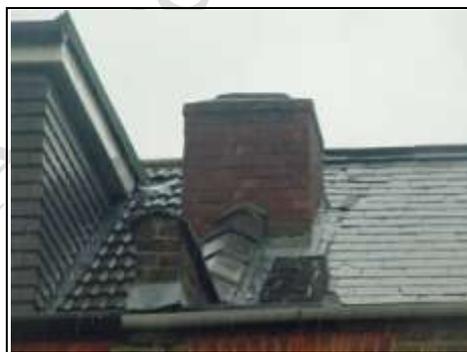
Rear right hand chimney
(lead looks to be cut straight rather than following the brick joint)

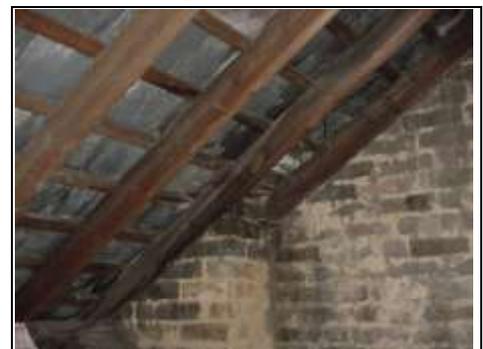
Dampness coming in around rear right hand chimney

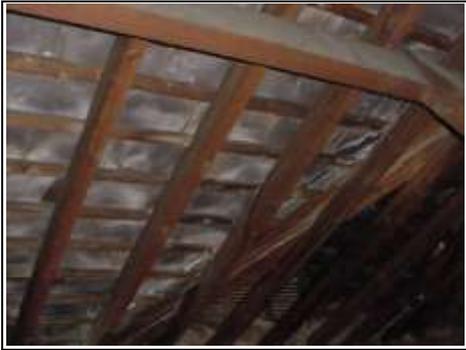
Having stood inside the roof space for quite awhile whilst it was raining there was not very much rainwater getting inside. Looking at the timber battens and common rafters (the timbers that form the pitch of the roof) we could see staining from where rainwater has got in which is probably wind driven rain that has penetrated the roof.

Dampness visible on timbers

ACTION REQUIRED: As a short term measure we would suggest boarding out the roof with a board with a solid insulation back (such as Celotex or Kingspan) which would then give a pseudo second line of protection for any dampness penetrating through the slates and

also allow you to establish exactly where the major roof leaks are and have these repaired.

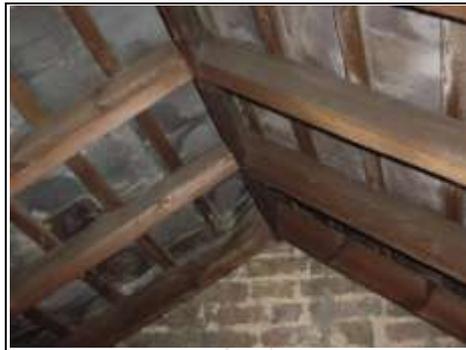
Dampness visible to underside of some of the slates

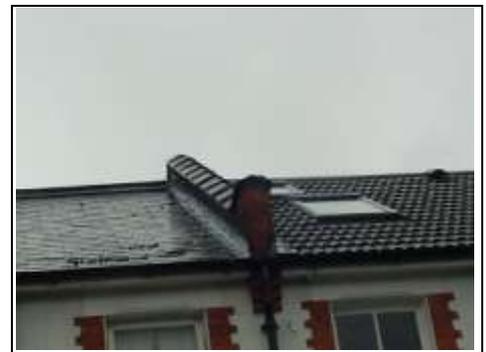
Adjoining roofs have been replaced with concrete tiles and the majority of the roofs in the road have been replaced.

Next door's loft conversion with concrete tile to right hand side and your roof to the left hand side

We believe you should negotiate a reduction in the price because ultimately you will have to replace the roof as have the majority of properties in the road.

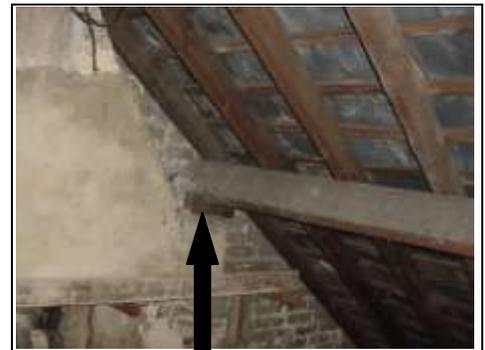
2.3) Purlin needs securing

Whilst no doubt the roof has stood like this for many years we would be happier if the purlin to the rear left hand side (all directions given as you face the property) was secured better particularly as it is near the chimney that has been removed. This could take the form of a timber at a diagonal giving a brace off a ceiling joist over a wall.

Purlin needs securing at rear left hand corner as balanced on a brick

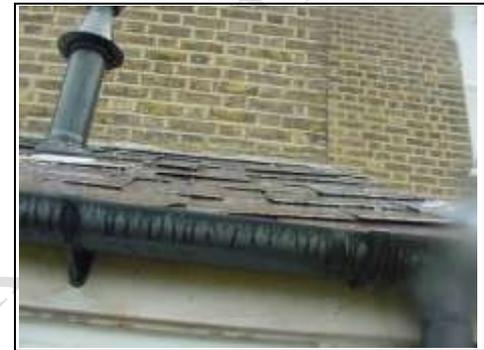
3.1) Whilst the rear roofs did not leak during the course of our inspection they are a miss mash of different types, styles and ages of roofs. These roofs, we would say, will suffer from problems in years to come probably starting with the middle tiled roof where the tiles already look to be uneven and displaced.

Poor quality slate to rear low level roof

ACTION REQUIRED: Next time it rains heavily observe how the roofs cope with heavy downpours if you intend to keep them and then employ a roofer to carry out repairs during dry weather and also obtain a supply of the slates.

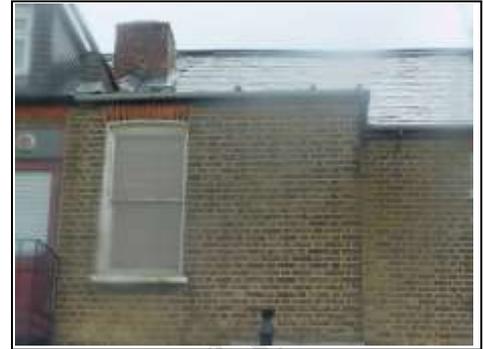
There is a flat roof at high level that is hidden from view. We believe it is a flat roof but obviously we cannot actually view this roof.

Flat roof we could not view to the rear which looks likely to be a lead roof

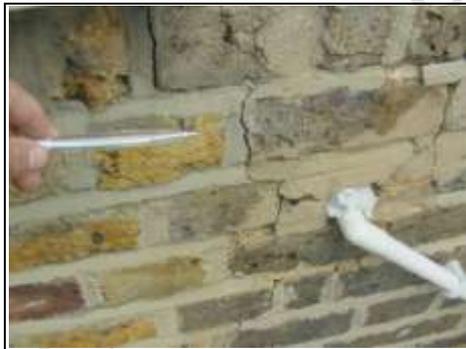
The property has Flemish Bond brickwork which is traditional for this era of property unfortunately the brickwork has been incorrectly re-pointed in a cement mortar.

Cement mortar re-pointing

ACTION REQUIRED: We normally recommend you need to employ the oldest brick layer you can find and asking him to come and carry out re-pointing work for the next few years using a stiff brush once or twice a year on the cement and re-point in a lime mortar until a good proportion of it is replaced.

Unfortunately the cement re-pointing, whilst well meaning, is not appropriate for this type of construction. A cement mortar has been used rather than a lime based mortar. We recommend you use lime mortar in any future repairs regardless of what the builders say! Using lime mortar will limit further damage to the brickwork, which is almost impossible to repair successfully. However, we would add that many, if not most, of the properties that are re-pointed are re-pointed wrongly; it is only in recent years that we have discovered the problems that can occur from it.

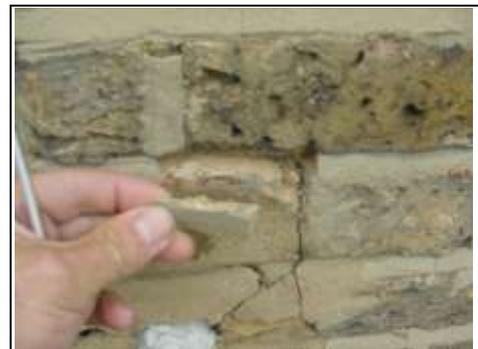
Cement mortar re-pointing breaking away

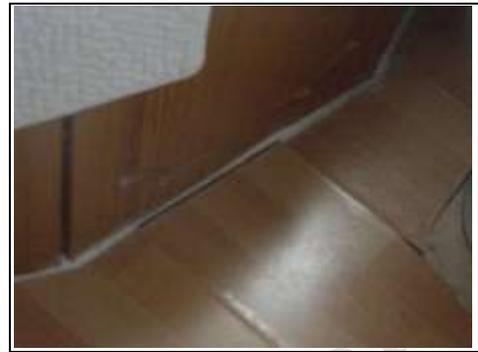
The laminate boarding that has been fitted is very poor in some areas and worn particularly in the bathroom.

Poor quality DIY laminate floor boarding

ANTICIPATED COST: This will naturally depend upon the quality and flooring material you require; please obtain quotations.

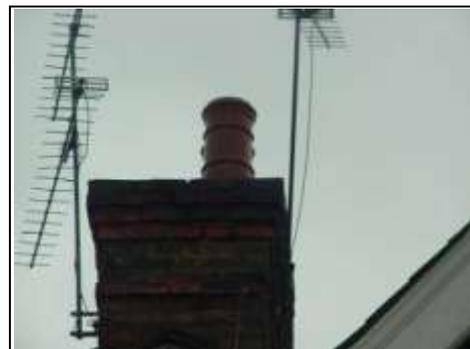
Close up of chimney One

Unfortunately we were unable to see the top of the chimney known as the flaunching, we therefore cannot comment upon them.

The only other point to make with regard to the chimney is the straps that have been used for the aerial. We have found in the past that

these cause damage to the brickwork as they produce pressure points on the chimney; we suggest that this be checked.

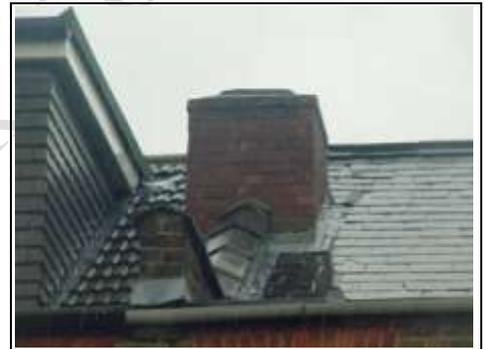
Chimney Two

This chimney has been relatively newly built in brickwork which we could see at first floor level but we could not see at ground floor level as it has been removed.

ACTION REQUIRED: Your Legal Advisor to check Local Authority Approval has been obtained.

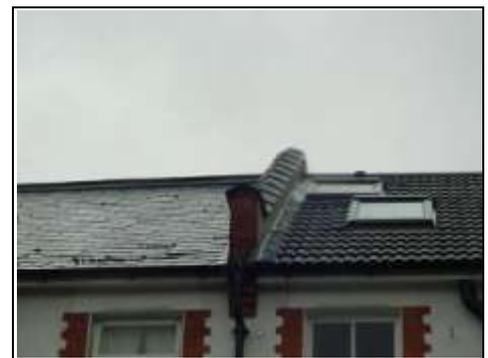
Parapet wall

In this case there are parapet walls to either side of the roof these are built from brick with a coping stone, where we could see it, and a stepped flashing.

Finally, we were only able to see approximately fifty percent of the parapet wall, therefore we have made our best assumptions based upon what we could see. A closer inspection may reveal more.

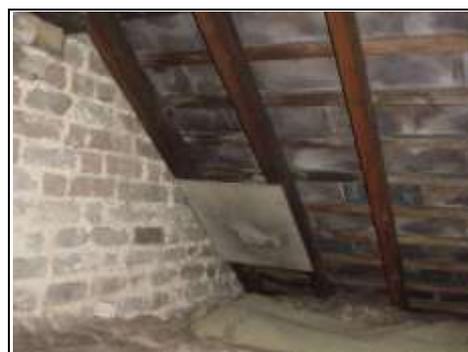
Underside of roof showing slates and piece of asbestos

ACTION REQUIRED: We always recommend all asbestos is removed as not only does it have the potential for problems it does tend to affect value as some people simply will not buy a property with any asbestos present.

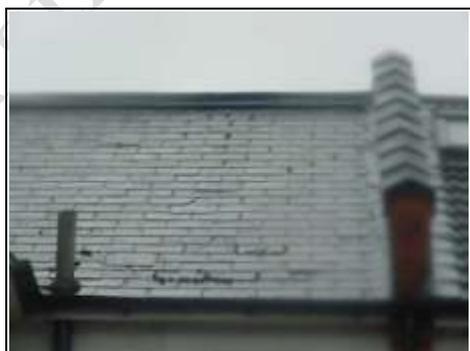
Some displaced and slipped slates to the front of the property

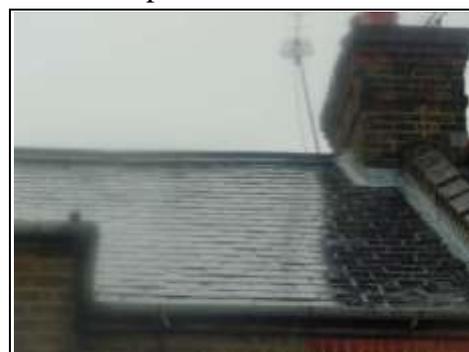
Undulating rear roof

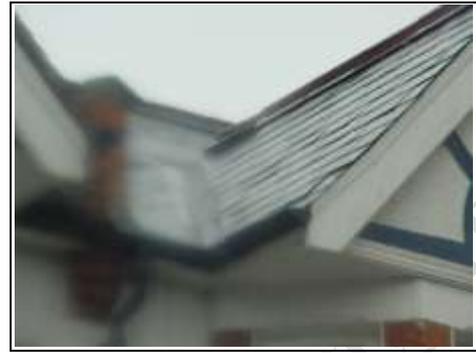
Photo of roof with raindrop on it showing perimeter has lifted slightly

We noted that some of the perimeter slates were lifting; this can happen where a sloped roof is not bedded flat as in this case and ultimately this can lead to some lifting of the slates.

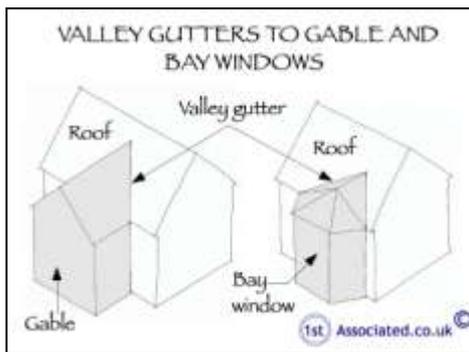
Valley gutters

There are some slipped slates which we could see dampness is allowing into the structure. This we believe probably relates to slates being displaced around the valley gutter. It is not possible to view this area from ground level and a more close up inspection is required.

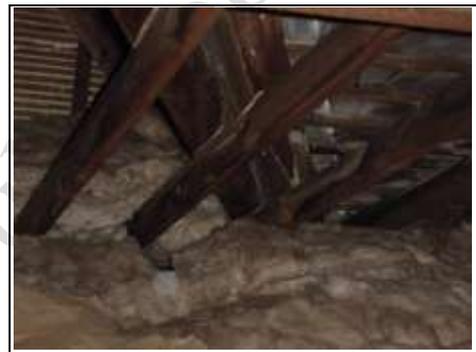
Dampness getting in beneath valley gutter

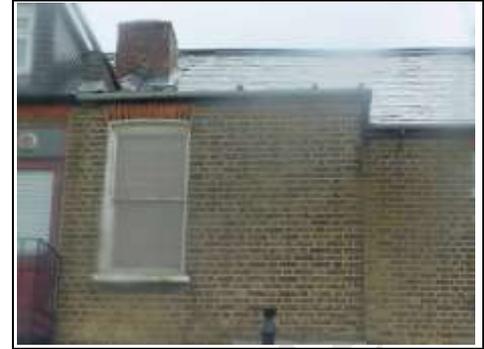
Flat roof to rear

Please see our comments in the Executive Summary as we could literally not see this roof and it does require a close up check.

The edge that we could see looks to be metal possibly lead this type of roof very much depends upon the type of decking and the skill of the person that has made the roof.

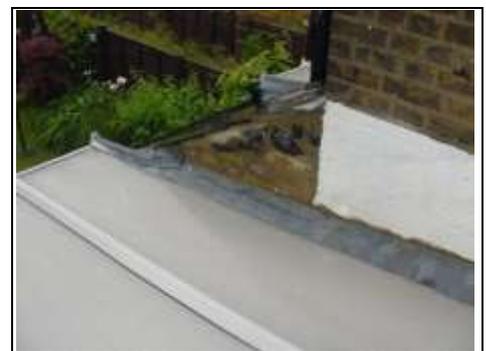
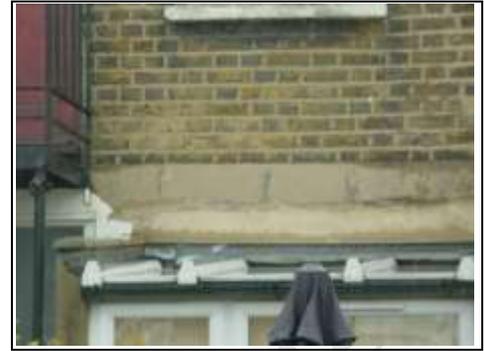
Polycarbonate roof over kitchen

There is a polycarbonate roof to the kitchen and conservatory area. We generally find that polycarbonate is a cheaper alternative to carry out a roof and ultimately it does tend to leak at the joints. In the case of where it has been used in a kitchen it may well get condensation.

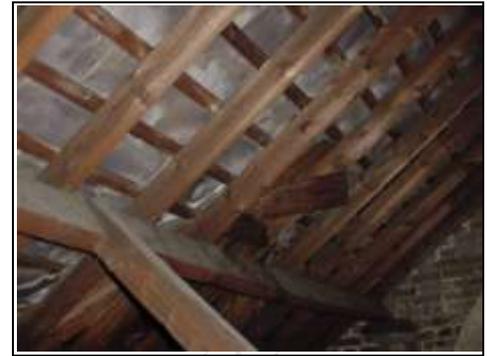
General view of inside of main roof

Our examination was limited by the general configuration of the roof and the insulation. What we could see was generally found to be in average condition for its age, type and style considering there is no protective underlayer i.e. there is dampness in some areas and salts showing that there has been dampness in other areas. It is, however, feasible that there are problems in the roof that are hidden.

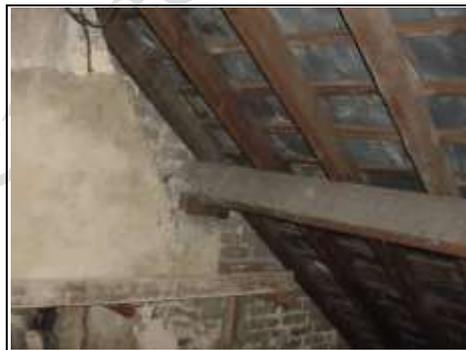
Purlin on rear left hand corner balanced on a brick needs securing

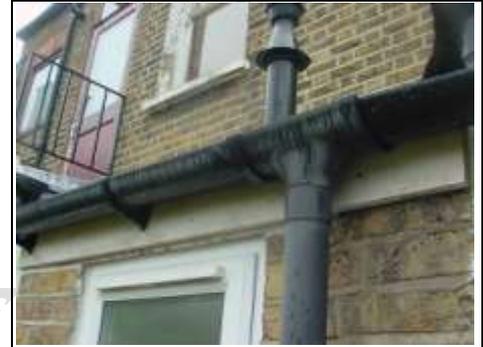
Gutter and downpipe

There may be some minor leaks but most people would be happy to live with these providing repairs are carried out within the next six to twelve months.

ACTION REQUIRED: We would recommend you stand outside the property next time it rains heavily and see how well the drains cope with the rainwater particularly looking at the guttering and the joints. We would also recommend that the gutters and downpipes are cleaned out, the joints are checked and the alignment checked to ensure that the gutters fall towards the downpipes.

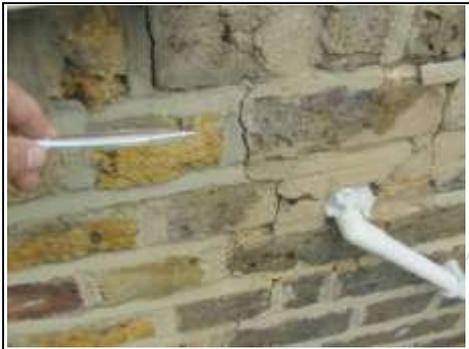
The brickwork has been incorrectly re-pointing using a cement mortar rather than a lime mortar.

Cement mortar re-pointing

ACTION REQUIRED: Re-point in a lime mortar. Please see our comments in the Executive Summary.

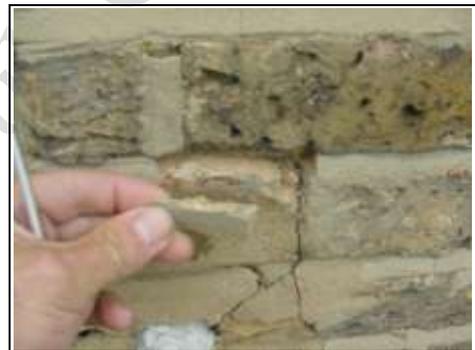
Cement mortar re-pointing
crumbling away

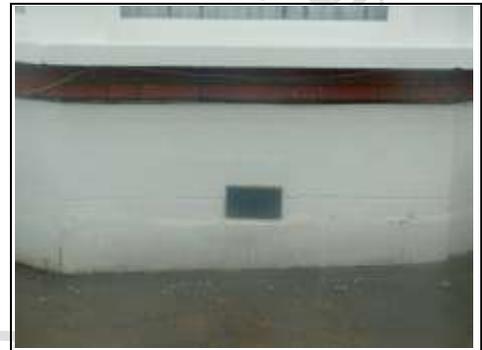
Damp proof course may have been added?

All modern properties should incorporate a damp proof course (DPC) and good building practice dictates that a differential of 150mm (6 inches) should be maintained between the damp proof course and ground levels. In this case, cannot see a DPC, in theory one should have been added.

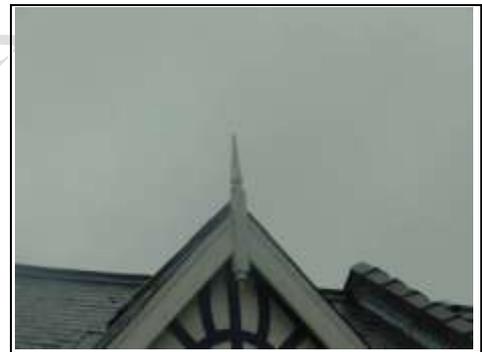
Fascias soffits and bargeboard

The fascias, soffits and bargeboards are timber. They are painted and we would comment they are in slightly below average condition for their age, type and style.

ACTION REQUIRED: We recommend redecoration in the summer of 2013. Make sure gutters and downpipes are watertight before carrying out any work on fascias and soffits.

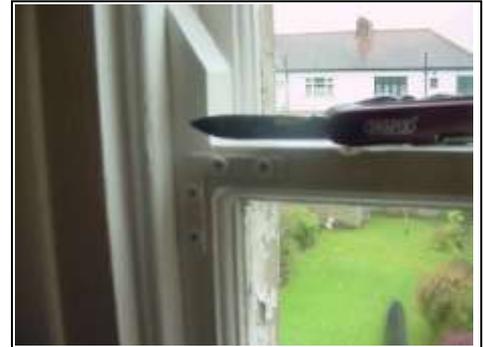
We would specifically comment some of the rear timber windows for example the rear right hand bedroom (all directions given as you face the property) require repair.

Window held together by metal straps

There is painted render to the front of the property and also painted timber work. Please see our comments with regard to carrying out re-decoration of the fascias in the summer of 2013 and we would also recommend repairs to the windows are carried out at this point in time as well.

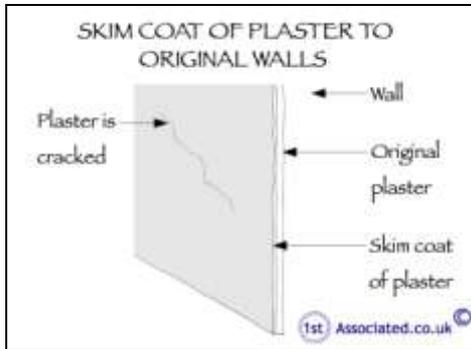
Skim coat of plaster

We noted some hairline cracking to front left hand bedroom plaster and rear left hand bedroom (all directions given as you face the property). Whilst there has been movement in the property we believe this cracking relates specifically to a modern gypsum plaster being applied, please see our sketch.

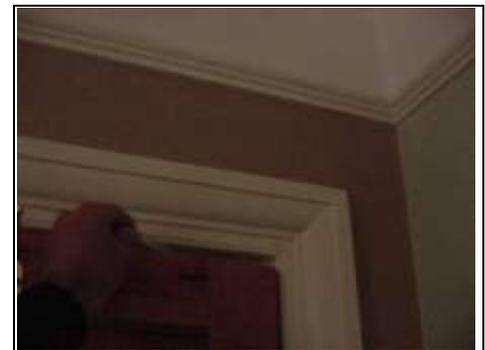
We could see there has been movement in the property to the rear left hand door which is out of square.

Movement in rear left hand bedroom door

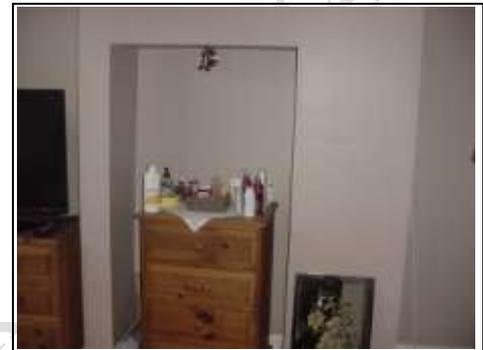
We noted chimneys have been removed both to the left and right hand side.

Unusual fireplace front left hand side Master bedroom

ACTION REQUIRED: Please see our comments in the Executive Summary.

Your Legal Advisor needs to specifically check with the Local Authority for removed chimneys and associated chimney breasts and Building Regulations Approvals and advise by e-mail immediately if chimney breasts are found to have been removed. We would recommend opening up the structure to check the condition. If we are not advised we will assume the relevant Building Regulations Approval has been obtained.

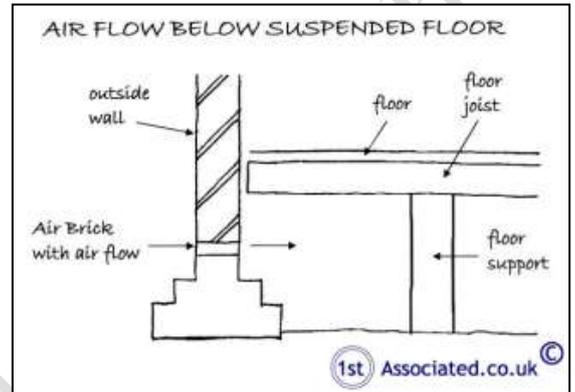
There is a mixture of a suspended timber floor to the front of the property, which require air movement underneath to minimise wet rot, dry rot and woodworm, and a solid floor to the rear.

Suspended timber floor

Solid Floor to the rear

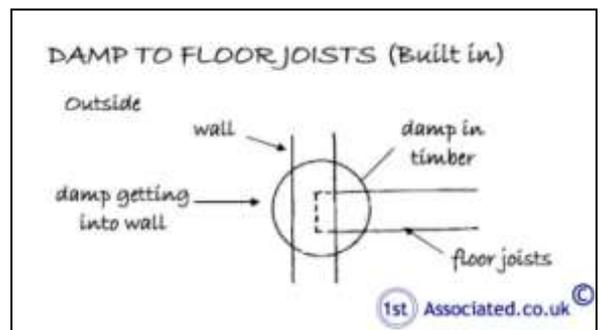
Damp to built in floor joists

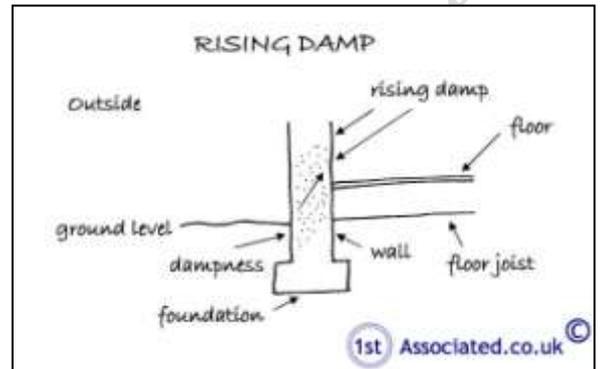
Rising damp

A random visual inspection and tests with a moisture meter have been taken to the perimeter walls and some internal walls. In this particular case we have found rising damp and we would comment as follows that the readings were higher than we would have expected in this age, type and style of property.

ACTION REQUIRED: Please see our comments in the Executive Summary.

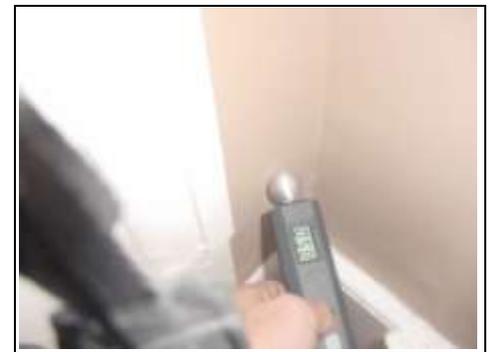
Testing for rising damp

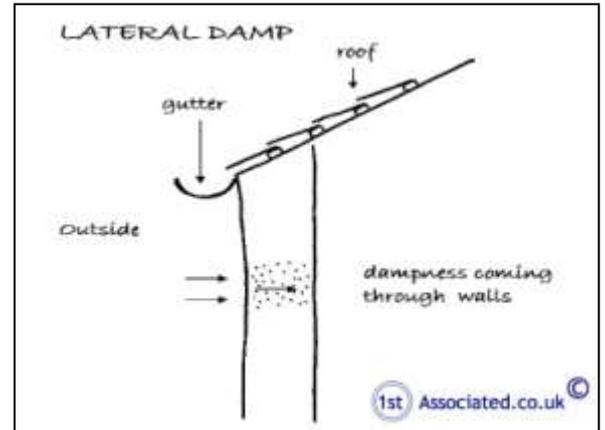
We used a damp meter on the external walls. We have found minor dampness which is in line with what we would expect to find.

Lateral damp

ACTION REQUIRED: Please see our comments in the Executive Summary.

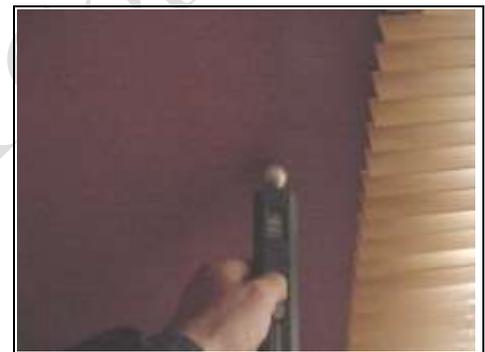
Testing for lateral dampness

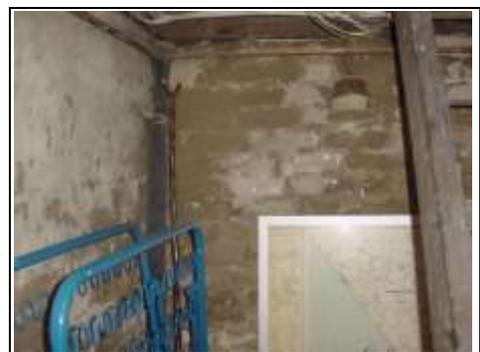
You have a small cellar we assume this was originally a coal cellar which is damp and we would not store anything of value in this area.

Cellar

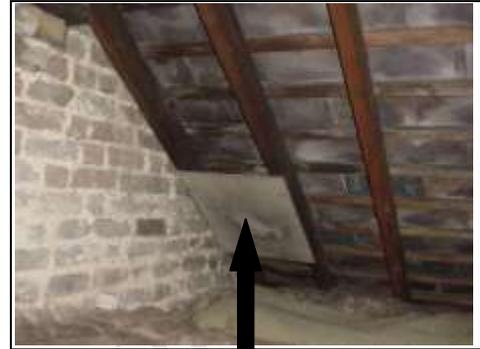
In a property of this age there may well be some asbestos. In this case we have noted asbestos to the flue and an asbestos sheet to the underside of the roof.

Asbestos to the underside of the roof slates.

ACTION REQUIRED: If you wish to confirm you are 100 percent free of asbestos you need to have an asbestos survey carried out.

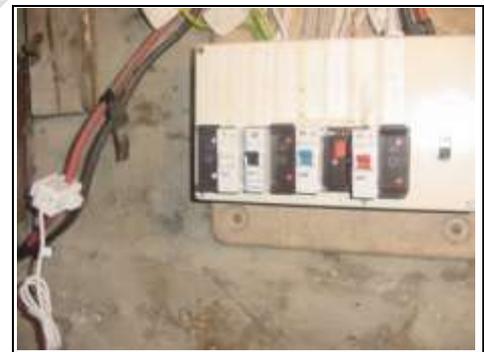
The electric fuses and consumer units were located in the cellar. The fuse board looked dated from the 1960s/1970s and better are now available.

Fuse Board

ACTION REQUIRED: Install a new fuseboard and add additional socket points.

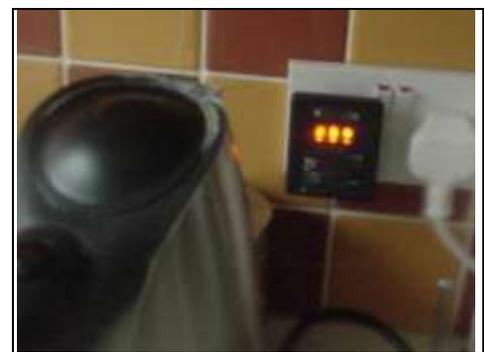
We carried out an earth test in the kitchen area to the socket point that is normally used for the kettle, this proved satisfactory.

Earth Test

ACTION REQUIRED: As the property is changing occupancy an Institute of Electrical Engineers (IEE) test and report should be carried out by a NICEIC registered and approved electrical contractor or equivalent.

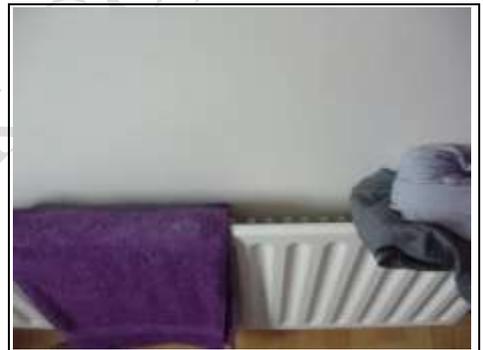
We noted single panelled radiators which may not heat the rooms to your desired level as quickly as you may wish.

Single panelled radiator

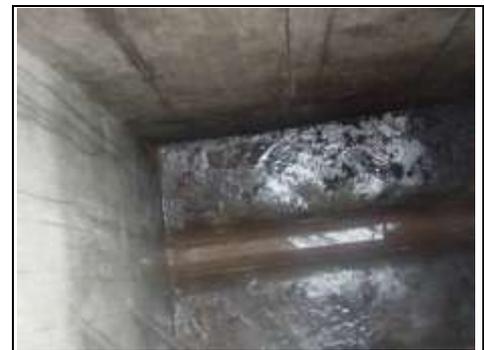
Manhole

From what we could see it is **concrete** built and looks to be a relatively modern drain.

ACTION REQUIRED: Your Legal Advisor to check and confirm if there have been problems with the drains by posing a written question on this issue.

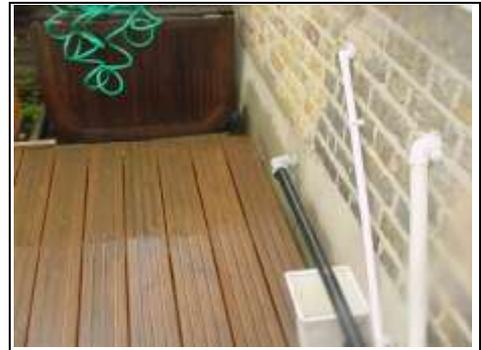
There is a decking area next to the property which where it touches the main building may be causing capillary action.

Decking to the rear

ACTION REQUIRED: Moving decking away from the building a fraction.

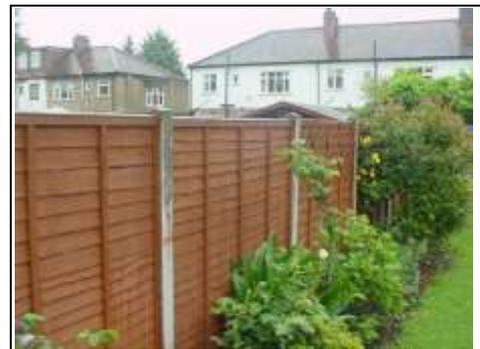
Left hand side fence which is traditionally yours has concrete 84 posts and timber panels.
