# RESIDENTIAL BUILDING SURVEY

**Camberwell,  
London,  
SE5**

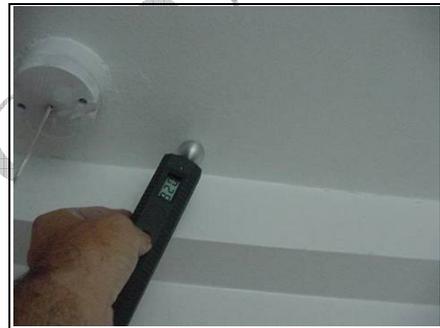
The Gann meter readings showed no dampness on the ceiling

**ACTION REQUIRED:** Ad hoc repointing to the exterior of the property.

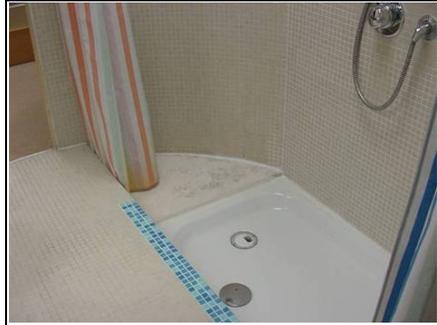
Circular shower room on top floor

This may well be historic, as when we ran the shower for ten minutes on the top floor there was no visible signs of dampness coming through. However, having said that often there needs someone to actually be in the shower to cause problems.

**ACTION REQUIRED:** We recommend that you live in the property to check whether it is still leaking.

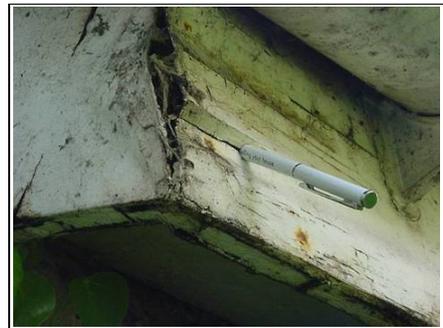
We note the timber cladding was in a particularly poor condition and needs to be repaired / replaced.

Checking timber cladding

**ACTION REQUIRED:** We recommend the cladding is repaired/replaced.

**ANTICIPATED COST:** In the region of £2,000 to £4,000, depending upon quality of work and exact quantity; please obtain quotations.

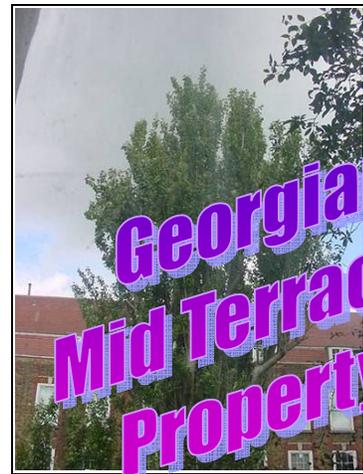
Note, there are Poplar trees growing close by to the rear of the property (not within your land). Poplar trees are well known for having a large root system that can damage to properties.

Poplar trees to rear

**ACTION REQUIRED:** You need to check the insurance with regard to the premiums you will have to pay in relation to this. They also need to specifically request whether there has been any problems with regard to structural issues on the property; we note that next door looks to have been re-built to the gable end area and the rear of the property.

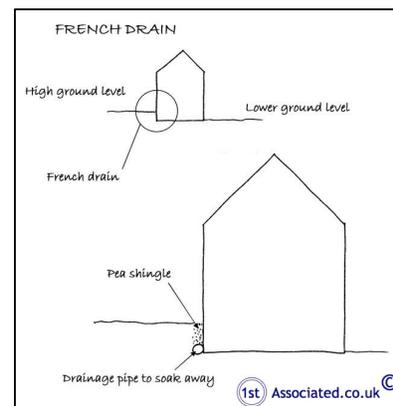
Example of a French drain

The xxxxxx woodworm report refers to flight holes appear to be old and no longer active and not able to inspect sub-floors. We would comment on the sketch that identifies high ground levels, we would recommend that a French drain be added (see sketch) rather than a chemical damp proof course.

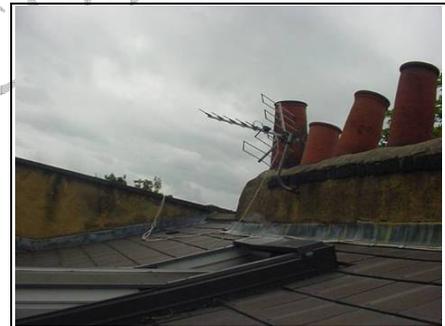
Left hand chimney

This chimney is large in length and is render finished with numerous chimney pots. From what we could see from roof level (we were perched on a ladder looking out of the roof window) some of the chimney pots are at angles, etc, and looked in slightly below average condition considering their age, type and style.

Unfortunately we were unable to see the flaunching, which holds the chimney pots in place, but we can see that some of the chimneys pots are at an angle.

**ACTION REQUIRED:** There is likely to be some work to the flaunchings and we would always check the flashings when work is being carried out.

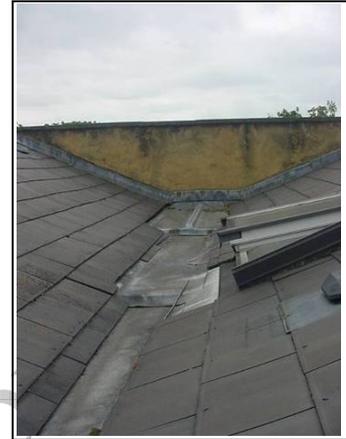
Parapet wall and stepped valley gutter

There is staining in it indicating that dampness is coming into it but this is not that unusual for this age, type and style of property. Unfortunately, the problem with having a vaulted/cathedral ceiling internally is that any dampness that does get through can be seen. There were no obvious visual signs of dampness getting in at the time of our inspection but with an internal ceiling such as the one mentioned the risk is higher.

Ideally, when carrying out work to the chimneys (by the summer of 2013) we would recommend that the parapet wall is looked at closely and possibly will need repairs/replacement to the coping stone.

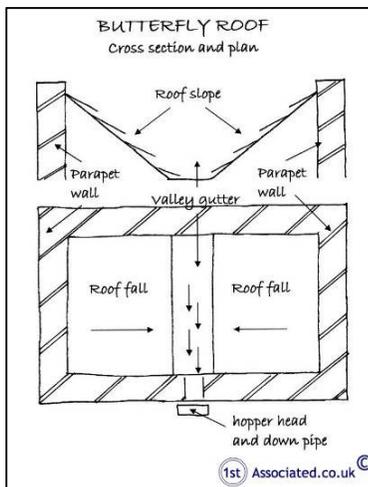
Butterfly roof

The main roof is a butterfly roof which is pitched and clad with manmade slates and, from the top floor bedroom via a ladder through the roof window, we could see inspect the roof visually and this looks in average condition considering the roofs age type and style. The problem with a manmade slate such as this is the wind can catch it and displace the slates, however most damage tends to occur when someone goes onto the roof to inspect the parapet walls or to check the valley gutter, or something similar.

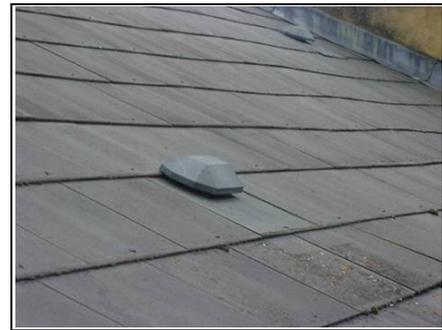
Air vent on roof

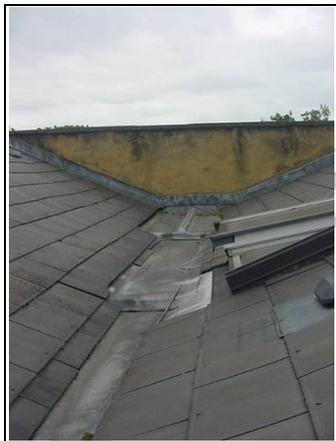
We were pleased to see there was a stepped lead flashing valley gutter. We see these rarely; perhaps one in twenty times, but this is how valley gutters should be detailed. There is sufficient fall to get the rainwater away, having said that you still do need to clean them occasionally, or flush them through by running water through them. The hopper head at the end of the valley gutter does tend to be a problem as these do tend to overflow, which is why we have recommended replacing it ultimately with a hopper head with an overflow section built into it.

Butterfly roof with stepped valley gutter

**ACTION REQUIRED:** You need to regularly maintain the valley gutter as it is a common problem within butterfly roofs that these leak, particularly along what is known as the spine beam which is the central valley gutter area.

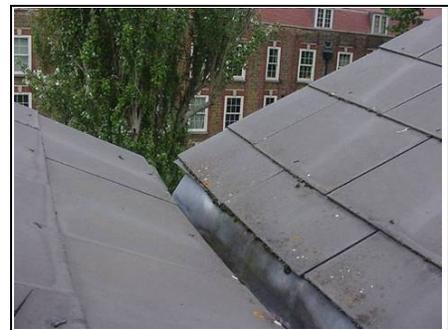
Valley gutter

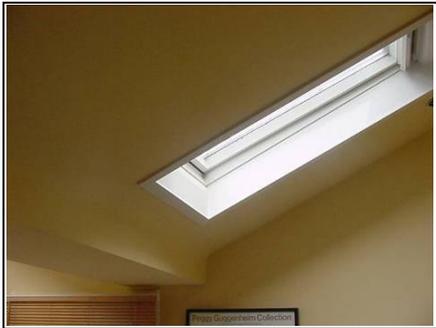
The property has three purpose made roof lights, which looked in average condition. They are set within the pitch of the roof, sometimes known as a cathedral ceiling. We could not see any major dampness staining around them. Whilst there is an extract fan in the shower room area the addition of the roof windows really allows good ventilation of this area.

Roof window

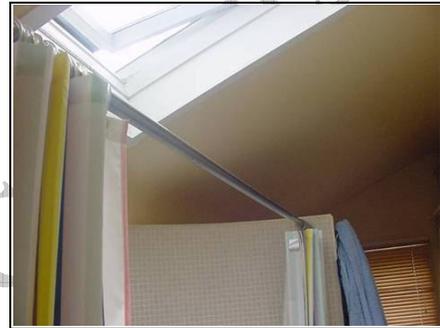
Roof window above shower

It seems inevitable with roof windows that they will sooner or later leak. If this doesn't occur then they seem prone to condensation. Keep a cloth handy!

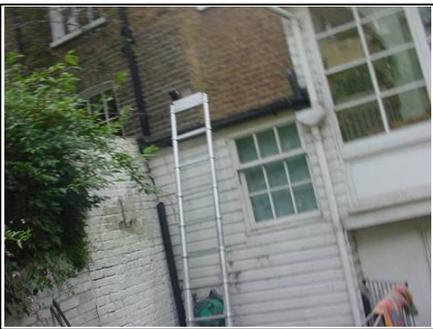
Ladder access to view flat roof

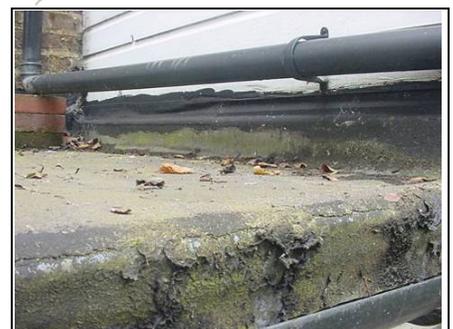
The flat roof is covered with asphalt. It has moss growing on it, which may cause dampness to enter the property. We believe it is leaking from the damp readings we got internally.

Flat roof

**ACTION REQUIRED:** It can be a problem hunting around for a leak on a flat roof so we would suggest a new coat is applied to the entire roof.

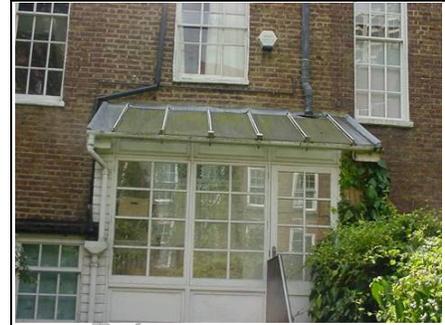
The conservatory roof is covered with glass. It has moss covering on it. We were pleased to see lead flashings around it, although the timber is deteriorating which cause leaks to occur.

Conservatory roof

**ACTION REQUIRED:** As you will see in the conservatory section there are fairly major repairs to the conservatory required.

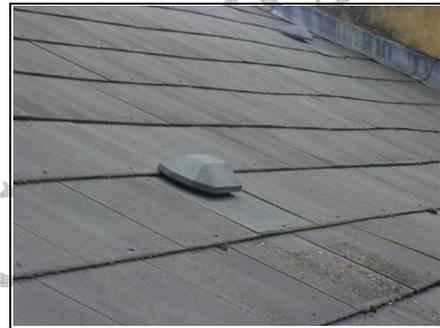
We can see plastic mushrooms which are a venting system from the 1970's/1980's which now tend to be superseded as we use a breathable felt, but it is good to see and does indicate that some thought has been given to the roofing. We would comment that depending upon the ventilation level you may have solar gain during the summer (it is amazing how hot a black manmade slate can get) and equally in the winter if the roofs are not well insulated you can get thermal heat loss.

Air vent on roof

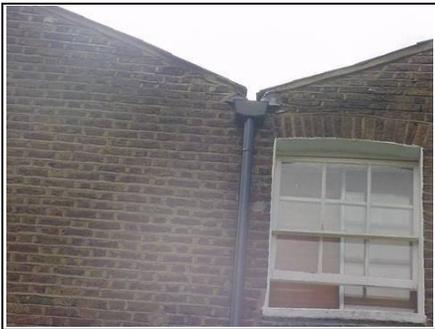
The main butterfly roof has a hopper head and downpipes, all located to the rear and is in plastic. We often find that plastic hopper heads are too small and do overflow and need regular cleaning, which is relatively difficult/dangerous as you have to literally get on the edge of the roof to clear them.

Plastic hopper head and downpipe from the main butterfly roof

**ACTION REQUIRED:** We much prefer a slightly larger hopper head with an overflow on it. As you can see from the photo on the right, the basics of maintenance need carrying out such as clearing the leaves from the gutters.

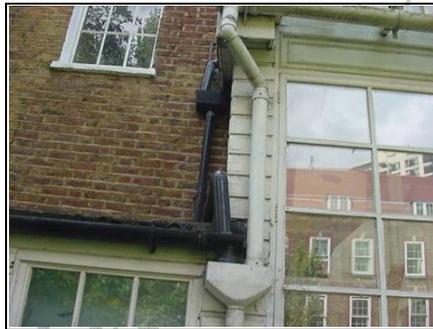
Gutters and downpipes from the conservatory roof

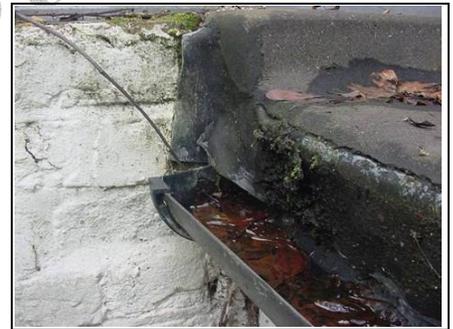
Gutters full of leaves

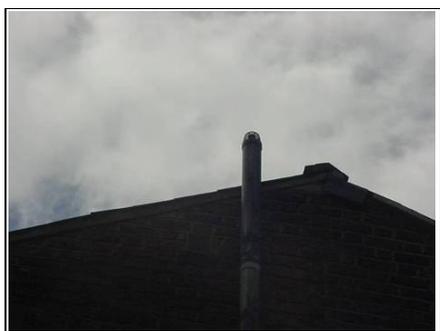
Gutters need clearing

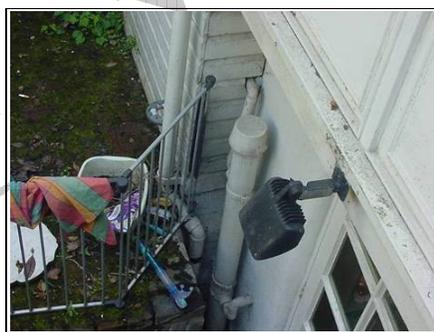
The property has plastic soil and vent pipes. There is one that goes up to roof level and a second one with what is known as a Dergo valve, which is the trade name for an air inlet valve which is a one way vent.

Dergo valve or soil and vent pipe between lower ground and upper ground floors

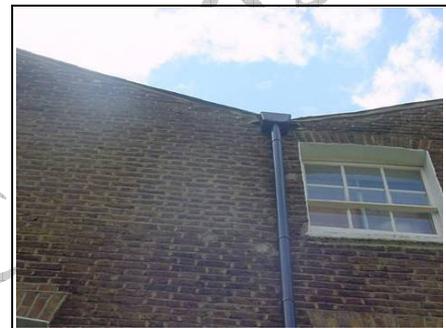
Generally Flemish Bond brickwork is liable to penetrating dampness internally, dependent upon the condition of the brickwork and the exposure to the weather. In this case it is essential that external faces be kept in good condition.

Flemish bond brickwork

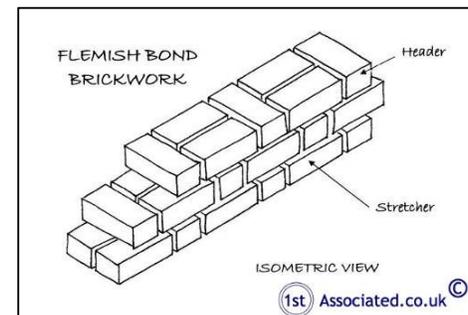
Flemish Bond brickwork

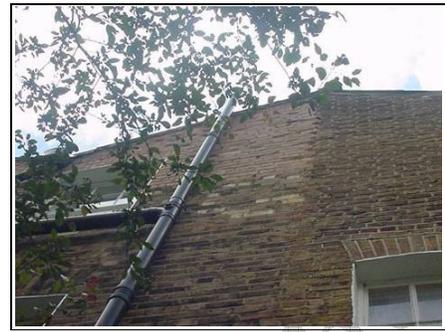
Next door looks to have been partly re-built and this can affect your property.

Next door partly re-built

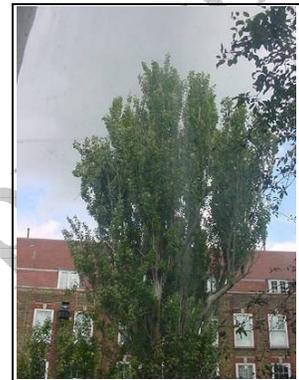
There are a line of Poplar trees to the rear within what insurance companies would term as influencing distance of the property. These are on other people's land on what looks to be Local Authority built housing.

Poplar trees to rear

**ACTION REQUIRED:** Your legal adviser needs to check and confirm that the Local Authority carry out regular maintenance to the trees as they do have a well known root system that can damage properties. Having said that, if the tree and the house have been together for a long time they tend to accommodate each other, but for example in 2012 when we started off the year without much rain trees were hunting for water which, from what we understand it, meant that their root system spread (we are not an arboriculturalist).

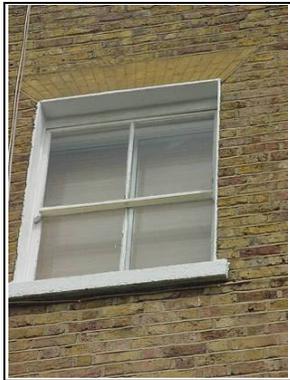
Close up of top floor sliding  
sash window

**ACTION REQUIRED:** Generally the windows are in average condition but would benefit from a redecoration in the summer of 2013.

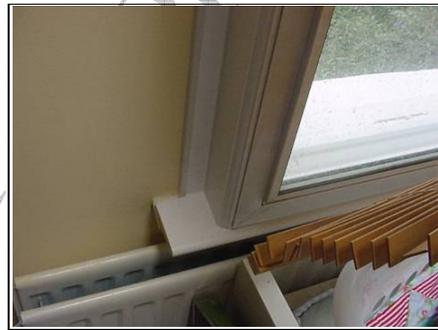
Good quality secondary glazing on  
the top floor

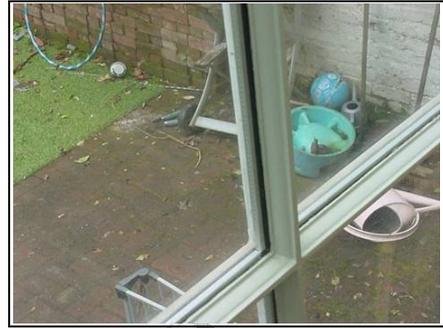
The conservatory has a relatively thin double glazing in it. The thing with double glazing in this type of thin mullion and transom construction window is the weight so you do need to ensure it is kept in good condition.

Double glazed conservatory window

**ACTION REQUIRED:** You need to repair the conservatory as soon as possible.

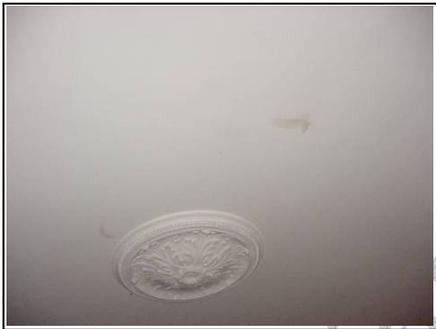
Ceiling rose lower ground floor, possibly original lath and plaster

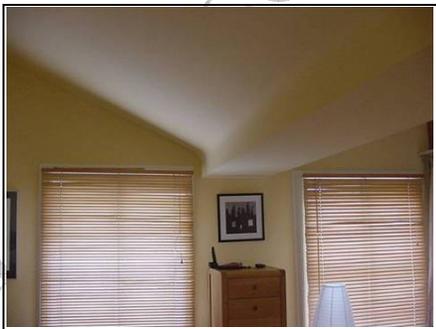
Vaulted ceiling on top floor, likely to be new plaster

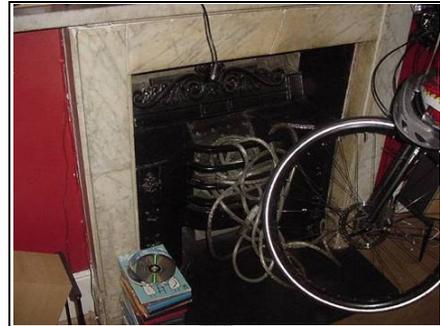
Fireplace to rear in lounge

It is strongly recommended that flues be cleaned and checked for obstructions prior to use to minimise the risk of hazardous fumes entering the building.

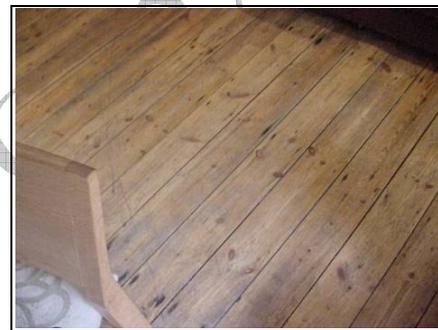
The floors to the front of the property are suspended timber floor or a sprung floor. Our concern is that there may be some rot underneath. We feel it is more likely that the floor is cross-battened than a traditional suspended timber floor, but nevertheless we have added a sketch just to show you this example of suspended floor construction.

Flooring to lower ground floor

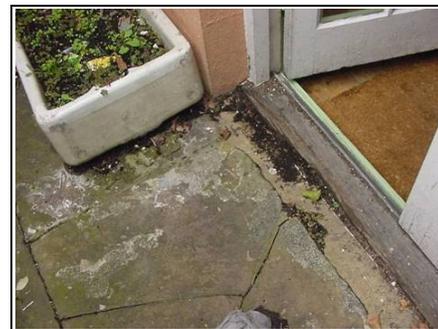
Our biggest concern with the lower ground floor is that it is level to/below ground level.

Threshold bar between front area and front lower ground floor

**ACTION REQUIRED:** Please see our comments in the Executive Summary.

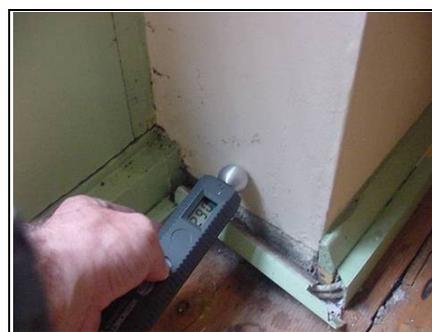
A random visual inspection and tests with a moisture meter have been taken to the perimeter walls. In this particular case we were getting minor damp meetings at the base of the property. We believe this is a combination of condensation and the ground levels externally to internally being the same, or above them, particularly for example to the rear of the property. Our solution to this would be to add a French drain rather than any of the chemical treatments as we like buildings to breathe.

Testing for rising damp

**ACTION REQUIRED:** Please see the Executive Summary and Appendices

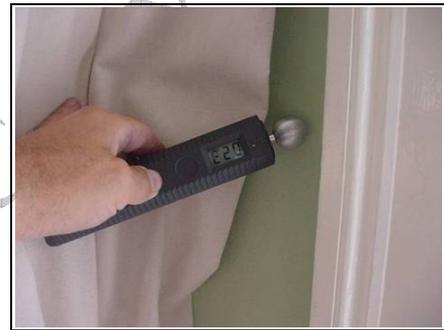
We used a damp meter on the external walls. We have found minor dampness, with the exception of where it appears to be coming in via the rear flat roof and via the pointing to the rear of the property.

Testing for lateral dampness

**ACTION REQUIRED:** Please see our comments in the Executive Summary.

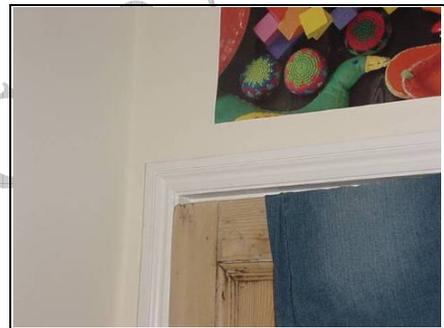
The original doors have been replaced with stripped timber panel doors which are popular in this style of property. We can see that quite a few of them do not fit properly, we assume this is either from minor movement in the property or bad workmanship when the new doors were hung.

Rear bedroom where movement can be seen in the door frame

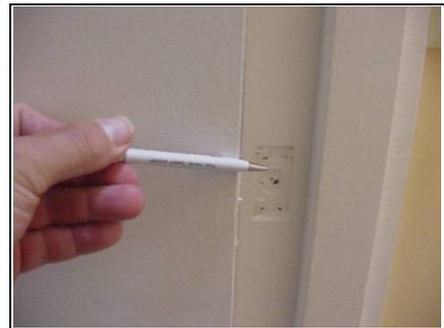
Perco fire door closer removed

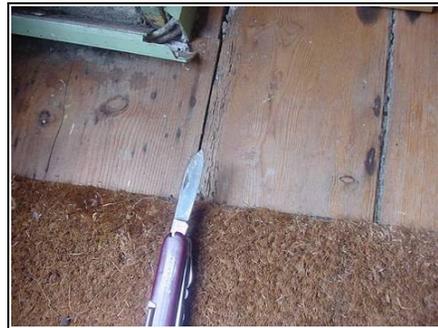
The roof / floor is the main area that we look for woodworm. Within the floor we could see old signs of woodworm but we do believe it to be old woodworm. We could only truly confirm this when the floor is opened up but we are fairly certain.

Old woodworm in lower ground floor

**ACTION REQUIRED:** Please see our comments in the Executive Summary.

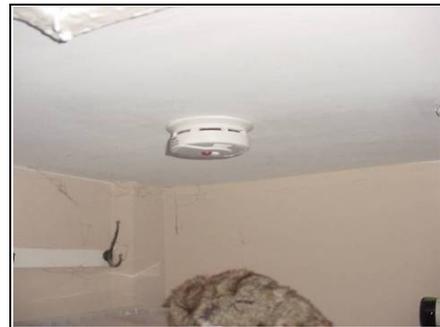
Some smoke detectors were noted. The current Building Regulations require that they be wired into the main power supply. Obviously in a property of this age this is difficult, as it would mean having surface mounted wires or cutting wiring into the plaster.

Smoke detector

**ACTION REQUIRED:** We would recommend, for your own safety, that smoke detectors be installed. We would always recommend a hard wired fire alarm system and are also aware that some now work from a wireless signal which may be worth investigating. Whilst fire is relatively rare it is in a worst case scenario obviously devastating.

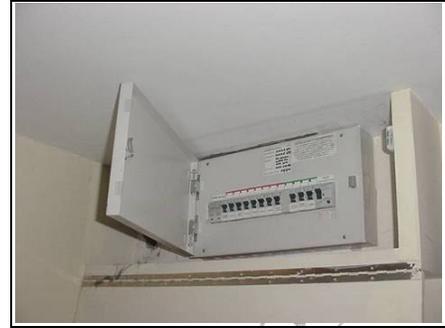
The electric fuses and consumer units were located in the front right hand corner of the lower ground floor. The fuse board looked dated and better are now available. In an older property a defective fuse board can be particularly dangerous.

Fuse Board

**ACTION REQUIRED:** As the property is changing occupancy an Institute of Electrical Engineers test and report (IEE) should be carried out by a NICEIC registered and approved electrical contractor or equivalent.

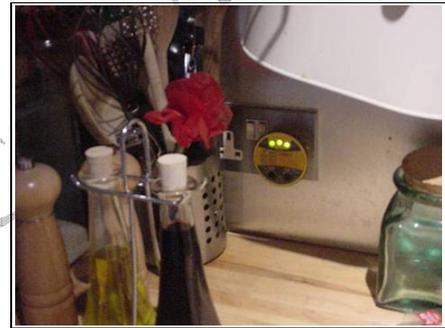
We carried out an earth test in the kitchen area to the socket point that is normally used for the kettle, this proved satisfactory.

Earth Test

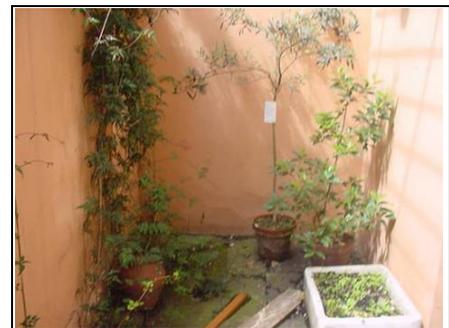
Front patio area

**ACTION REQUIRED:** Ideally we would recommended weep holes are added to the wall to take away the pressure of any water.

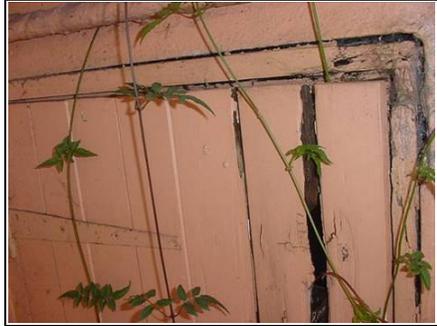
Rotten entrance door

**ACTION REQUIRED:** We would not recommend this as they are underground and very hard to keep watertight. It depends how watertight you need to keep them and we would suggest we have a discussion on this as we have not met you at the property.

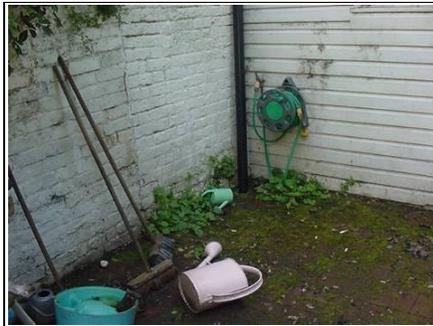
There is a reasonable sized rear garden. We did note some moss which indicates it does not get much sunlight and it is overlooked.

Moss in rear garden

**ACTION REQUIRED:** Please see our comments in the Executive Summary.
