RESIDENTIAL BUILDING SURVEY

**Kenley,
Surrey
CR8**

**Three Storey
Mid-Terraced
New House**

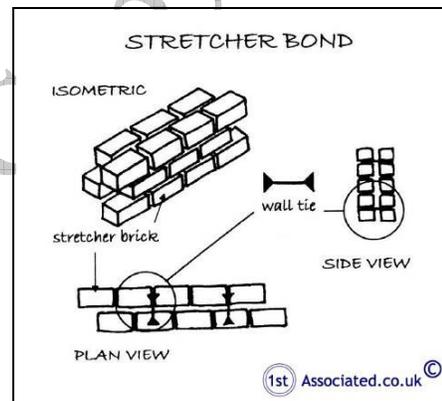
If built quickly, with poor quality standards, then the mortar can be dropped in the cavity and span between front and rear walls which can lead to dampness coming in. This is the problem that No. 6 has been facing.

ACTION REQUIRED: We recommend having your property opened up and the cavity tray cleared.

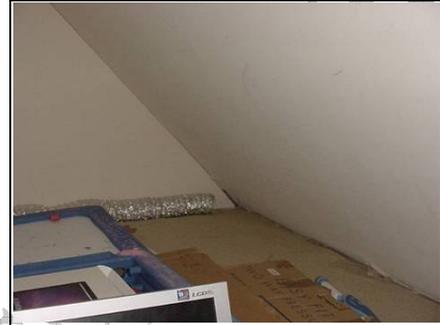
We noted in the roof space that the mechanical vent pipe (also known as Elephant trunks in the trade) from the bathroom has come undone, and another vent pipe is discharging into the rear cupboard.

Vent pipe in discharging into rear cupboard.

ACTION REQUIRED: Reconnect vent pipes.

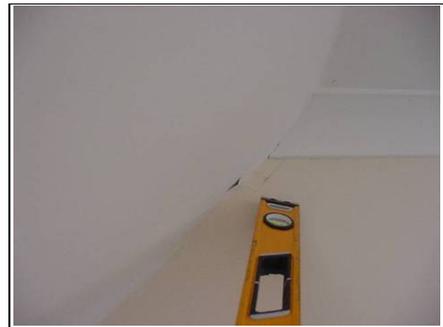
The plasterboard joints have been taped and painted without a skim coat of plaster from what we can see.

Poor finish to plasterboard joints

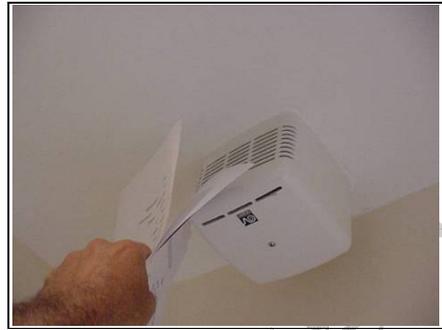
The draw on the extract fans in this property is not particularly great and the pipes in two instances (the only two instances we saw) have not been connected or have come unconnected, and are discharging into the roof, which is not good.

The extract fan has a poor draw

ACTION REQUIRED: Replace extract fans with large humidity controlled extract fans and make sure they are vented to outside air.

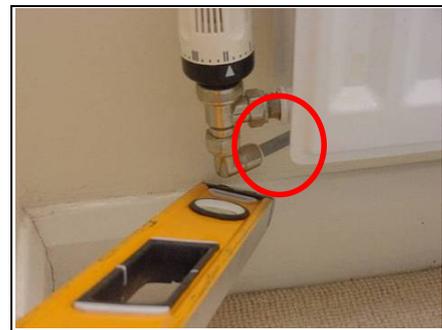
As is sometimes the way on more modern properties, microbore pipes have been used. We are not particularly keen on these as in our experience with running rental properties, they do not have the same flow. In this case they are plastic, which we do not think there in an in-use history of; remember as surveyors we like to see a good 30 years of something being used before we recommend it! You will need to accept that this is a characteristic of the property.

Plastic microbore pipe

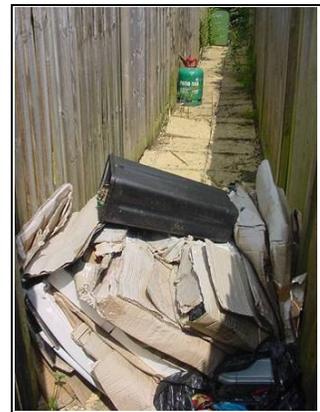
There is an alleyway/access to the rear, which we believe relates to this property. It has an uneven walkway with paving slabs and needs clearing of vegetation.

Rear alleyway/access full of rubbish

ACTION REQUIRED: Your legal adviser to check who has ownership of this area.

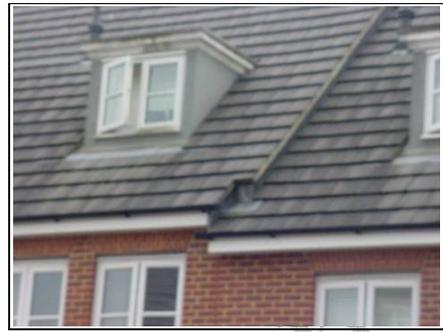
The houses are on a very slight slope which means there is a step in the roof of the adjoining property.

Step in roof

ACTION REQUIRED: Carry out periodic inspections and maintenance of the roof, as required.

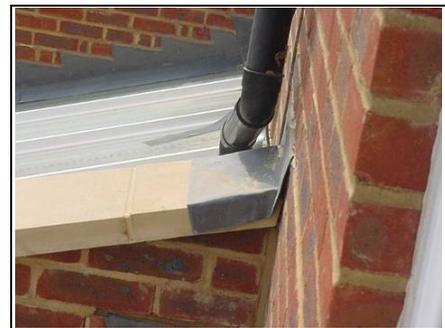
We believe the lead detailing could be better to the top of the coping stone.

Lead flashing not bedded properly

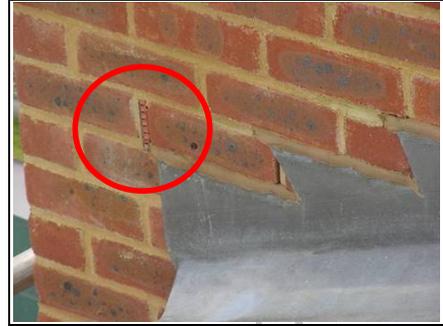
We noticed a weep hole in the parapet wall, which is very unusual.

Weep hole in parapet wall (circled)

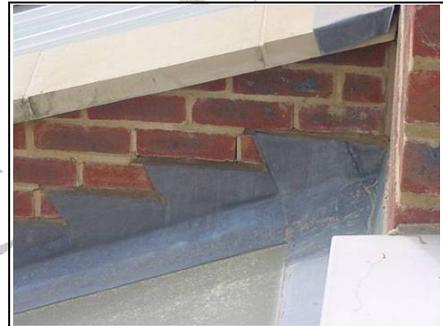
Just a general comment on the quality of workmanship; we can see that some of the perpendicular ends have not been re-mortared. It is not unusual to leave these un-mortared where flashing have been added but they should have had the mortar repointed.

Perpendicular end not done properly

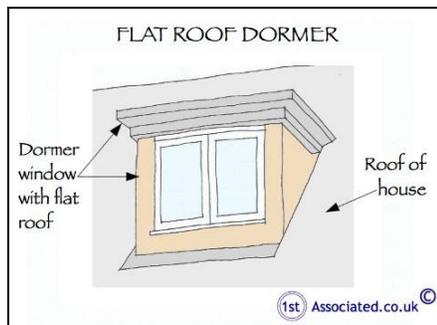
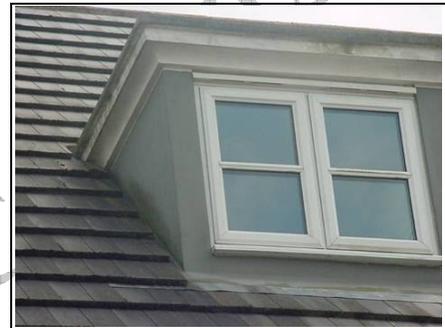
There is a dormer window roof to the front of the property. We believe it has glass reinforced plastic (GRP) to the top and sides. Generally we could comment for their age, type and style they are in average condition, with some slight staining on the sides.

Dormer window

Dormer window to front

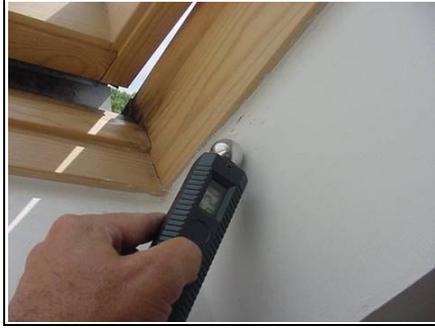
The property has a purpose made roof light to the rear, which looked in average condition. The important factor with roof lights is the flashing around them, in this instance we would comment we could see minor dampness coming through internally, which may be from wind driven rain, where the window was left open.

Signs of dampness coming through

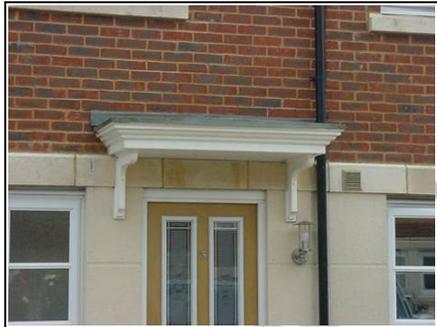
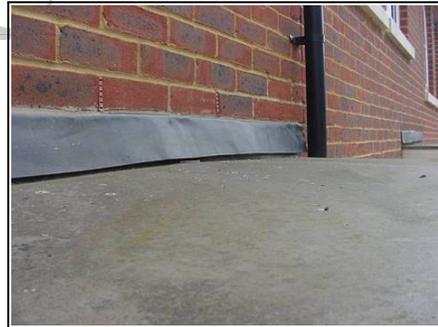
The porch roof to the front is flat. It is covered with a glass reinforced plastic and a lead flashing is in average condition for its age, type and style. We would comment that there is some damage to the left hand side. You may also notice this does not have gutters, which is not unusual for a small area of flat roof on a modern property.

Porch roof

Close up of porch roof

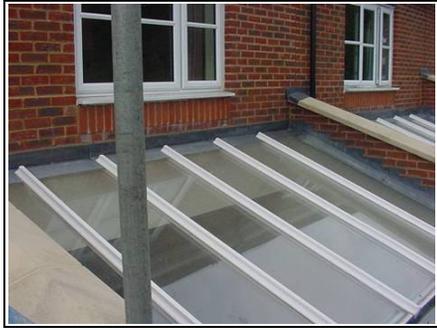
The conservatory roof is glass with a lead flashing and is in average condition.

Glass conservatory roof

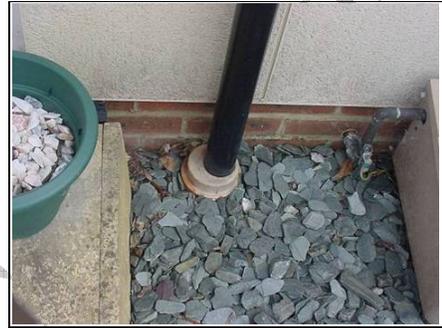
There may be some minor leaks but most people would be happy to live with these providing repairs are carried out within the next six to twelve months.

Downpipes feed directly into the ground

ACTION REQUIRED: We would always recommend you stand outside the property next time it rains heavily and see how well the drains cope with the rainwater particularly looking at the guttering and the joints.

We always recommend that the gutters and downpipes are cleaned out, the joints are checked and the alignment checked to ensure that the gutters fall towards the downpipes.

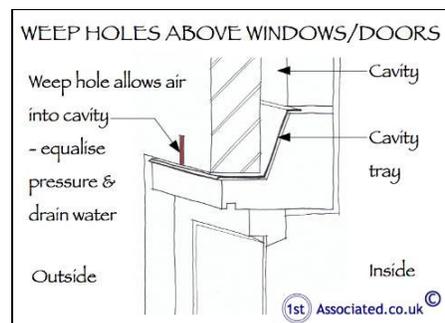
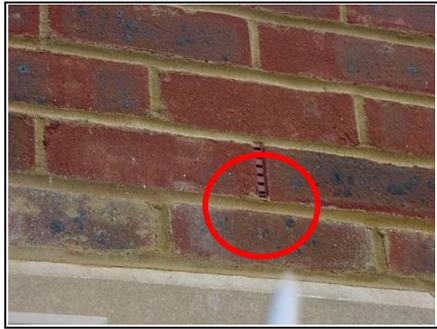
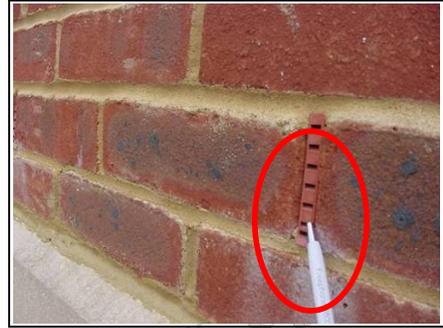
Weep holes at high level

The property next door has had problems with these.

Weep hole

Weep hole to rear

ACTION REQUIRED: We recommend the NHBC come and remove your weep holes, check they are clear and check the condition of the cavity. This can be carried out using a borescope, also known as an endoscope.

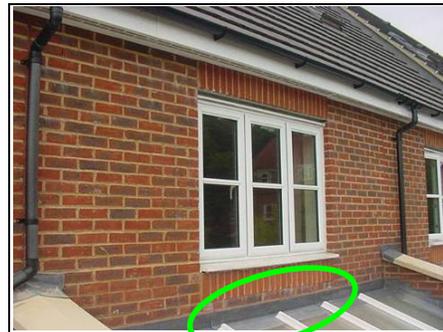
We noted some efflorescence on the brickwork.

Efflorescence under rear window, there will be weep holes in this section too

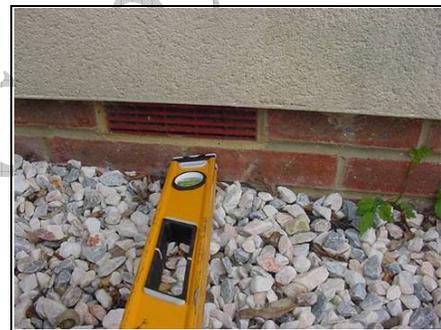
Air brick

ACTION REQUIRED: Ensure the air bricks are clear.

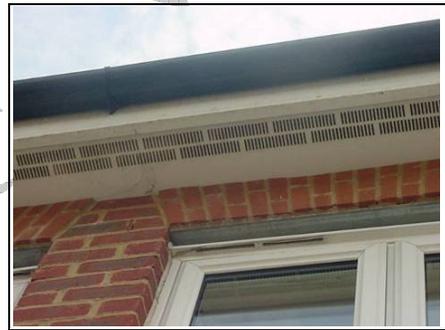
We believe the fascias and soffits are plastic, but it is very difficult to be certain. We hope they are not painted timber as this will be very hard to redecorate given the height of the building. We would comment they are in average condition for their age, type and style. We were pleased to see vents in the soffit boards.

Air vents to soffit boards

ACTION REQUIRED: Make sure gutters and downpipes are watertight before carrying out any work on fascias and soffits.

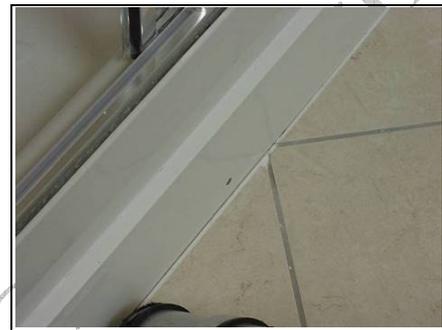
We noted that tiles have been laid on top of a wooden floor in the bathrooms, which is not ideal.

Tiles on to wooden floor - looks like shower unit's been opened up

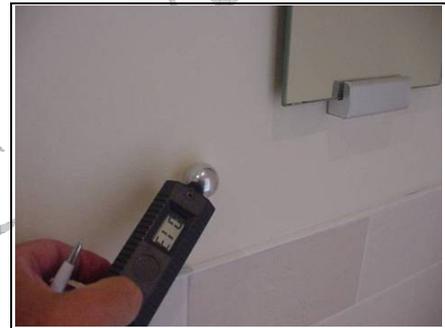
We used a resistance meter on the external walls, however we have been unable to get readings due to the walls being dry lined, but we have tried to check where we can.

Testing for lateral dampness

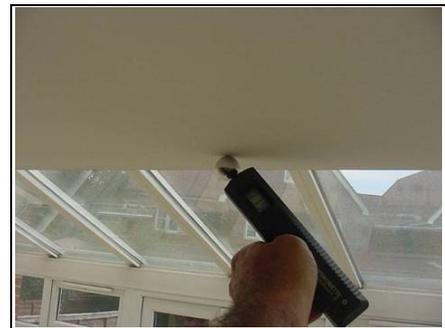
We found dampness in the conservatory and double checked the level of dampness with our electronic damp meters.

Double checking level of damp in conservatory

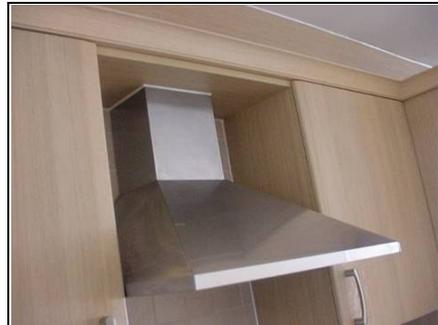
Good sized extract in kitchen

ACTION REQUIRED: We would recommend humidity controlled large extract fans be added to kitchens, bathrooms and drying areas.

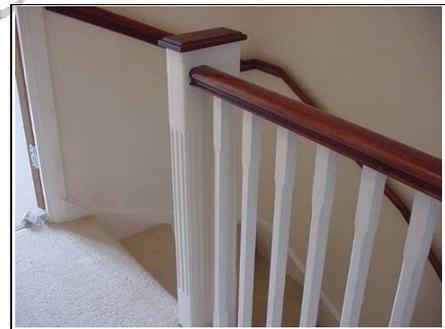
Handrail detail

We were unable to examine the underside of the stair timbers due to it being lined, which precluded our inspection, so we cannot comment further upon the stair structure. We can, however, say that the lining gives a resistance to the spread of fire if such circumstances were to occur.

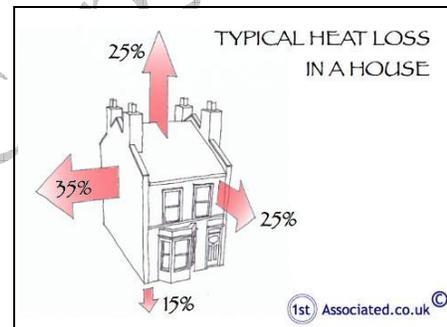
Some roof insulation was present although not to current Building Regulations requirements of 300mm. In this instance there is indeed approximately 300mm.

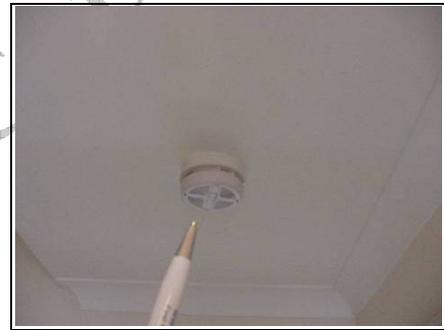
Smoke detector

Some smoke detectors were noted. The current Building Regulations require that they be wired into the main power supply. Obviously in a property of this age this is difficult, as it would mean having surface mounted wires or cutting wiring into the plaster. We were pleased to see that you do have a hard wired system.

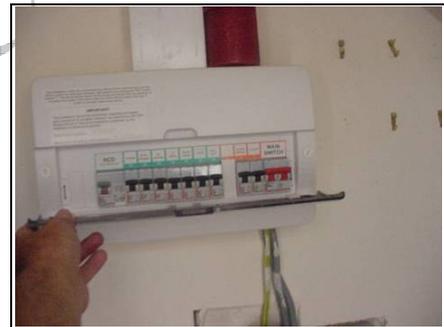
Fuse Board

The electric fuses and consumer units were located under the stairs and are fairly new. The electricians should have been tested as part of the property being leased.

ACTION REQUIRED: Obtain a copy of any certificates.

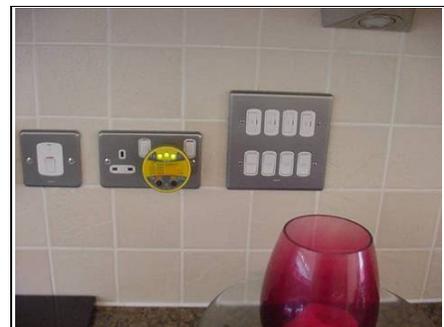
We carried out an earth test in the kitchen area to the socket point that is normally used for the kettle, this proved satisfactory.

Earth test

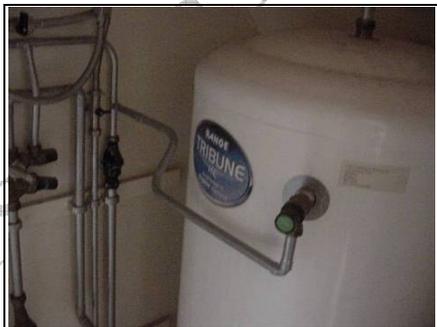
There is a factory insulated hot water cylinder located within the cupboard in the master bedroom on the top floor. This cylinder will therefore have a good thermal efficiency, although not as good as the more modern hot water cylinders. However, in this case it is unvented.

Hot water cylinder - unvented

ACTION REQUIRED: We recommend this be vented externally.

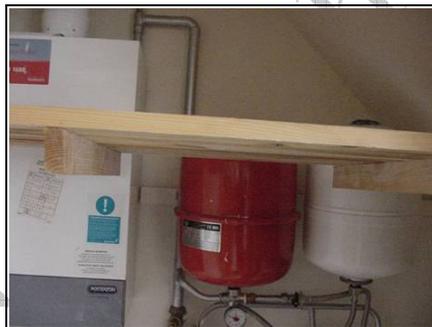
The wall mounted Potterton boiler was located in the cupboard the master bedroom on the top floor. We noted the vent was discharging internally.

Our limited inspection of the hot water and central heating system revealed no evidence to suggest any serious defects but we would nevertheless recommend that the system be tested and overhauled before exchange of contracts and that a regular maintenance contract be placed with an approved heating engineer.

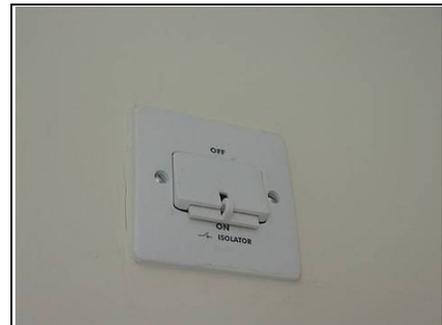
Switch for isolating the shower
In the first floor rear en-suite
shower room

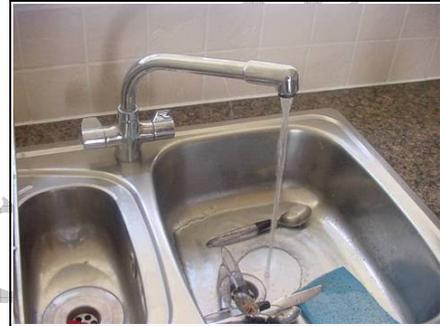
The cold taps have been run for approximately quarter of an hour in the kitchen. No build up or back up was noted.

Checking water pressure in kitchen

ACTION REQUIRED: We would recommend a closed circuit TV camera report of the drains.

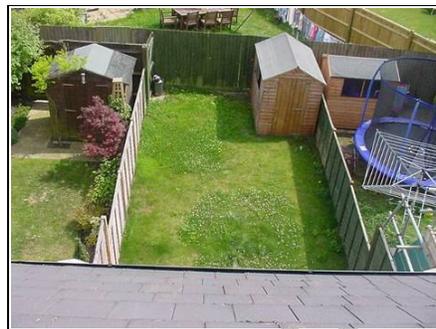
The garden is very overlooked by other properties.

Rear garden

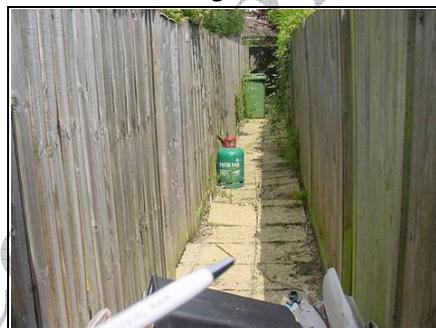
There is an alleyway/access to the rear, which we believe relates to this property.

Rear alley way

ACTION REQUIRED: Please see our comments in the Executive Summary.

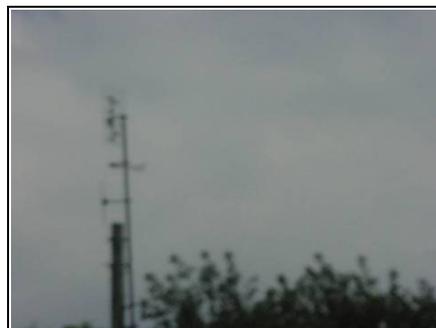
Be aware that there is a large mast nearby, which some people may find a nuisance.

Nearby mast

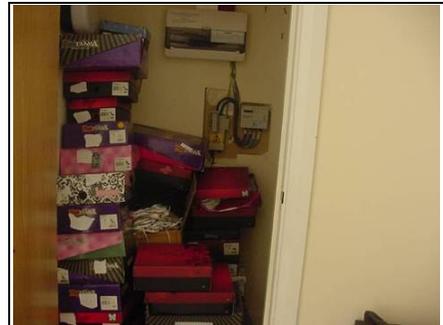
Stored items in cupboard under stairs
