RESIDENTIAL BUILDING SURVEY

Stanmore,
HA7

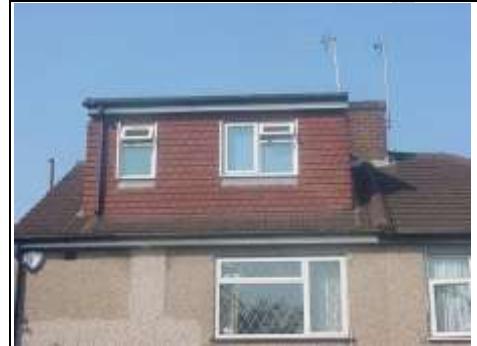
With an older style loft conversion such as this it may not have been insulated and as such can suffer from solar heat gain during the summer months and heat loss during the winter months.

Rear of loft conversion

ACTION REQUIRED: We would generally recommend that a roof access is formed into it so that you can actually access the roof to view it. We also recommend that at the same time insulation cut to falls is added to the roof and a high performance felt. This way you will deal with any roof problems in this area once and for all.

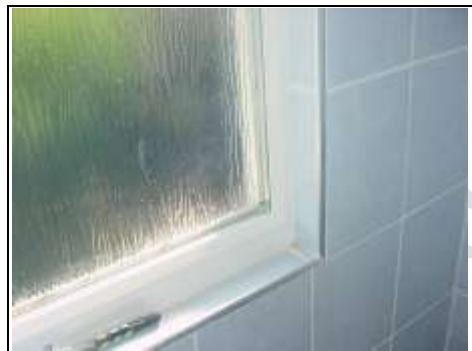
Thin walls in loft conversion
(en-suite shower room)

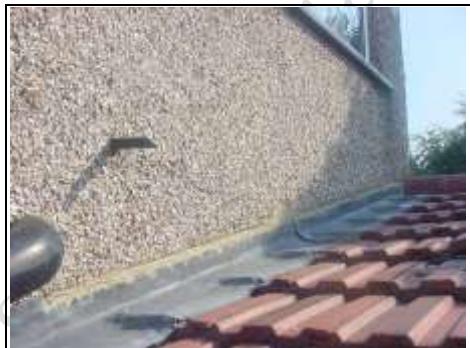
Flashing where the extension meets the main building

ACTION REQUIRED: Keep all the gutters clear and remove moss and tree debris as the build-up can aid water getting into the roof.

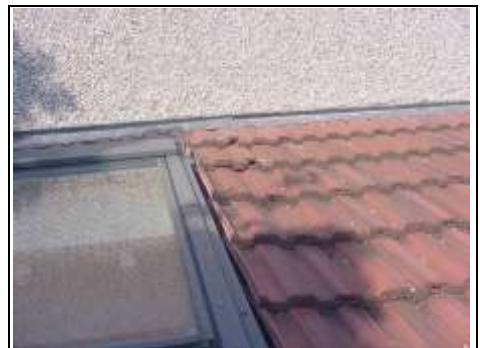
Shallow pitched roof to kitchen extension

Shallow pitch of roof (remember to keep guttering around roof lights clear)

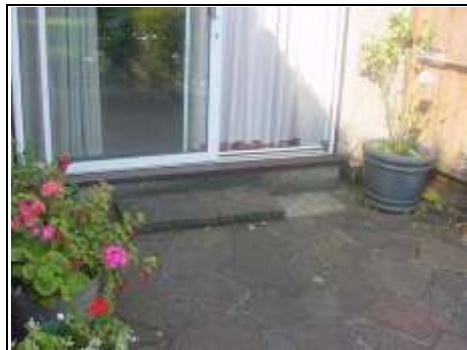
Possibly due to the extension being added there do not seem to be sufficient air bricks to the property.

Patio doors with blocked air bricks

ACTION REQUIRED: We recommend that you double check that there are airbricks to both the front and the rear of the property to allow a through flow of air. Next time the carpets are replaced (or before 2014) we recommend you open up a section of the floor to check the condition of the timbers underneath.

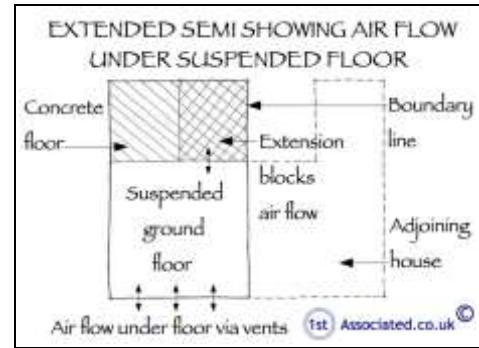
This sketch is not exactly the same as this property but it shows how the extension blocks the air flow

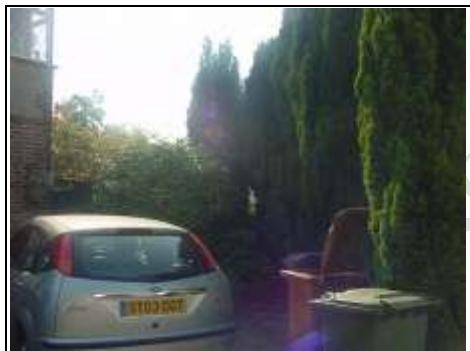
There are trees closer than most insurance companies would like and you may have to pay a premium because of this. We have personally found that where there is a mature tree and the house is relatively old, as in this case, then as long as the tree is well maintained then little damage occurs.

Trees to the front right hand side

ACTION REQUIRED: Your Legal Advisor should specifically ask in writing if the owners have had problems with roots in the drains in the past. We would recommend a closed circuit TV camera report to establish the condition of the drains to check if there are roots within them.

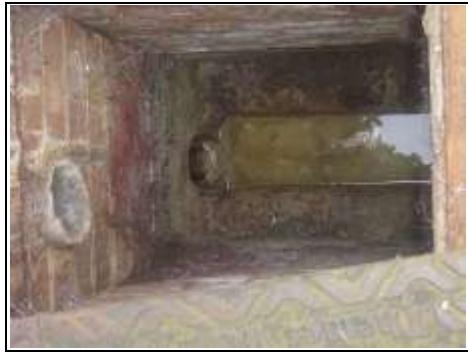
Drain (front) with tree roots
coming through
(not very clear in photo)

Please see our photographs earlier in the report showing some roots in the drains. These need to be cut back. For this reason we would recommend a closed circuit TV camera report to establish the condition of the drains to check if there are roots within them.

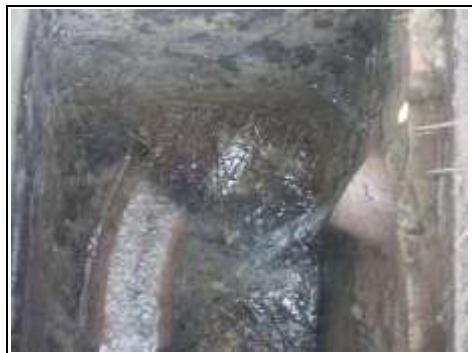
Drain (rear) with tree roots
coming through

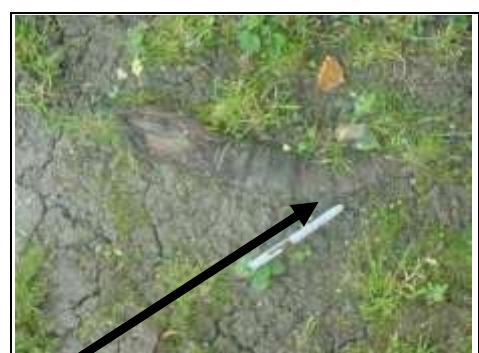
Tree roots coming through in
the garden

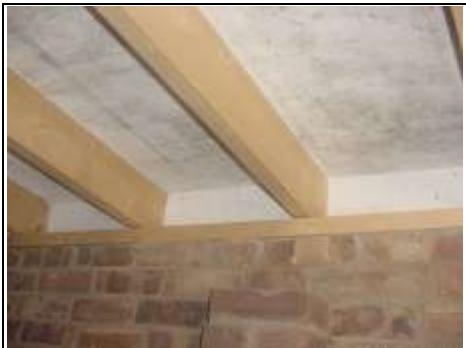
Mould coming through

ACTION REQUIRED: The roof is vented sufficiently from what we can see and it may simply be there is not enough general air movement in the garage. If this is the case you need to add some air bricks. We would also recommend that you cut back the bushes etc. that are starting to take over the rear of the roof and at the same time make good the parapet wall.

ANTICIPATED COST: A few hundred pounds; please obtain quotations.

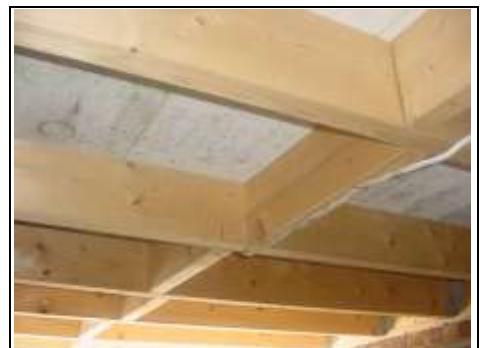
Mould indicates condensation is occurring

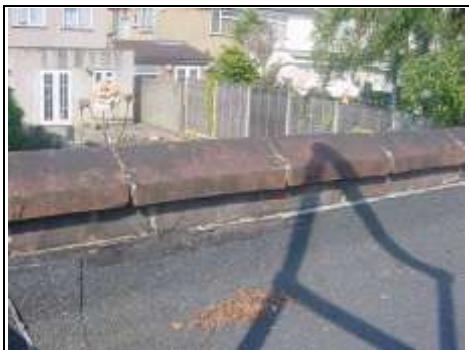
Parapet wall needs re-pointing

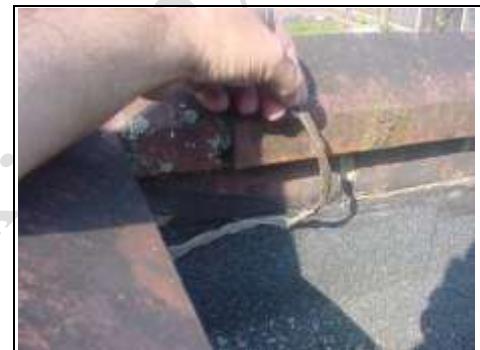
Mastic coming away

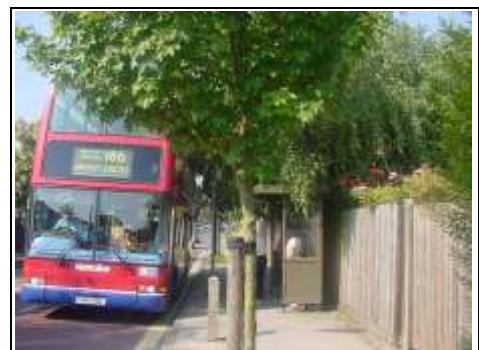
There is a fairly active bus stop near to the access to the garage. The trees may or may not shelter the view of your property.

Bus stop close to garage entrance

ACTION REQUIRED: You need to check that you are happy with this.

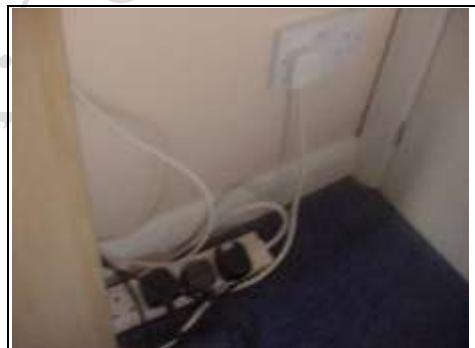
More socket points needed

We would also recommend increasing the number of socket points as there seemed to be a fair number of extension leads and adapters being used.

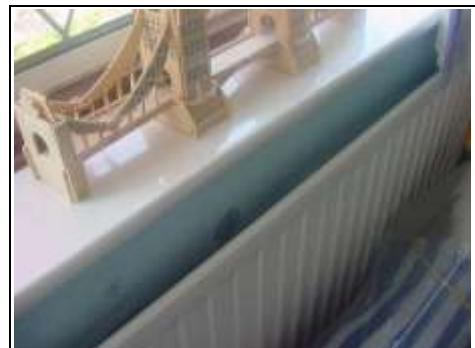
This property has single panel radiators. These may not warm the property as you would wish.

Single panel radiator

ACTION REQUIRED: You may wish to add double panel convection radiators. It is best to live in the property for a while and establish if it is warm enough for you before you carry out any work.

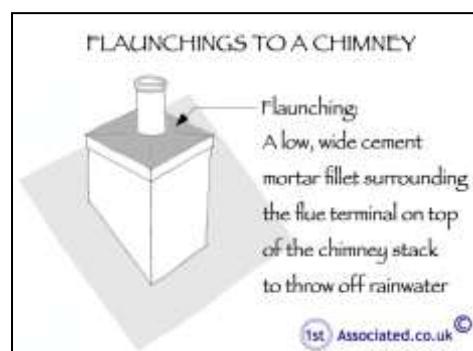
This chimney is brick finished with a lead flashing and no chimney pots. From what we could see, as we had a limited view, it looked in average condition considering its age, type and style.

Unfortunately we were unable to see the top of the chimney known as the flaunching, we therefore cannot comment upon them.

ACTION REQUIRED: Periodically inspect the chimney for weathered pointing.

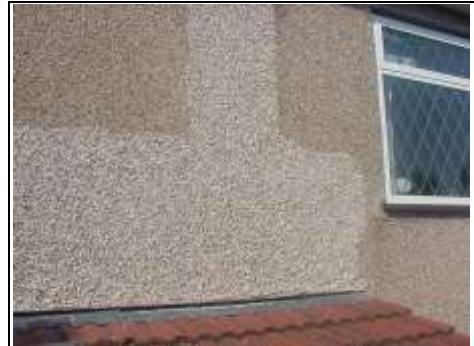
We spoke to the owners about this and they advised us that when the extension was carried out the rear chimney that used to vent the boiler was duly removed.

Chimney has been removed to the rear of the property

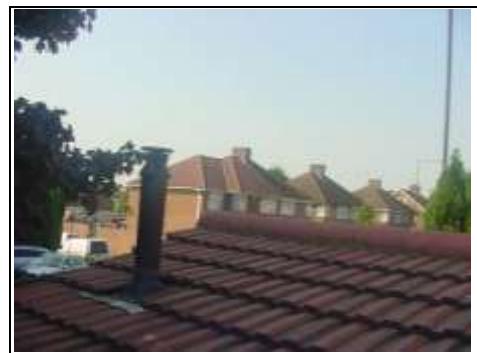
Flue from the boiler in the kitchen

The property has a metal flue leading from the boiler that is visible on the rear extension roof. Where it is through the roof there is a lead flashing (which we were pleased to see).

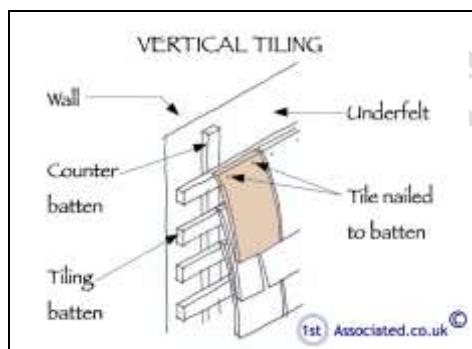
Vertical tiling

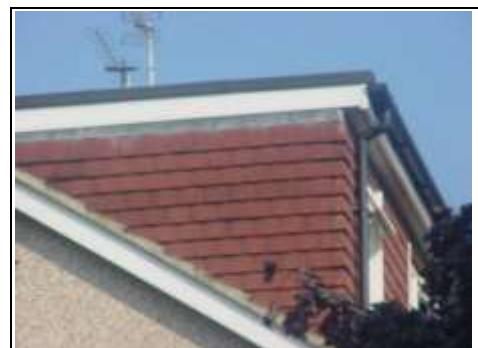
Dormer window side

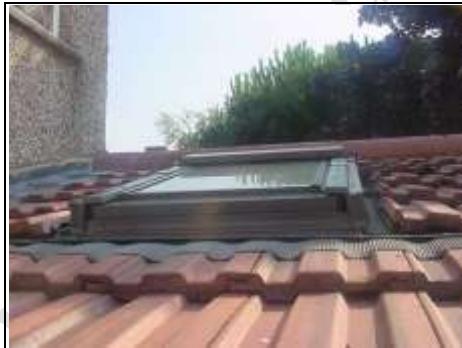
The property has four purpose made roof lights, two at the front of the main roof and two to the rear extension roof which all looked in average condition. The important factor with roof lights is the flashing around them.

Roof window to rear extension roof

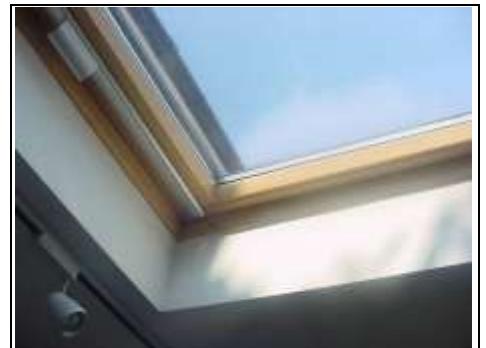
Roof window from within kitchen

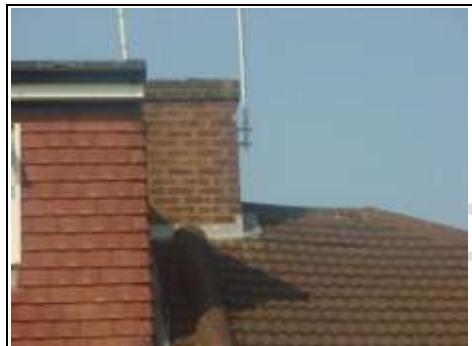
Hidden roof

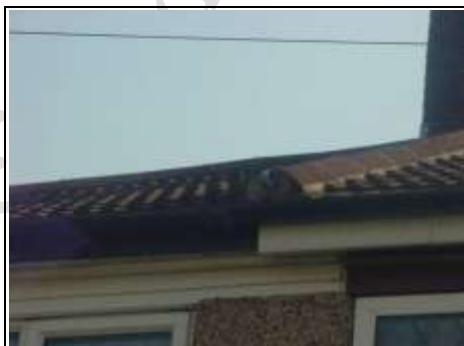
Hog backed tiles between the two roofs that indicate they were put on at different times.

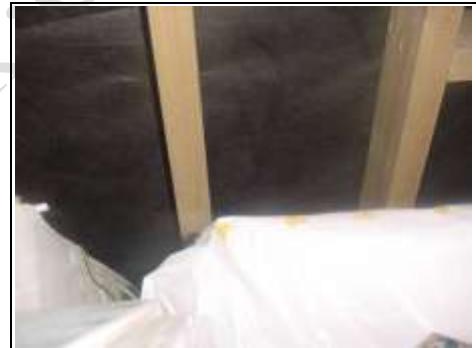
We have had a limited view of the protective underlayer due to rooms being formed in the roofs. The photos that we have included in this section are taken from within the cupboards and show perhaps ten per cent of the roof. They do indicate to us that an older style protective underlayer has been added – we could not see any ventilation that would typically be present in a more modern conversion.

This photo shows the common rafters (the ones that form the pitch of the roof) and the dark area between is the underlayer.

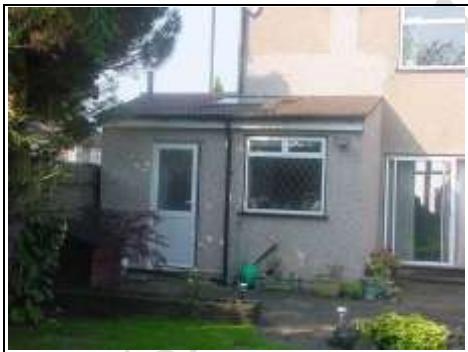
There is a shallow pitched roof clad with a concrete tile. There is a protective underlayer visible into the gutter which is our preferred detail. Wind driven rain getting in is the weak area and also where the pitched roof meets the main building.

Shallow pitched roof to kitchen extension

ACTION REQUIRED: Please see our comments within the Executive Summary and carry out periodic inspections and maintenance of the roof, as required.

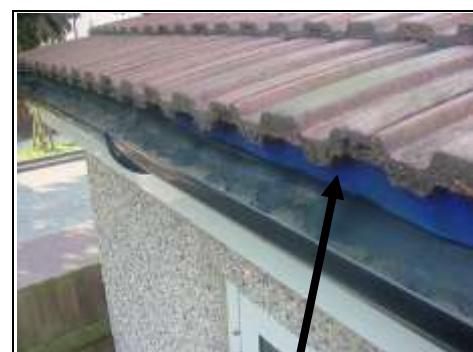
Underlayer visible on pitched roof

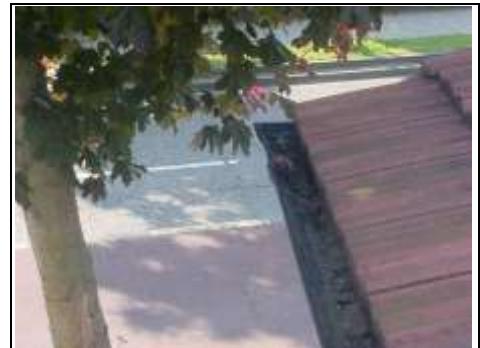
Gutters need clearing of leaves

We would always recommend that the gutters and downpipes are cleaned out, the joints are checked and the alignment checked to ensure that the gutters fall towards the downpipes.

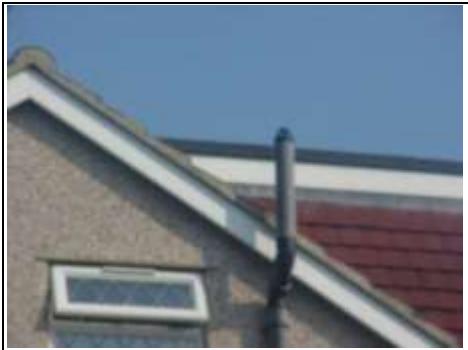
Soil and vent pipe

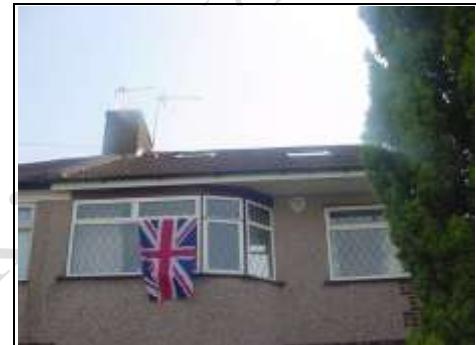
The external walls are finished in a pebble-dash render. We are always wary when we see rendered properties as it usually means they have been rendered for a particular reason.

In this particular case we believe from looking at the surrounding buildings it is part of the original aesthetics. This can clearly be seen from where chimneys have been removed and alterations have been carried out to the rear for the extension as the pebble-dash does not match at all.

Pebbledash render

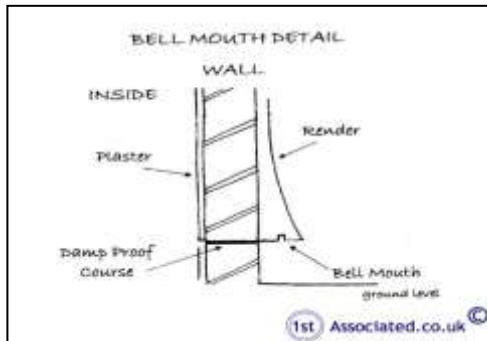
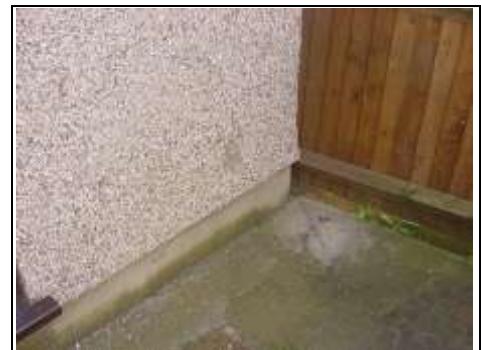
To the base of the render there was a bell mouth detail. We would also comment that the crazy paving may be slightly high.

Bell mouth to the base of the property

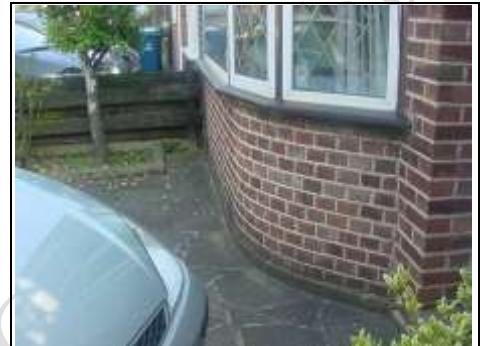
There is some decorative brickwork to the front around the bay window. The brick work coursing is a mixture of brick patterns and it would be normal in this age, type and style of property to have a solid wall construction which is what we would expect here.

Brick work detail to front bay

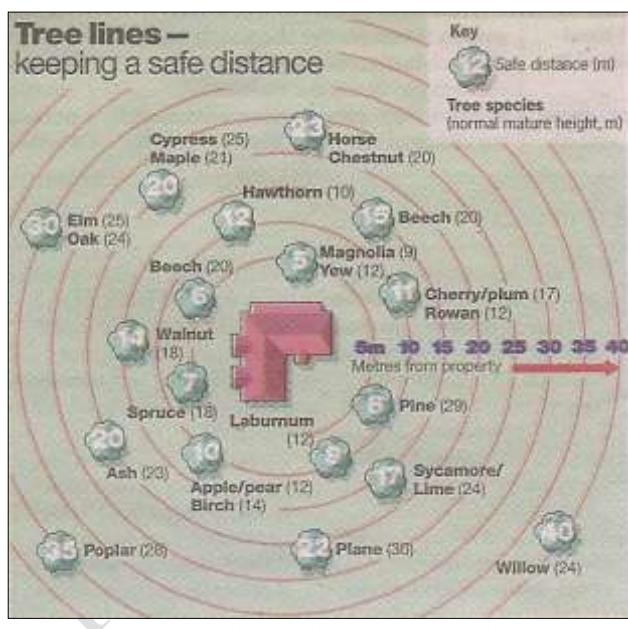
Trees to the right of the property
(all directions given as you face the property)

We recommend that you check your insurance and check who the present owners are insured with before you purchase the property to see if there are any premium excesses etc. Please see our comments within the Executive Summary.

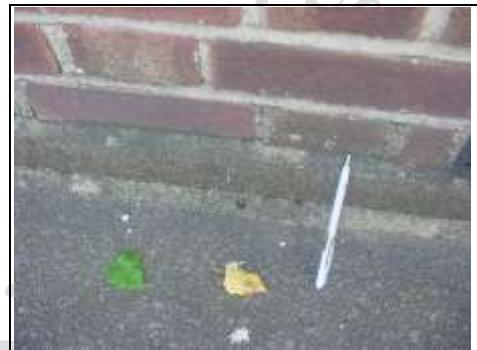
All modern properties should incorporate a damp proof course (DPC) and good building practice dictates that a differential of 150mm (6 inches) should be maintained between the damp proof course and ground levels. In this case we can see a DPC. This is slightly lower in some areas possibly due to the paving being added on top of the original surface.

DPC is slightly low in places

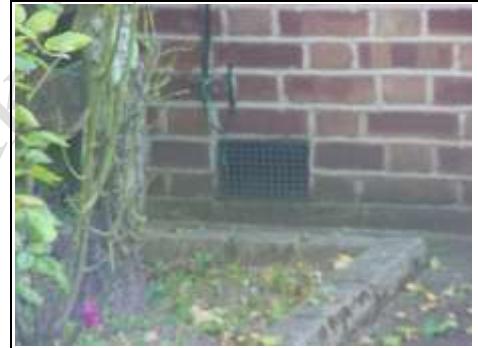
There are airbricks at low level. Air bricks are essential to have a through flow of air as this helps to reduce the chances of wet rot, dry rot and woodworm.

Air brick (front)

ACTION REQUIRED: Please see our comments within the Executive Summary

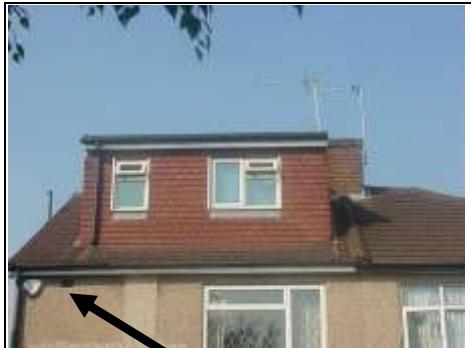
There are vents at high level.

Air brick

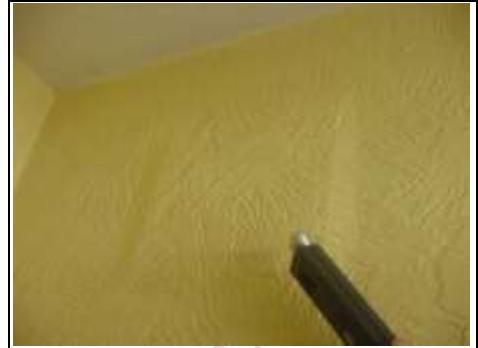
Internal air vent wallpapered over

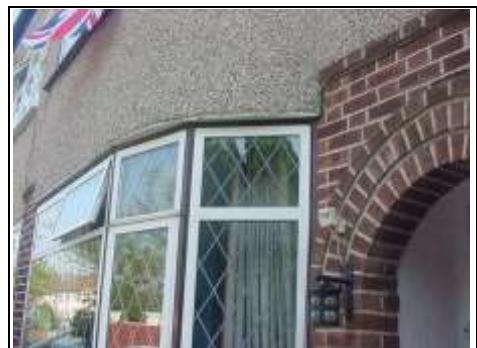
The property has timber double glazed windows in a timber frame without trickle vents, which generally look to be of average quality.

Timber double glazed windows

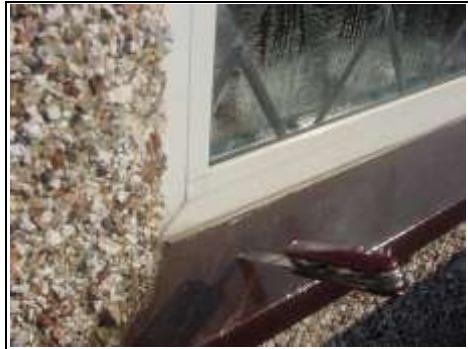
Testing the timber windows with a knife

This is where we push the knife into the window to check for rot. It is not rocket science!

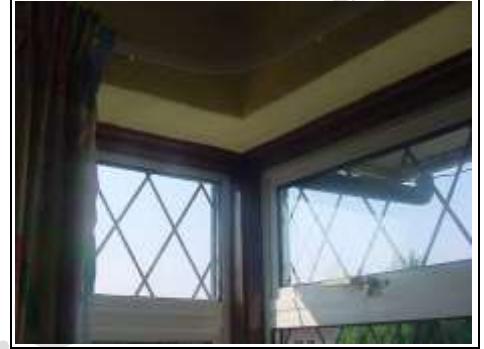
Leaded light window

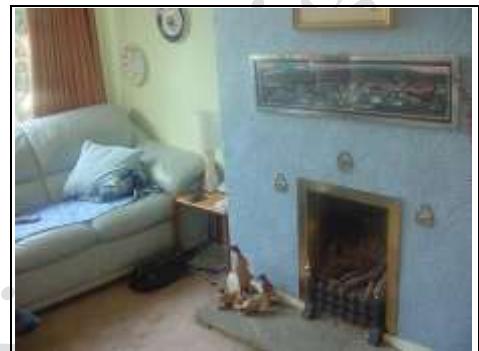
There is a feature fireplace in the lounge but we were advised it has not been used for many years and has only ever been used at Christmas.

Feature fireplace

It is strongly recommended that flues be cleaned and checked for obstructions prior to use to minimise the risk of hazardous fumes entering the building.

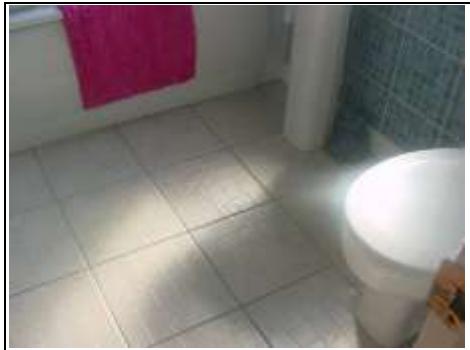
With a wooden floor you will always get some deflection, however minor. This deflection in the floor will ultimately mean that the tiles will need re-grouting.

Tiled floor on timber in bathroom

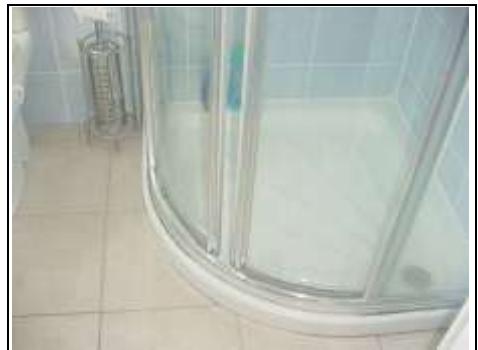
The en-suite shower room also has tiles laid on a timber floor, please see our earlier sketch.

Tiled floor on timber in en-suite shower room

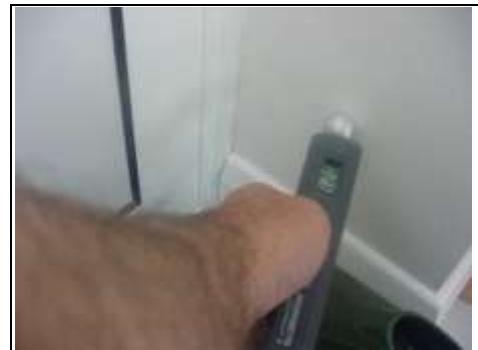
A visual inspection and tests with a moisture meter have been taken to the perimeter walls. In this particular case we have found no rising damp. We would comment that some areas of ground level are high externally and ideally should be lowered but this would be fairly difficult.

Testing for rising damp

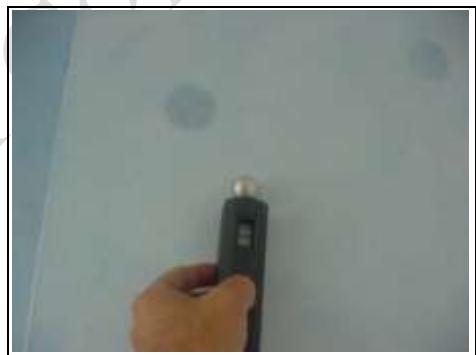
We used a damp meter on the external walls. We have not found dampness.

Testing for lateral dampness

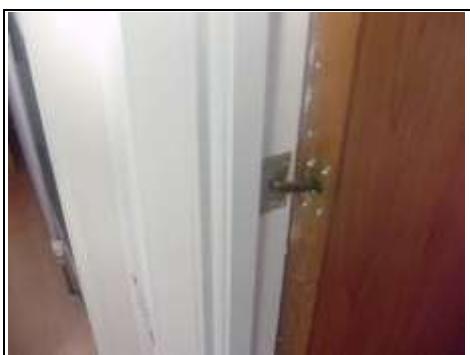
The doors are veneered doors. The perko door closers make these fire doors. At the time this conversion was carried out there was a requirement to have fire doors to a staircase. This was to stop the chimney effect of fire transferring from one floor to the next. You should keep these doors in place.

Perko door closers. These indicate
loft conversion has been carried out
legally

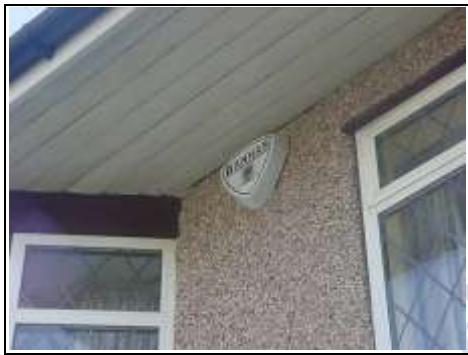
A security system has been installed. A good alarm system should not only help reduce break-ins but also your insurance. We are not experts in this field and therefore cannot comment further.

Security alarm box

ACTION REQUIRED: Further information should be obtained from the vendor and the installer.

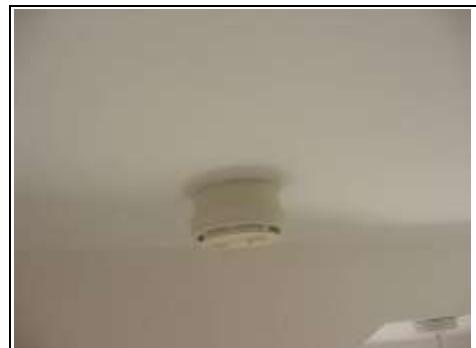
A hard wired system was noted which we were pleased to see.

Hard wired smoke alarm

ACTION REQUIRED: We would always recommend a hard wired fire alarm system and are also aware that some now work from a wireless signal which may be worth investigating. Whilst fire is relatively rare it is in a worst case scenario obviously devastating.

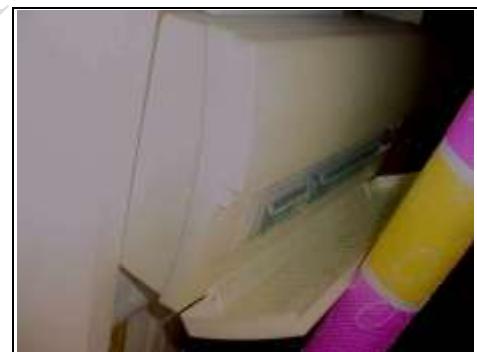
The electric fuses and consumer units were located under the stairs. The fuse board looked slightly dated, circa 1970's/1980's.

Fuse Board

ACTION REQUIRED: Please see our comments within the Executive Summary.

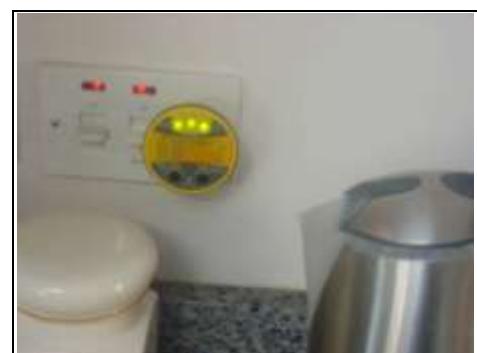
We carried out an earth test in the kitchen area to the socket point that is normally used for the kettle, this proved satisfactory.

Earth Test

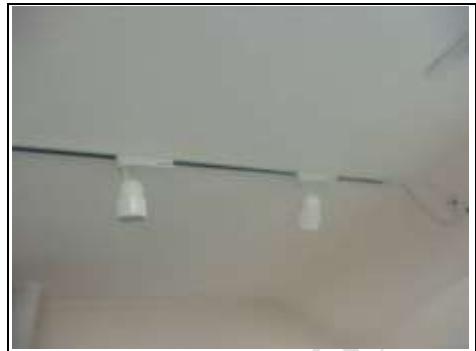
A lighting track was used in the kitchen which is slightly unusual and which we rarely see but it seemed to work quite well.

Lighting track

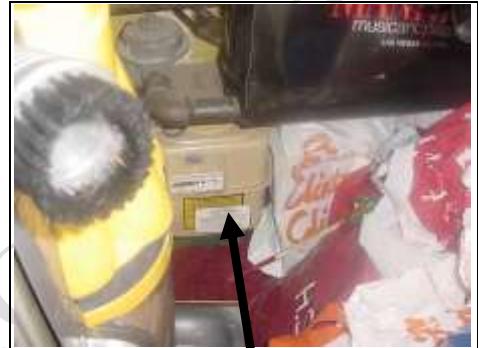
We are advised that the property has mains gas. The consumer unit is located under the stairs.

Gas consumer unit

ACTION REQUIRED: As a matter of course it is recommended that the entire gas installation is inspected and made good, as necessary, by a Gas Safe registered contractor. Thereafter the installation should be serviced annually.

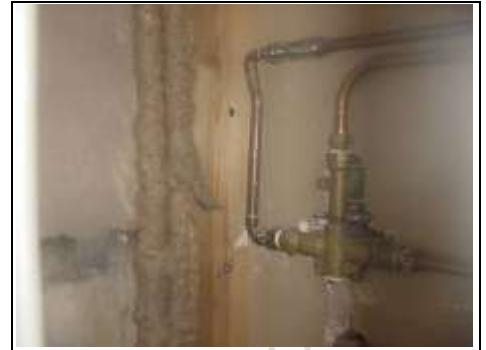
The plumbing, where visible, comprises copper piping. No significant leakage was noted on the surface, although most of the pipework is concealed in floors, walls and ducts. It was slightly unusual that we could see the back of it within the rear left hand room.

Plumbing visible in cupboard in rear right bedroom. The photo shows valves which can be turned on and off.

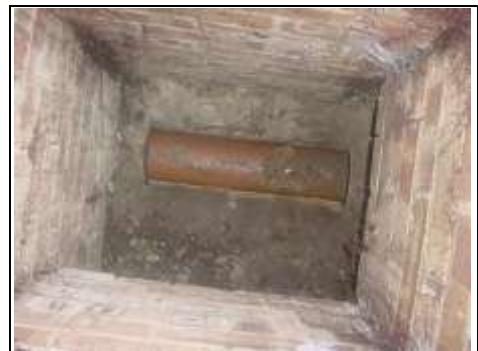
We duly lifted the cover and found it to be free flowing at the time of our inspection.

From what we could see it is brick built.

Manhole (front right)

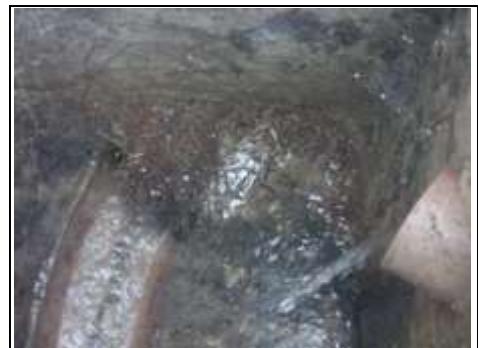
There are tree roots in this manhole.

Manhole (middle right)

ACTION REQUIRED: Please see our comments within the Executive Summary with regards to a closed circuit TV camera report.

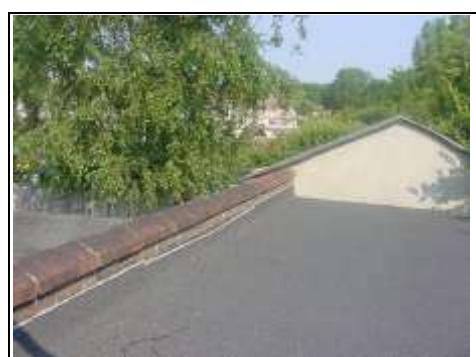
Flat roof

The garage roof is in average condition and probably has another ten years of life providing that the repairs are carried out to the parapet wall and the trees are cut back.
