ENGINEERS REPORT / SPECIFIC DEFECTS

Relating to Cracking to the Rear of the Property

**Ground Floor Apartment within a Large
Early Victorian Property in London**

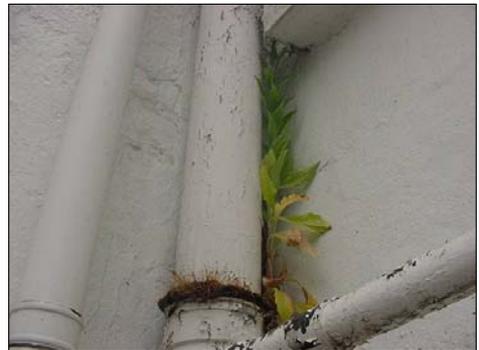
3. Externally we noted that the soil and vent pipes showed signs that they are leaking quite badly with a vegetation growth, which are immediately next to the widest part of the crack, which we feel will be causing additional problems with the freeze / thaw cycle.

In our discussions with the owner she advised that the gutters had been replaced. We would assume that deterioration had been caused to the render and possibly the brickwork before this by the discharging of rainwater down the face of the property.
