SPECIFIC DEFECTS REPORT

Relating to Cracking to the Plasterwork Due to Dampness

Victorian Terraced Property in London

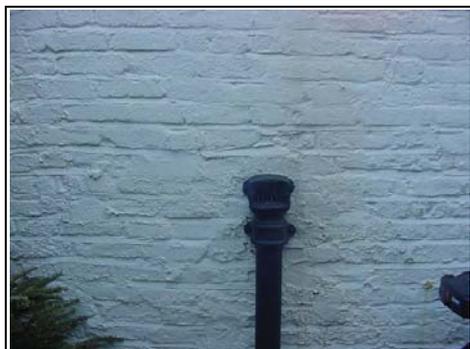
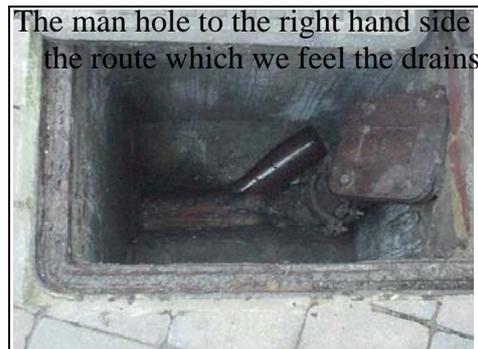
The man hole to the right hand side being along the route which we feel the drains will take

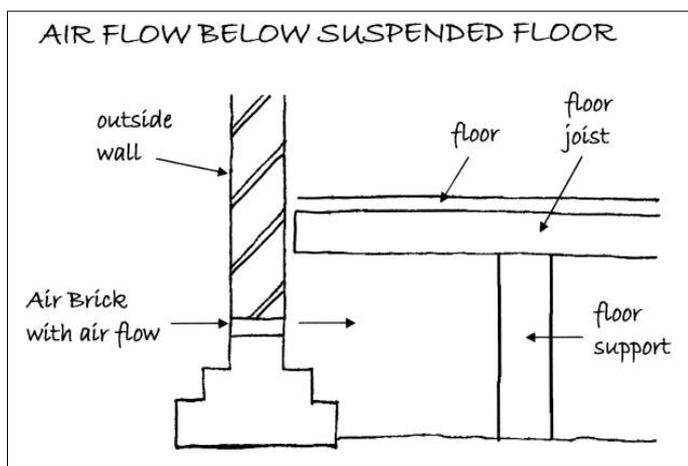
As an aside with a suspended timber floor to the front of the property and a concrete floor to the rear of the property, the concrete floor can affectively be acting as blotting paper, as there is no way that any moisture underneath the floor can escape in this section and this again could be adding to the cracking in the kitchen area.
