# RESIDENTIAL BUILDING SURVEY

Dorset

## **INTRODUCTION**

Firstly, may we thank you for your instructions; we have now undertaken a Building Survey (formerly known as a Structural Survey) of the aforementioned property.

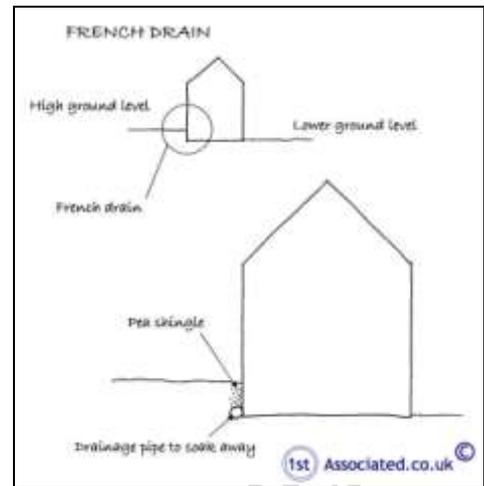
### 2) **Car Parking Area runs towards the Property and will cause dampness**

**ACTION REQUIRED:** Our preferred method would be a French Drain. Without this there will be damage, deterioration and dampness to the base of the render over time.

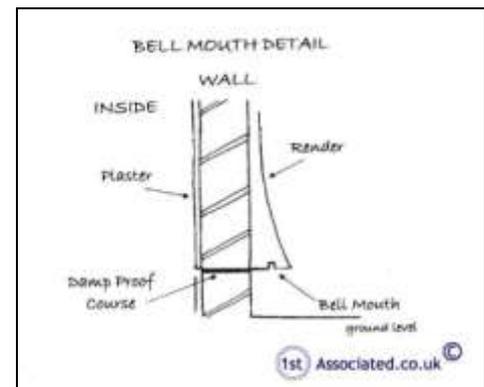
### 3) Render

**ACTION REQUIRED:** Add a running gully / French drain.

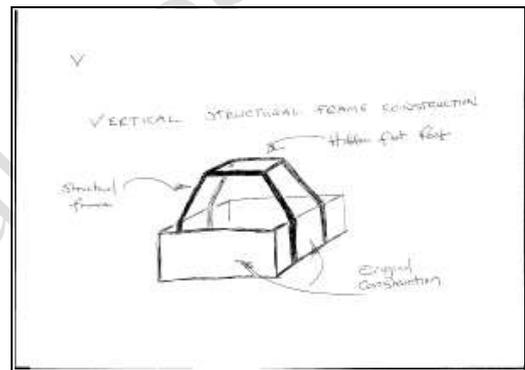
### Movement/Cracking to the render

This mixed type of construction and the relatively hard cement render that you have on the property may well cause cracking to the render that you will have to seal and redecorate. Unfortunately the property with this new development has not had the test of time.

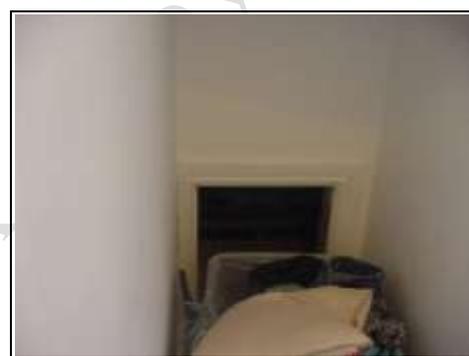
Roof access located within the  
cupboard

The main roof is accessed via the loft hatch located within a cupboard to the front right hand first floor bedroom. From here we effectively had what we would term as a head and shoulders view of the roof which means we looked at approximately ten per cent of the roof.

Whilst this does show how well the property has utilised the roof space forming the rooms within the roof, (we could literally see where the plasterboard goes around the steel frame), it means that much of the structure is actually hidden from our view.

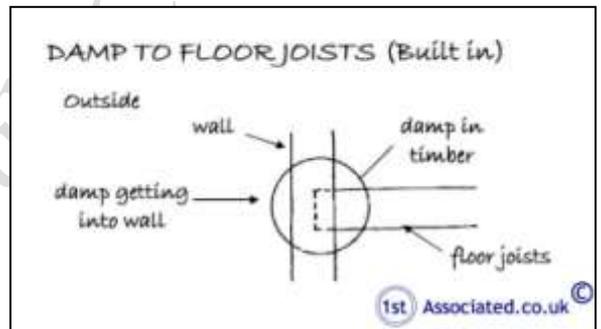
Original floor joists may well remain although sometimes it is harder to keep them than just start afresh. If they do then they may well be embedded. Please see our sketch.

**ACTION REQUIRED:** Existing owner/developer to confirm whether all are new floors or part original.

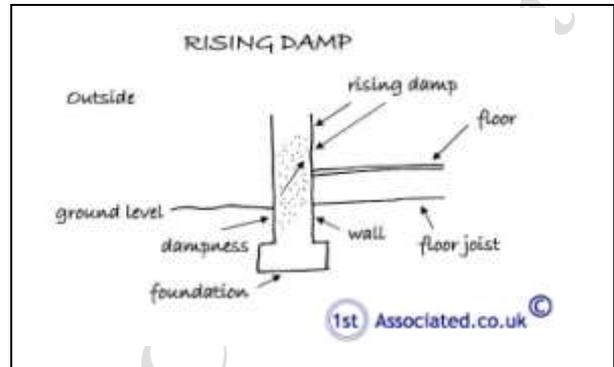
A random visual inspection and tests with a moisture meter have been taken to the perimeter walls and some internal walls. Whilst we didn't find any readings we are concerned that the outside floor levels are similar to the inside floor levels without any French Drain or other way of getting the water away from the property.

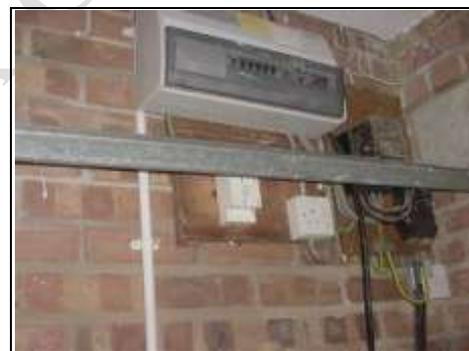
Fuse Board

The electric fuses and consumer units were located in the garage. The owner advised us that this is as new and that IEE (Institute of Electrical Engineers) certificates will be available.

**ACTION REQUIRED:** Your solicitor to check the IEE certificates.

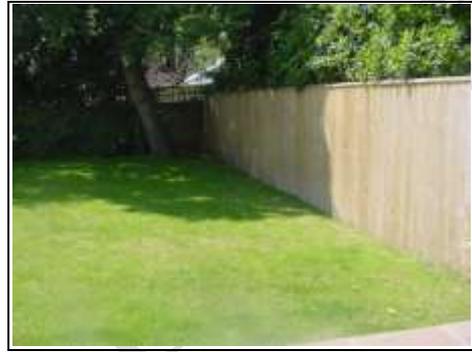
Rear garden

The garden is to the rear and is grassed and has some mature trees.
