COMMERCIAL BUILDING SURVEY

XXXXXXXXXXXX
XXXXXXXXXXXX

London

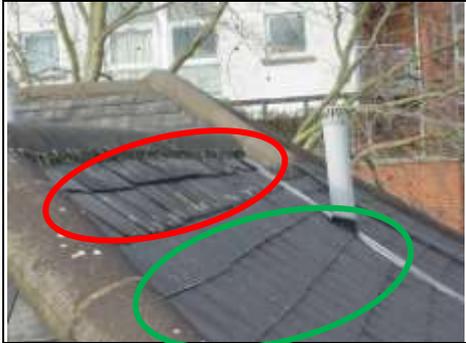
The main pitched roof has a mixture of quarried slate and manmade slates, possibly with asbestos mix. We can see some of the slates are starting to turn from a black colour to a white colour showing through, which can often mean an asbestos mix.

Original slate to top (red oval)
Manmade slates below (green oval)

Our insurance company require us to advise we are not asbestos specialists and recommend you have an asbestos survey carried out by a specialist asbestos company on the entirety of the roof.

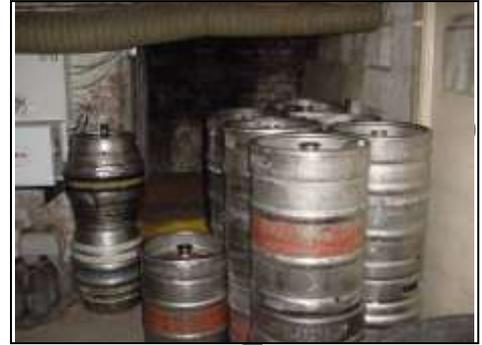
We were advised there was a sump pump but we could not see it, nor could we see the drains due the floor to ceiling storage of barrels limiting our view.

Barrel storage

This does indicate it is a flooding area. As we discussed, the London water table level is forever changing and also our weather seems to have altered/become more intense than it used to be, tending to lead to more flooding. This together with changes in water courses/new roads/new houses/alterations to existing houses (iceberg houses), etc.

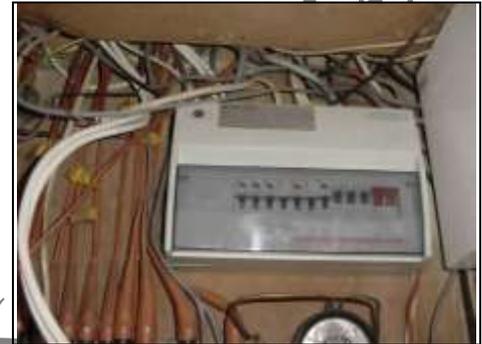
Fuseboard

Older fuseboard

The electrics failed our earth test and tripped the fuseboards so we do think there are problems. We also need to advise you of the following:

ACTION REQUIRED: Depending upon the extent of alterations you carry out we believe complete re-wiring is likely to be the best way forward.

We recommend an Institution of Engineering and Technology (IET) test and report to be carried out by an NICEIC registered and approved electrical contractor or equivalent.

ANTICIPATED COST: £250 - £500 (two hundred and fifty pounds to five hundred pounds) for an IET test plus any work recommended. For re-wiring expect costs in the region of £5,000 to £10,000 (five thousand pounds to ten thousand pounds). Please obtain quotations.

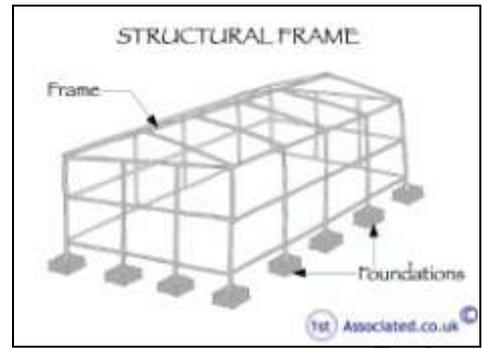
Structural frame sketch

As a further comment, we discussed the adding of a structural frame in the property so that alterations and extensions can be carried out to this building. You indicated this would be a solution that you would look at in the longer term and this may influence your decision and thoughts with regard to the structural movement.

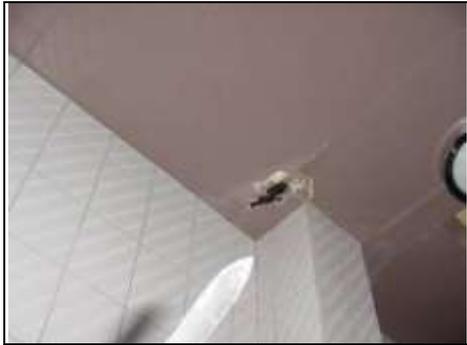
Dampness coming through from flat roof

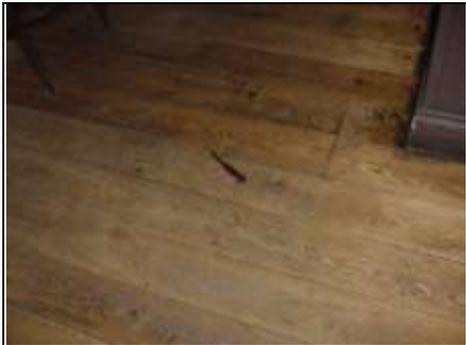
Undulations in floor by bar

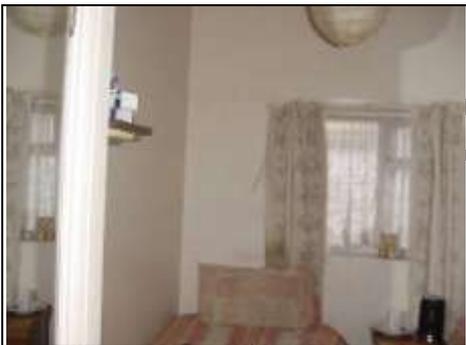
Room 1 – black mould
