SPECIFIC DEFECTS REPORT

Relating to Windows, Condensation and Black Mould

London

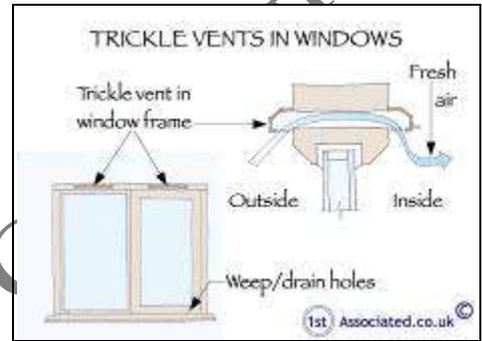
Trickle vents allow a trickle of air through, therefore stopping/reducing the likelihood of condensation occurring within the property.
