Example Survey Victorian Residential Building Survey

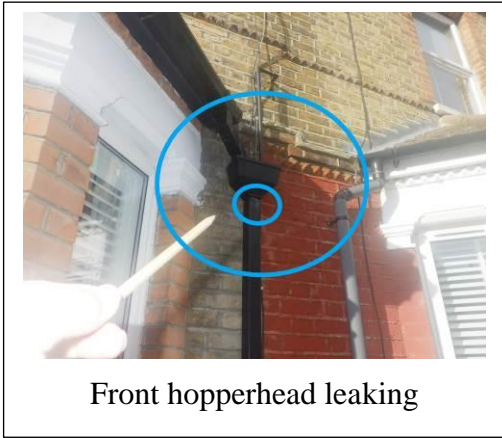
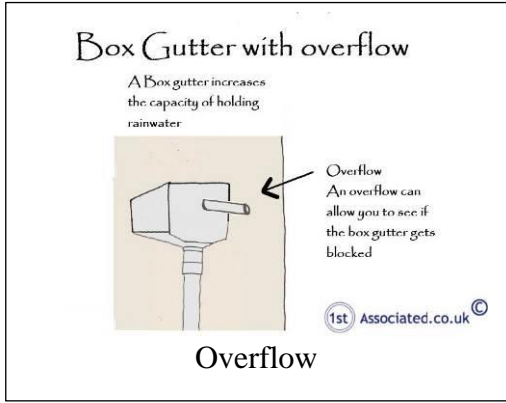
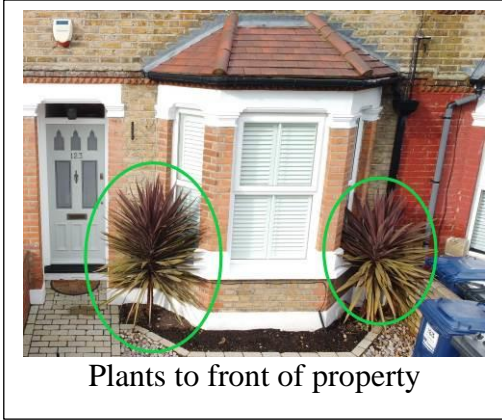
We found dampness to the front of the property which we believe relates to the downpipes and hopperheads leaking. It may be as simple as closing up the joint at the bottom of the hopperhead (small blue circle) or it may be that there is too much water going into the hopperhead and it blocks; we would recommend replacing with a larger hopperhead if this is the case.

We also noted that there are plants to the corner of the property highlighted in green. As much as we like plants it may reduce sunlight getting to the area and general air movement and won't allow the area to dry out.

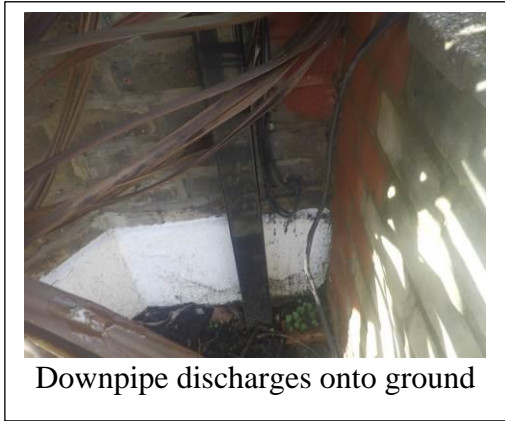
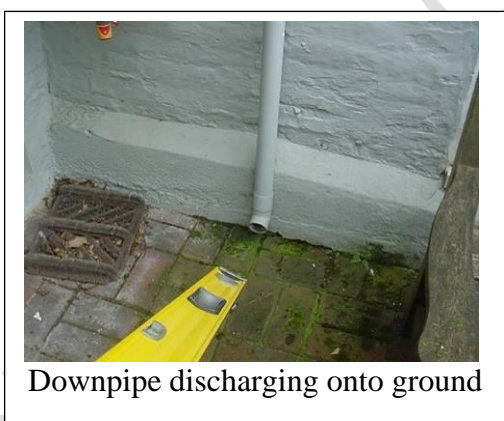
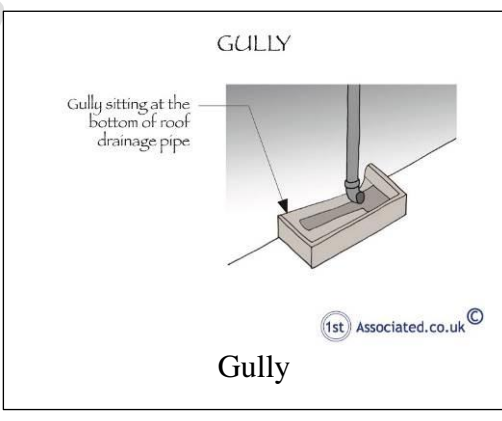
Finally, we would draw your attention to the downpipe and the gully which may be overflowing which generally could be sorted out with a better gully.

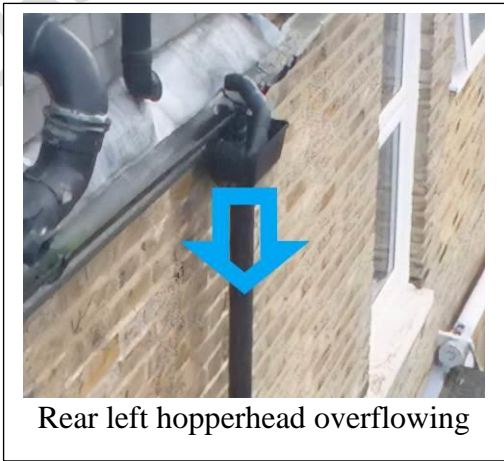
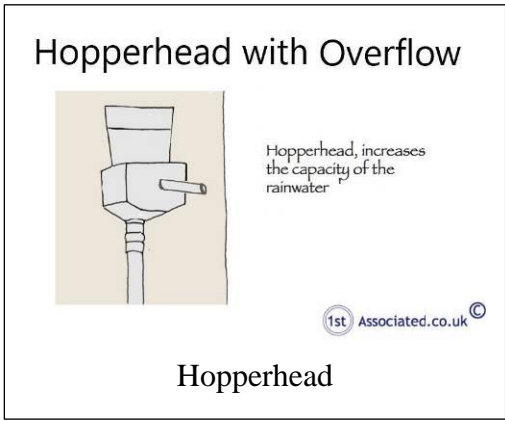
Rear dampness

The rear left hopperhead looks to be taking the water from the flat roof as well as from the rear roof of the property. Again, we think this may overflow.

We would recommend you stand outside the property next time it rains heavily and see how well the drains cope with the rainwater particularly looking at the hopperheads, guttering and the joints.

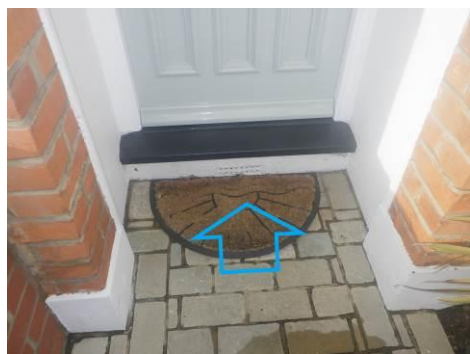
Front air vent acting as gutter

Unfortunately, whoever has carried out the paving to the front and rear has no understanding of older properties and how this type of property needs airflow underneath it.

ACTION REQUIRED: Normally we would recommend protecting the air vent however in this case in both instances we would recommend monitoring and if water is getting in we would recommend reducing the height of the ground / taking out the paving slabs to stop water getting in through the air vents.

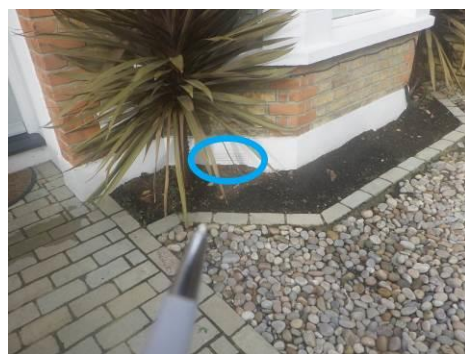
Front air vent

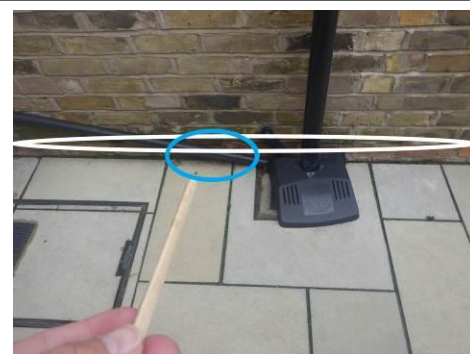
White – low damp proof course
Blue – Air vent

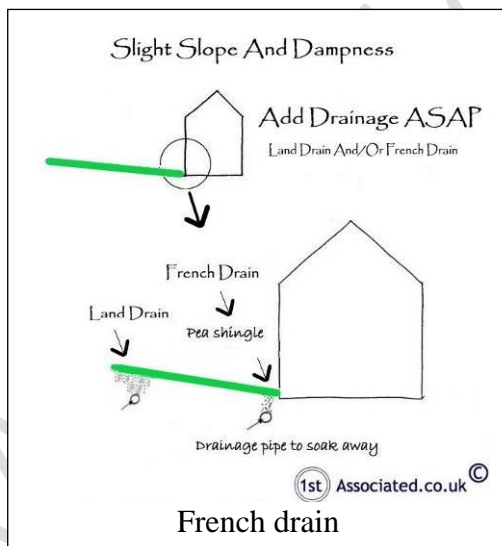
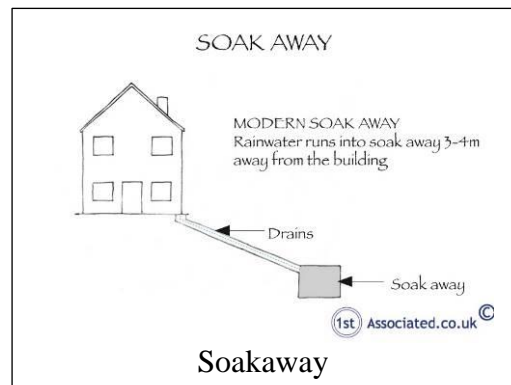
As already mentioned, there has been paving added to the rear which is quite popular however in this instance the paving looks to have been added on the existing ground level therefore reducing the height to the air vents and also to the damp proof membrane that we have already mentioned. It is very difficult to be certain on a dry day but it does look like the rear area is holding water and dampness is susceptible in this area and indeed we found dampness in our damp meter readings.

ACTION REQUIRED: The area needs to be monitored. If water is being held in this area then we would recommend a French drain and/or land drain diverts the water around the property and is discharged into a manhole (subject to obtaining approval) and/or a soakaway added (which will be additional cost).

ANTICIPATED COST: This work is likely to be costly and will involve removing quite a lot of the paving which is a shame however we cannot see any other way of doing it.

We would expect costs in the region of £5,000; please obtain quotations before legally committing to purchase the property.

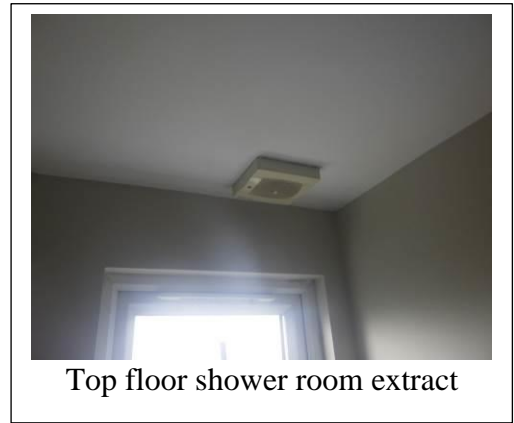
We noted an extract fan in the top floor shower room, we did not notice an extract fan within the kitchen.

ACTION REQUIRED: It is best to remove humidity as quickly as possible and therefore we would recommend upgrading extract fans to large good quality humidity controlled extract fans to the kitchen, bathrooms, shower room, plus any humidity generating areas:

By large extract fans we mean 150mm. There are also PIR (passive infra-red) fans available which sense movement in a room.

ANTICIPATED COST: We would anticipate costs between £250 - £500 per extract fan, depending upon the wiring required. We always recommend quotes are obtained before you legally commit to purchase the property.

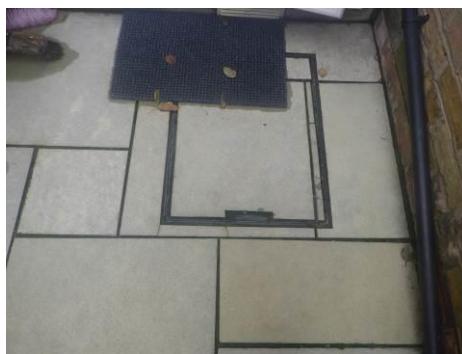
Rear manhole

ACTION REQUIRED: We would prefer to be on the safe side and recommend a closed circuit TV camera report of the drains.

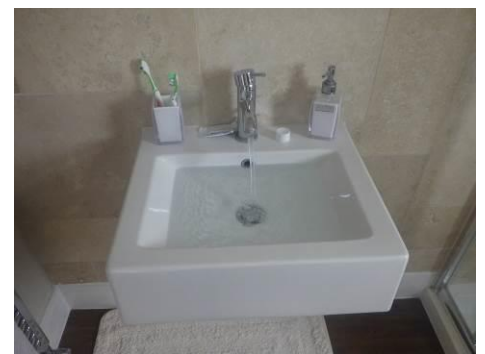
We ran the tap in the top floor shower room for fifteen minutes and found the water was slow to drain away however this could be due to the awkward external waste pipes that we sometimes have when properties have been extended like this.

Sink in top floor shower room slow to drain

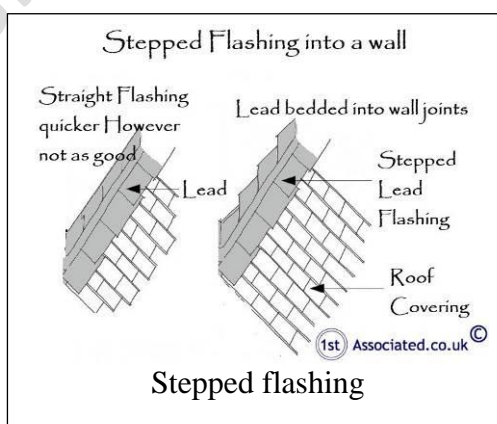
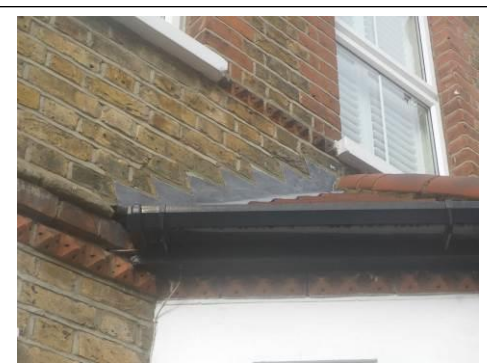
Front bay roof

This roof is pitched and clad with slate. It has a lead flashing where it meets the main wall. We would comment it is in average condition considering its age, type and style. We were pleased to see a stepped flashing which we consider better than a straight flashing.

Stepped flashing and cement

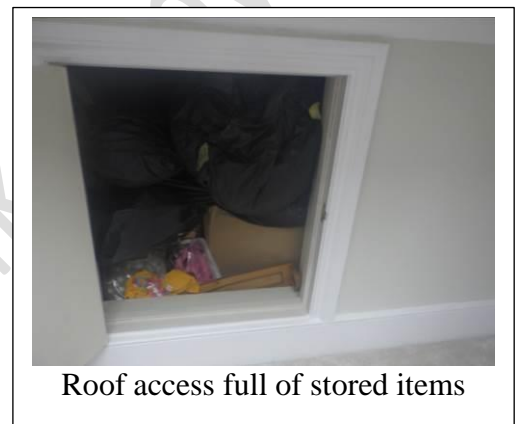
As rooms have been formed in the roof there is no roof access. There is a cupboard store area which was lined and we could not see the roof structure.

Roof access full of stored items

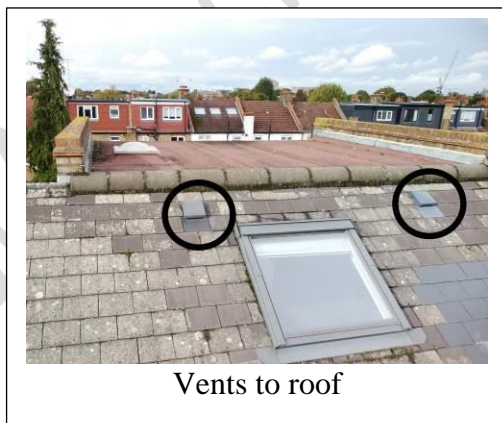
We noted mushroom vents on the roof.

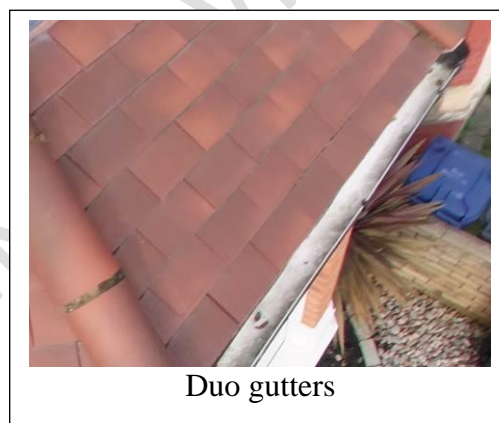
The property has plastic hopperheads, gutters and downpipes. Where we could inspect them properly they looked to be duo gutters which are modern gutters which are double lined and do not expand and contract as much as the older style black gutters.

There may be some minor leaks but most people would be happy to live with these providing repairs are carried out within the next three to six months.

ACTION REQUIRED: Please see the Executive Summary with regards to the downpipe problem to the front of the property.

We also recommend that the gutters and downpipes are cleaned out, the joints are checked and the alignment checked to ensure that the gutters fall towards the downpipes.

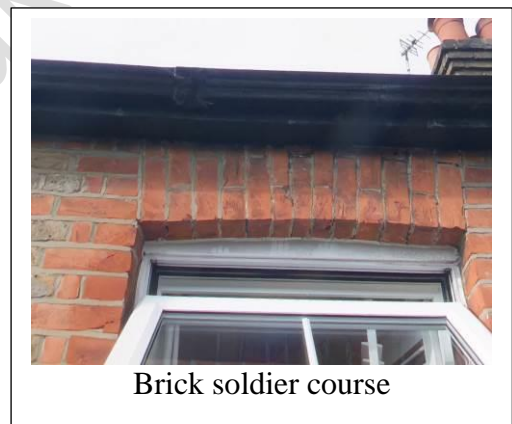
Brick soldier course

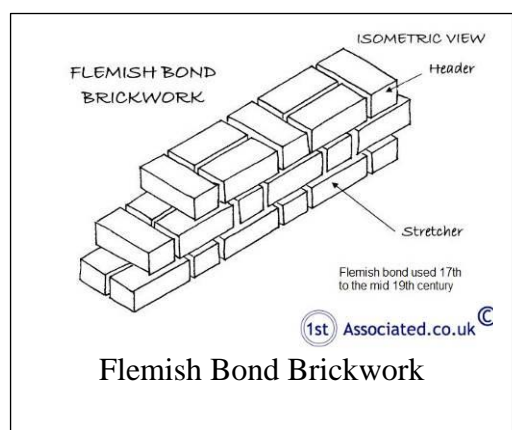
Flemish Bond Brickwork

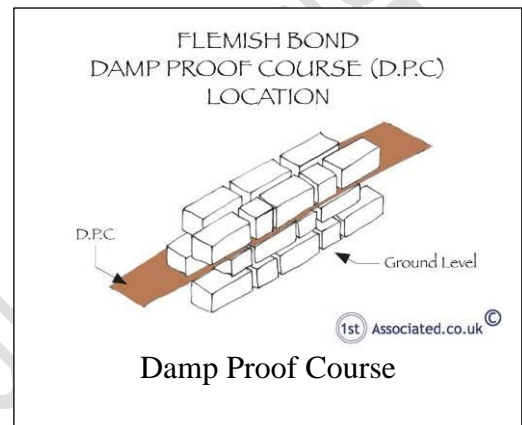
The property is likely to have a slate damp proof course as this was fairly standard in Victorian/Edwardian properties. In this case, the DPC is hidden by the plinth.

The DPC to the rear extension looks to be a felt. In this case the DPC is too low due to the height of the paving.

ACTION REQUIRED: Please see the Executive Summary.

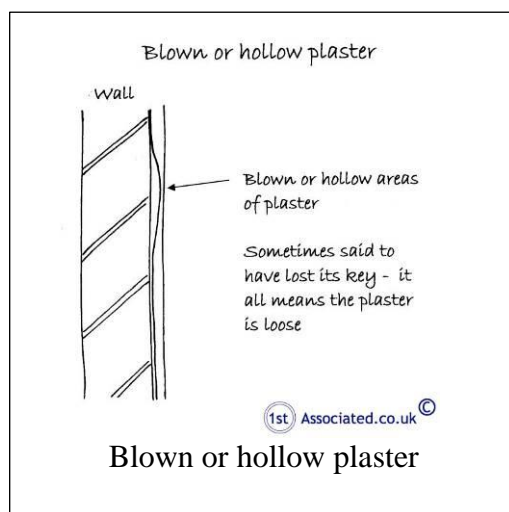
From tap testing to the staircase area we found some areas of blown plaster. It could be dry lining however we could also see some staining in this area.

When redecorating you may have to do some re-plastering.

ACTION REQUIRED: Please see our comments in the Executive Summary.

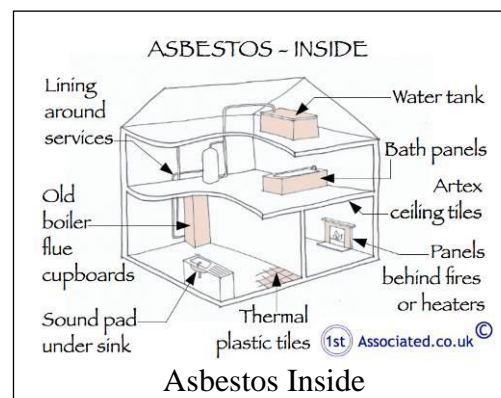
In a property of this age there may well be some asbestos. In this case, we have noted possible asbestos to the roof slates.

ACTION REQUIRED: Please see the Executive Summary.

If you wish to confirm you are one hundred percent free of asbestos you need to have an asbestos survey carried out.

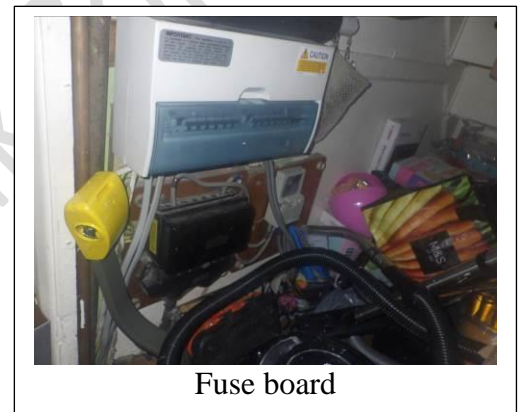
Fuse board

The fuse board is located under the stairs.

The fuse board looked from the 1980's/1990's and better are now available. We recommend it is replaced with a metal cased modern fuse board.

ACTION REQUIRED: We recommend a new fuse board with a fire resistant metal casing; please see the Executive Summary.

We recommend a test and report. We would also advise, as the property is changing occupancy, the Institution of Engineering and Technology (IET) also recommend a test and report and any recommendations should be carried out by a NICEIC registered, or equivalent, approved electrical contractor or similarly approved.

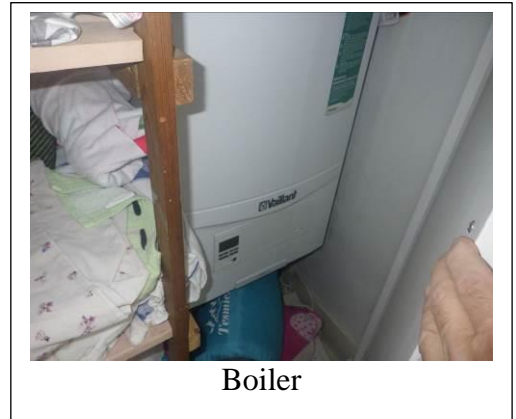
There is a wall mounted Vaillant boiler located in a cupboard in the front main bedroom, the owner advised the boiler was installed in XXX and last serviced on August XXX.

Our limited inspection of the hot water and central heating system revealed no evidence to suggest any serious defects but we would nevertheless recommend that the system be tested and overhauled before exchange of contracts and that a regular maintenance contract be placed with an approved heating engineer.

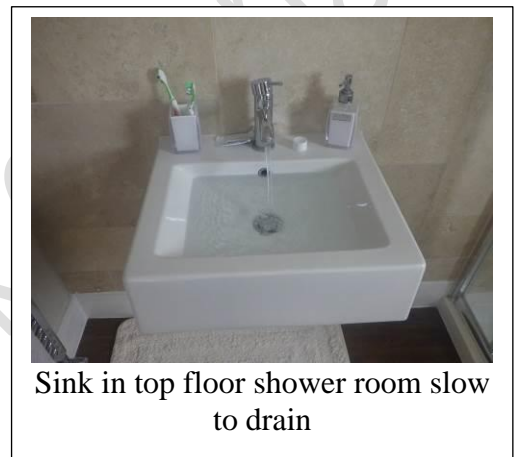
The cold taps have been run for approximately quarter of an hour in the top floor shower room and we found the water was slow to drain.

ACTION REQUIRED: Please see the Executive Summary.

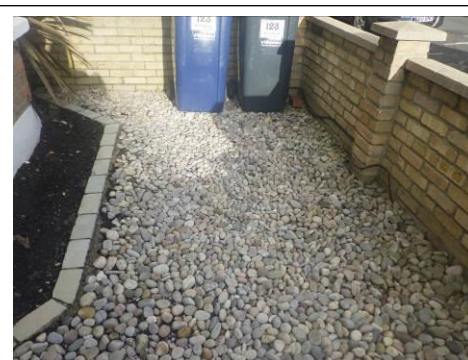
We were unable to find the front manhole, we are advised it is under the shingle.

Front manhole hidden under shingle
