Timber Frame Example Residential Building Survey

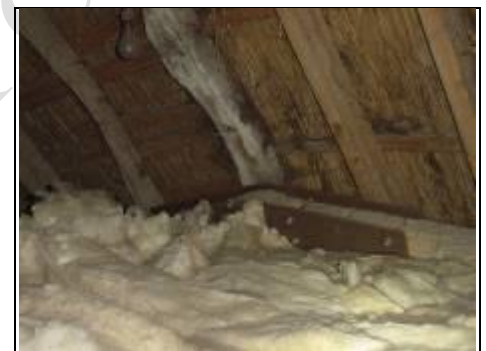
Brace at base of timber to left roof

We can also see metal brackets in some areas of the property. Specifically, we can see them in the left roof and we can also see them in the middle wall of the left hand room. These indicate there has been historic movement in this property. It is very difficult from a one off inspection to conclude whether it is still what is known as progressive.

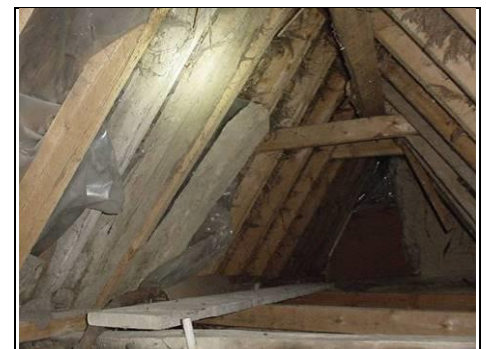
Mixture of new and older timbers to the centre roof

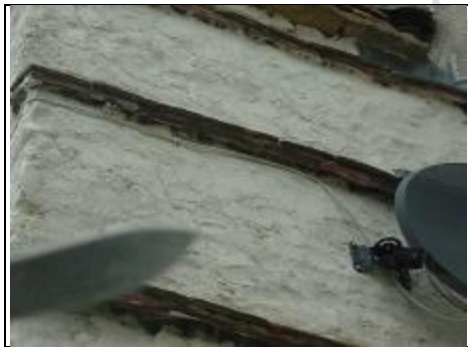
Over the years there have been many alterations, some of which we can see that the builders at the time did not understand the implications of what they were doing using modern materials on older buildings such as the cements that have been used as well as being against the legal requirements of a Listed building. We can also see some relatively recent work to the stone chimney with cement which again is not appropriate and will harm the building (see comments on lime every time within the Walls Section of this report).

Cement repairs on stone chimney

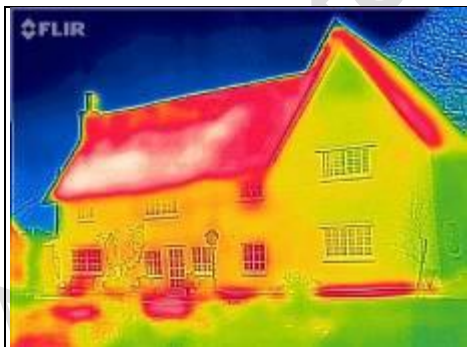
In addition to this we have also thermal imaged the property to see if this gives us any further clues and our evidence shows relatively low heat loss from the wall structure indicating that there is considerable replacement of the walls. Without opening up the walls we cannot confirm this but we do believe the thermal imaging information and the visual information in the roof give a good indication that over fifty percent of the walls have been replaced.

Heat coming out of floor, windows and roof to rear of property and little sign of the timber frame

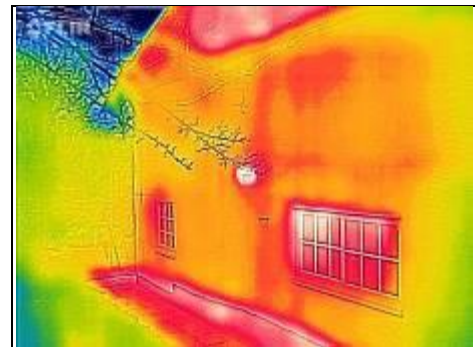
Thermal image indicates left side may be timber frame

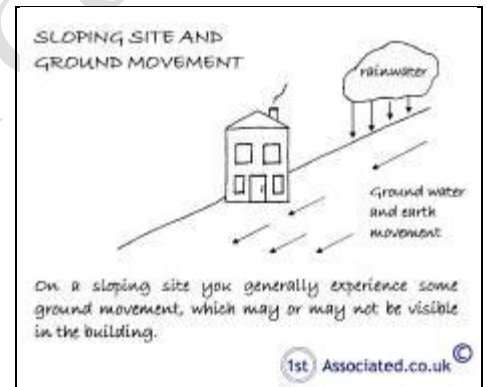
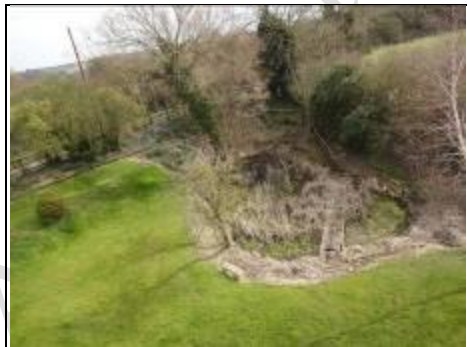
Historically this building has had a considerable amount of movement leaning from side to side. Also as it is on a sloping site it is integrally more unstable than the property on a level site.

Sloping site

Sloping site
~ Aerial View - 360 Photo ~

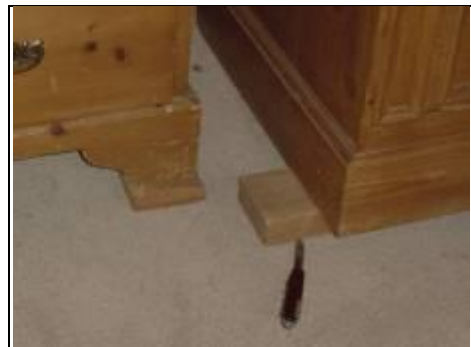
Furniture propped on uneven floors

When you are in the property you can see the extent of the slop on the property, in particular you can see that there has been a considerable amount of packing under the furniture.

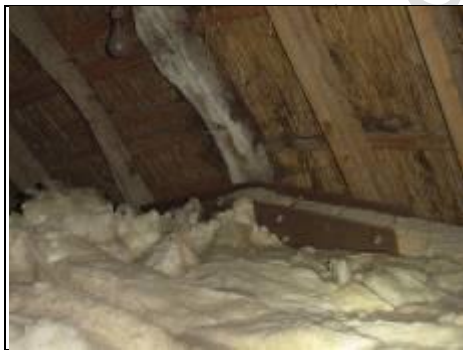
Brace at base of timber in left roof

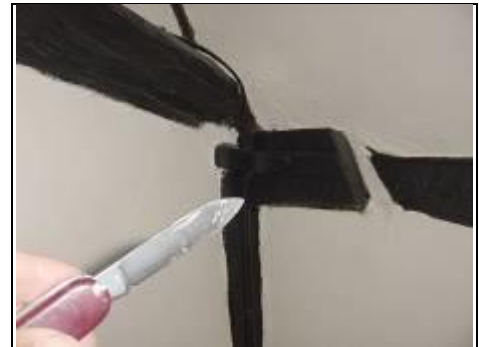
Brace added in middle wall on left side

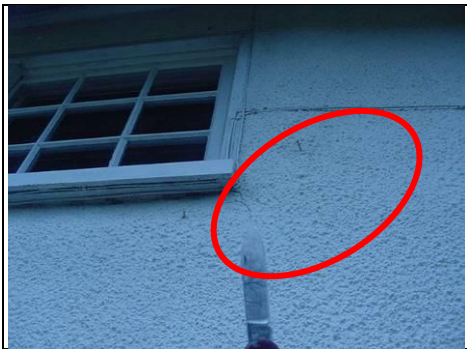
There is hairline cracking visible to some of the internal walls where the wall and ceiling joists meet and there is also hairline cracking to the gable end of the property. You do have to remember that the whole of this property has been repainted in the last few years hiding any usual indications. Again, these cracks are indicating sideways movement left to right.

Cracking to the window

ACTION REQUIRED: Ideally we would recommend the existing owners take out an insurance claim, advising that the cracking has been noted by a structural surveyor (this should cost them nothing other than time to write the letter). This usually means that the insurance company will carry out a monitoring exercise (the Building Research Establishment recommend monitoring any cracks for a minimum of one year) to establish if there is any progressive movement. Your future liability will be limited to the cost of the excess on the insurance providing the insurance company is happy for you to take over the insurance claim.

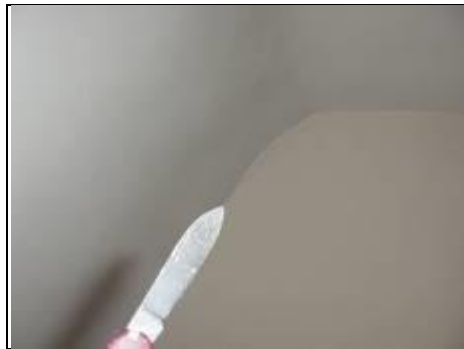
Hairline cracking in master
bedroom

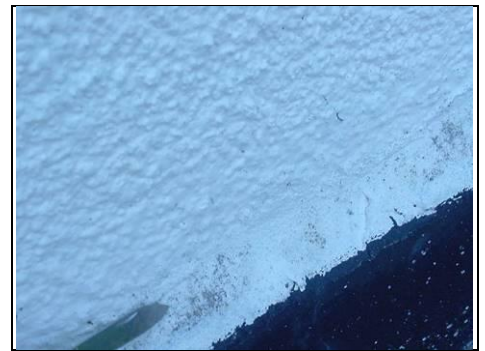
Moss visible

ACTION REQUIRED: Ideally as mentioned we would like to open up a section of the render just to see what it is made of. We would also be able to see what is behind it. We would be looking for opening up to be on the left hand side of the property.

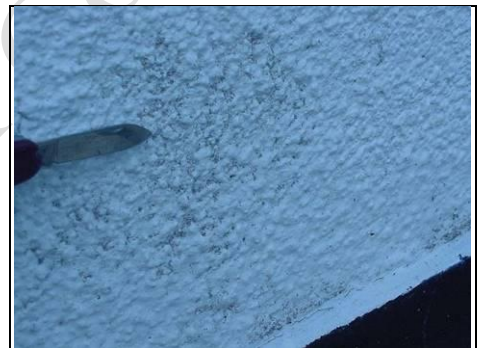
Moss showing through painted render

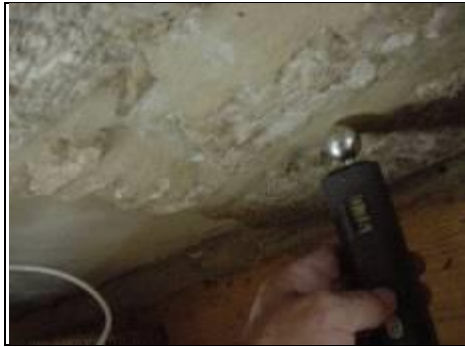
In various areas we found dampness coming in through the stonework for example and we can also see sulphate where there is orange/brownish staining where the soot is being drawn through.

Testing for dampness in fireplace stonework

ACTION REQUIRED: We would recommend the adding of a French drain around the property. Currently there are paving slabs around the property which unfortunately discharge water against the building.

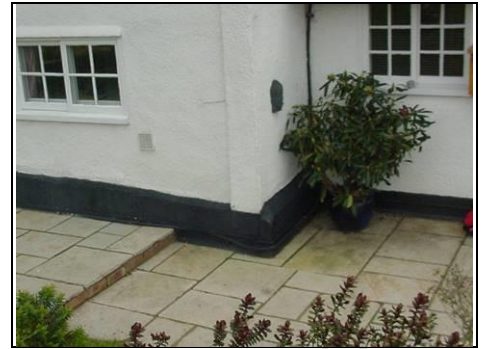
Paving around property

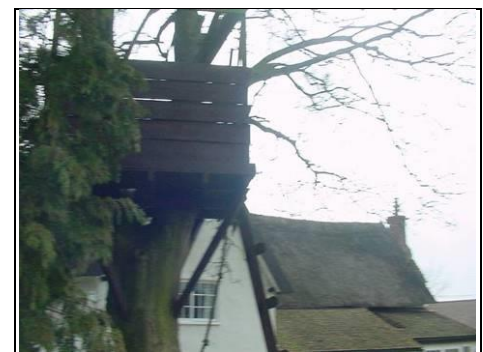
There is a tree in close proximity to the house. It does not look to have been maintained for many years, when we spoke to the owner he advised us that he had had advice with regard to the tree but in the end decided to do it himself.

A large tree close to the property

ACTION REQUIRED: Advice from an arboriculturalist (not a tree surgeon) is asked to view the property and give a ten-year plan for maintenance.

ANTICIPATED COST: £250 - £500, plus the cost of the work; please obtain quotations.

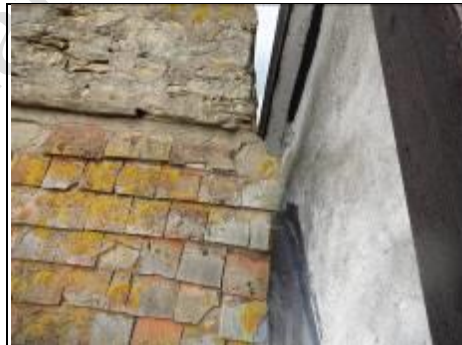
This chimney is a predominantly stone built chimney which has been finished in brick and has one chimney pot. There are tiles running down the side of the property in various stages, where it meets the main building there is a lead flashing. The problems were there is dampness getting in between the chimney and the main building into the stonework which forms the gable.

Gap between chimney and main building

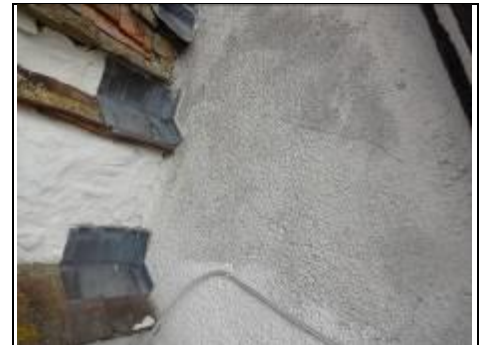
Mastic on lead to right gable

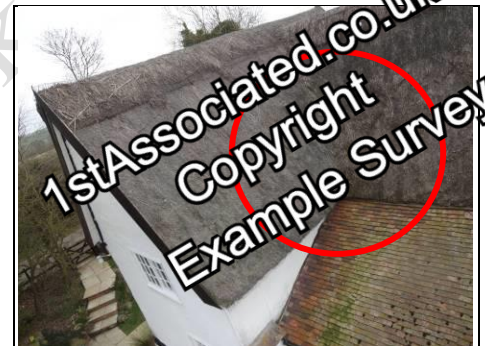
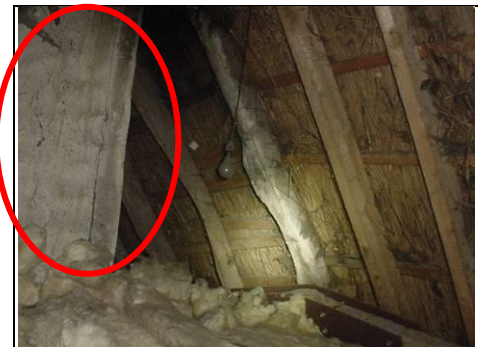
When we went partly into the left roof we were able to see what once may have been a chimney or a smoke hood which interestingly in years gone by were made out of timber. It is very difficult to confirm. It seems a logical place for a chimney to be however we have to add that we have had a very limited view.

Hidden chimney

Hidden chimney/smoke hood

ACTION REQUIRED: Further investigation required. As a general comment in an older property such as this all rooms would have originally been heated with a coal fire.

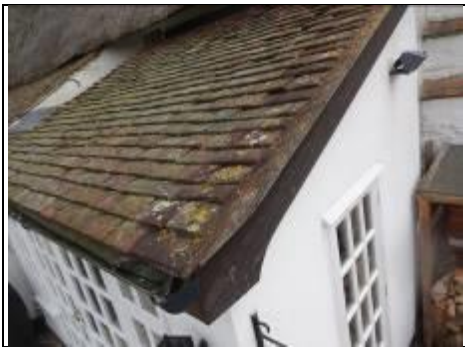
The property has a relatively shallow roof and as such water can sit on it and we noted that the tiles are starting to spall. We would recommend that work is carried out in this area.

Spalling to tiles

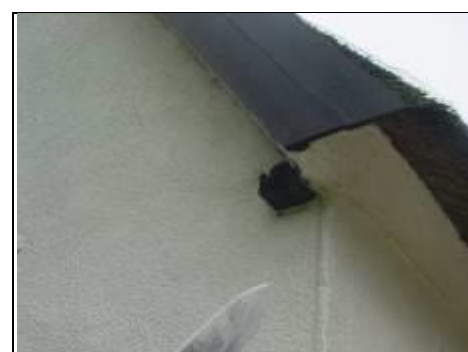
Purlins can be seen protruding out of walls which can lead to rotting

Further investigation is needed as we can see that metal brackets have been used to the left hand side roof and also in the walls structure below.

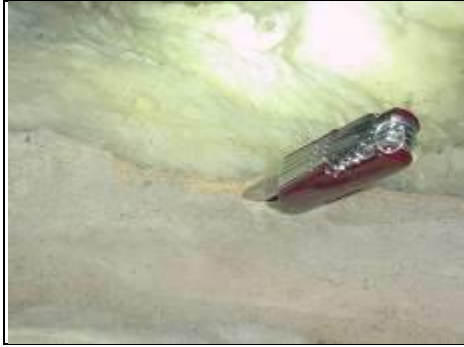
Unfortunately, the environment with insulation being added can improve the woodworm and encourage to breath from what we understand. There is a fair amount of insulation in the roof; all of this will have to be removed to properly view the roof to assess the damage to the timbers. We do feel that some of it is what we would term as a structurally significant in nature although there is of course woodworm in the roof that is not structurally significant. We found woodworm to the centre roof and we believe it also to the left roof.

Woodworm/rot in timer in middle roof where it meets left roof

ANTICIPATED COST: We would recommend setting aside £2,500 - £7,500. The reason why the figure is relatively large is we do think there is a likelihood that there are problems with the roof structure. There is an element of estimation on what we are commenting on as we have not had access to the left side of the roof, we would be able to comment further if direct access to the left side of the roof was formed and if insulation was removed. We do feel we have to warn and advise about the worst case scenario; please obtain quotations.

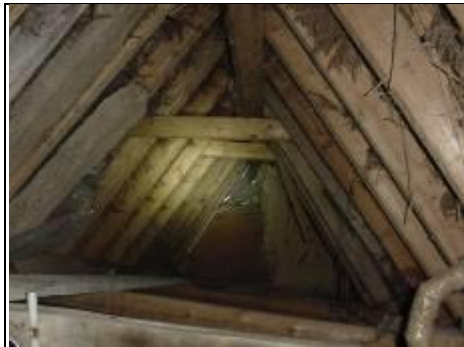
Most of timbers replaced in main part of roof

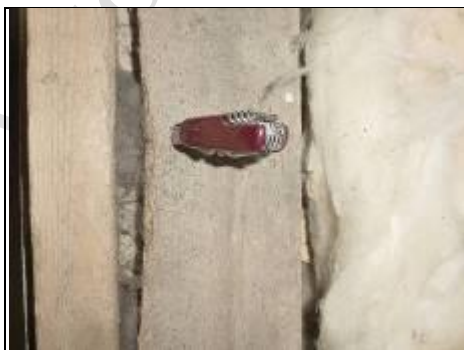
Woodworm

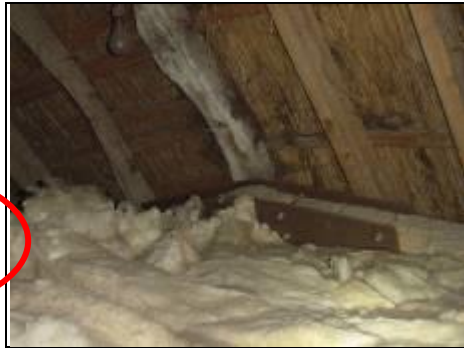
Brace at base of timber

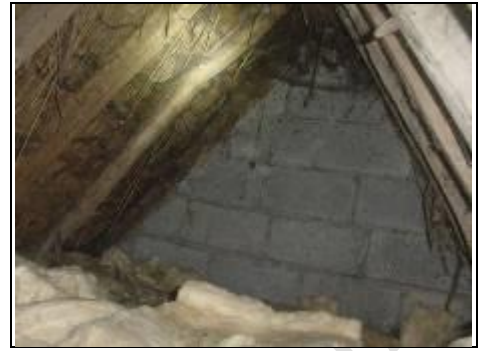
Stonework or blockwork?

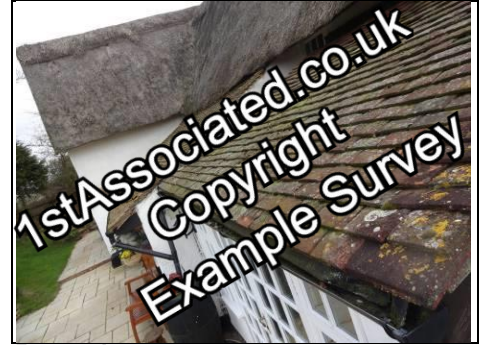
There are no gutters and downpipes to the thatch, they are only present to the tiled area which are plastic gutters and downpipes. Our concern always with gutters and downpipes on older properties is that they may be discharging into the ground nearby and causing dampness as traditionally they discharged on the ground.

Gutters and downpipes to tiled roof

ACTION REQUIRED: We would recommend you stand outside the property next time it rains heavily and see how well the drains cope with the rainwater particularly looking at the guttering and the joints and where they discharge onto the ground.

We also recommend that the gutters and downpipes are cleaned out, the joints are checked and the alignment checked to ensure that the gutters fall towards the downpipes.

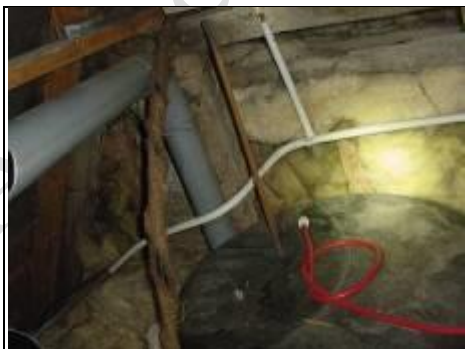
The property has a plastic cast iron soil and vent pipe.

Soil and vent pipe

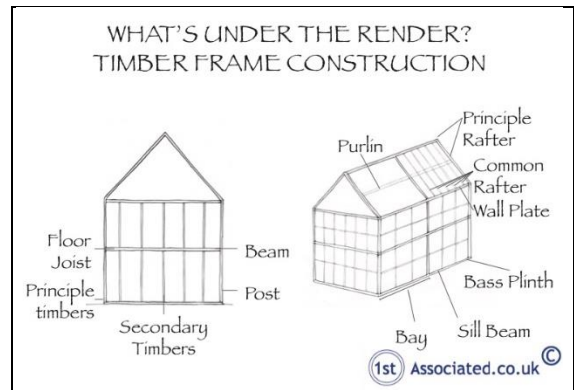
What is under the render?

From the hollowness when we carried out our tap test to the centre of the property we do believe the majority of this is timber framed however to the left side of the property we are not completely sure of the construction particularly as within the roof we have seen what looks like stonework or blockwork (we could not physically get into this roof as we were not happy that the timbers would take our weight particularly bearing in mind the metal bracing that we could see and there was no direct access into it). However, we will first of all assume that the property is timber framed and discuss this.

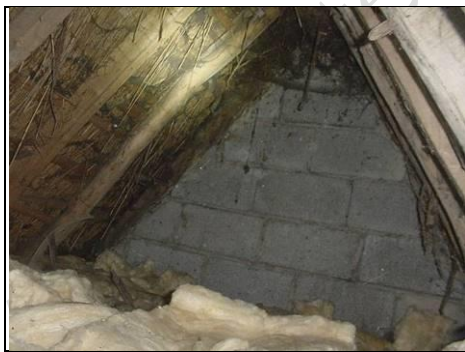
Stonework or blockwork?

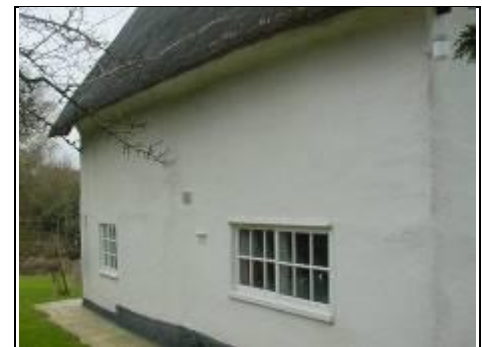
The external walls are finished in what looks to be a mixture of modern cement painted based render and also lime based render.

We are always wary when we see rendered properties as the render can hide a lot particularly in this case where we believe alterations have taken place.

Render

We have carried out a tap test (literally hitting the render with the back of a hammer). We found it to be in average condition with some hollow areas but not what we would term as excessive.

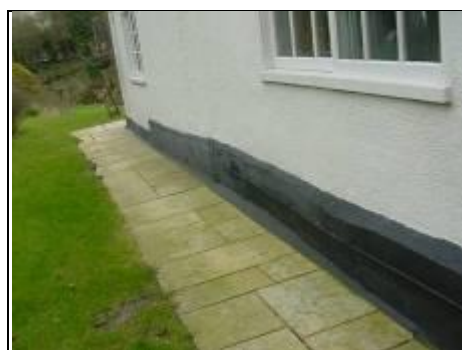
Stone or brick base

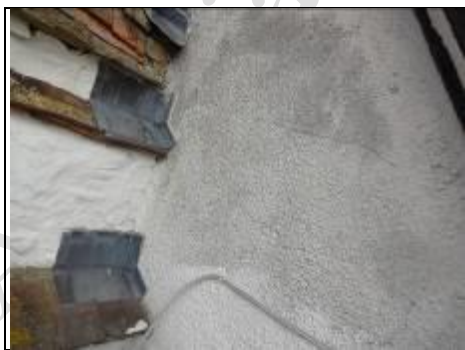
Hairline cracking to right gable
~ Aerial View - 360 Photo ~

We would remind you that any hairline cracks that appear need to be sealed as soon as possible to stop dampness and water getting in.

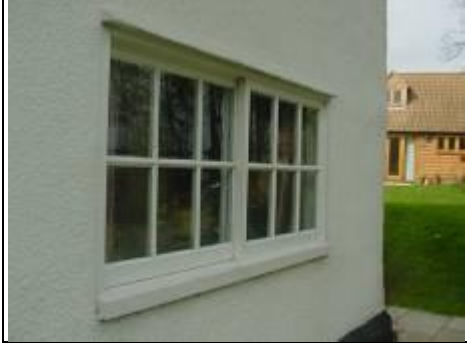
The property has timber single glazed windows with secondary glazing, many are horizontal sliding sash otherwise known as York windows. We noted rot to one of the windows.

York windows

ACTION REQUIRED: General repairs and easing and adjusting of the windows and doors.

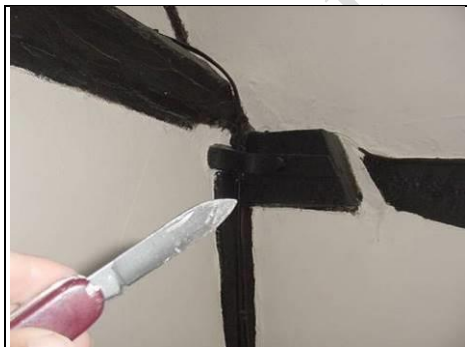
Infill panel with metal brace

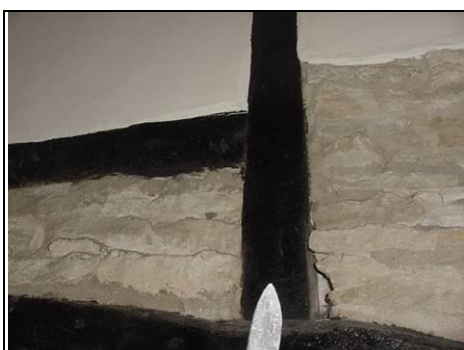
Infill panels and stonework

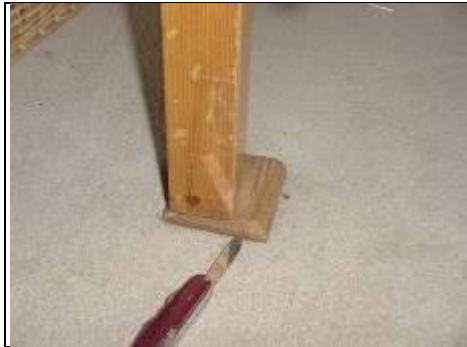
Floor undulating

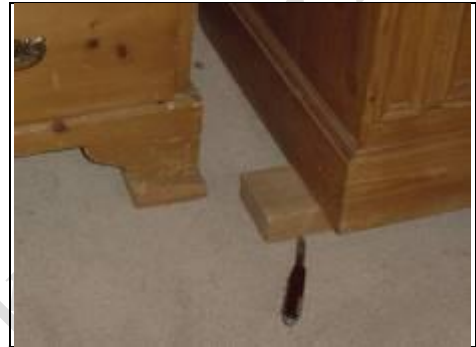
Floors undulating

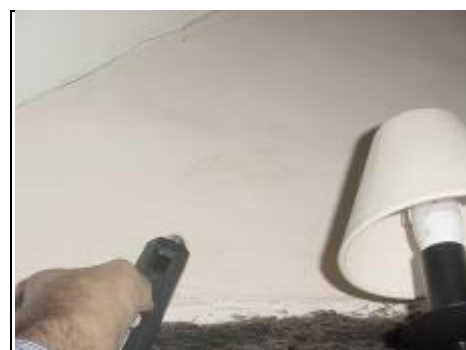
Dampness coming through plaster in right bedroom

ACTION REQUIRED: Please see our comments in the Executive Summary.

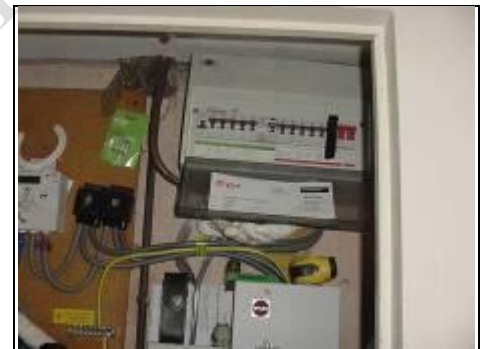
Fuse Board

The electric fuses and consumer units were located in a cupboard off the entrance hall. The fuse board looked to be a 1980's - 1990's style. In an older property a defective fuse board can be particularly dangerous.

ACTION REQUIRED: As the property is changing occupancy an Institution of Engineering and Technology (IET) test and report and any recommendations should be carried out by a NICEIC registered, or equivalent, approved electrical contractor or similarly approved.

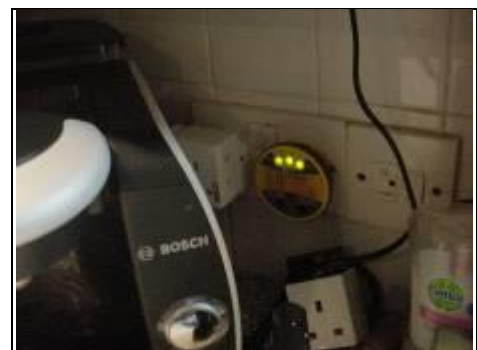
Earth test

We carried out an earth test in the kitchen area to the socket point that is normally used for the kettle, this proved satisfactory.

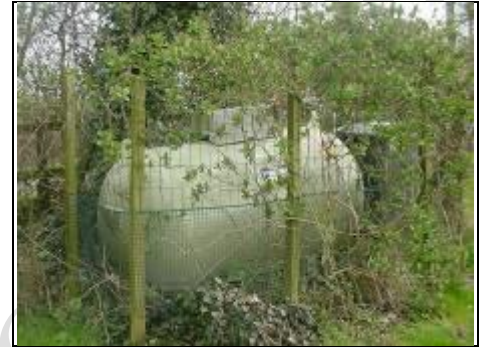
Propane gas

The property has propane gas. There are wood burners as well; we are not sure whether these are multi-burners or not.

ACTION REQUIRED: As a matter of course it is recommended that the entire gas installation is inspected and made good, as necessary, by a Gas Safe registered contractor. Thereafter the installation should be serviced annually.

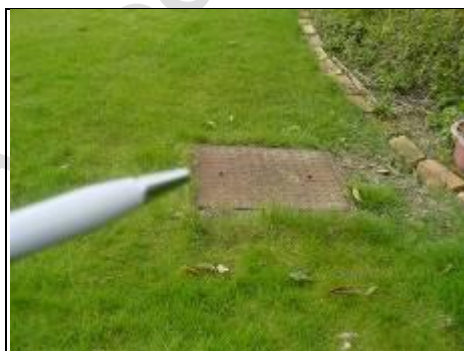
We duly lifted the cover and found it to be free flowing at the time of our inspection. From what we could see it is concrete built.

Manhole adjacent to garage

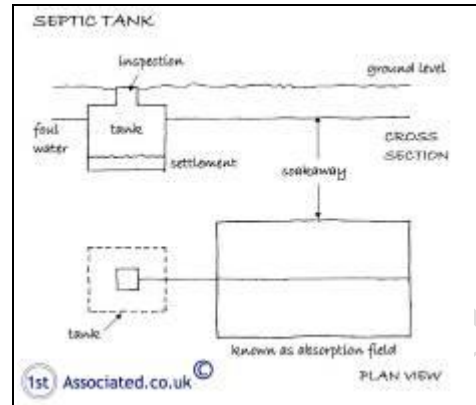
Septic tank

The property is on a septic tank.

We have been unable to determine the adequacy of treatment or the effectiveness of the disposal arrangements. The surface water discharges onto the ground.

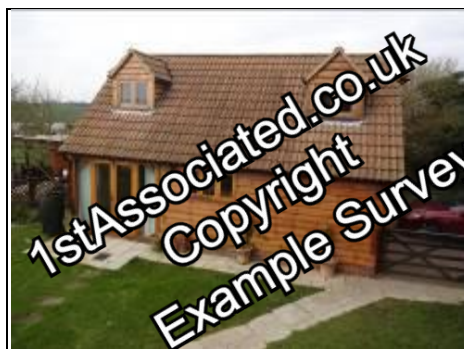
It was noted that the windows to the garage would benefit from re-staining.

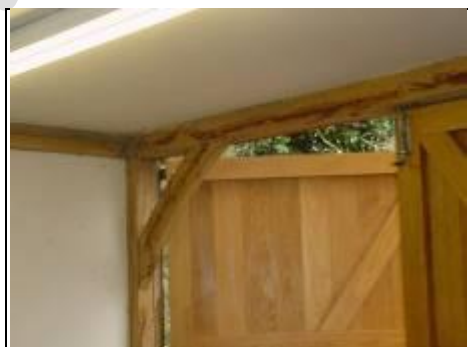
Dampness coming into garage

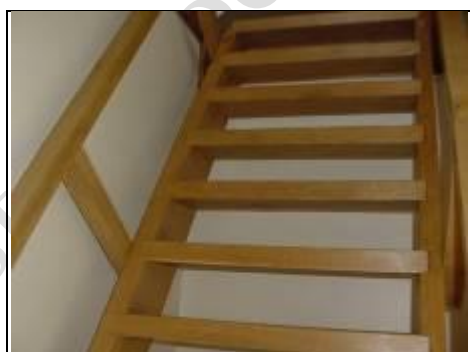
Steep steps
