Example Survey Victorian Residential Building Survey

GENERAL INTRODUCTION

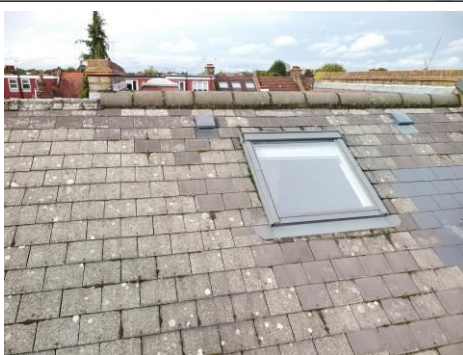
The main pitched roof is clad with manmade slate in a mixture of older and newer slates. The older slates look like they may have an element of asbestos.

Asbestos roof slates ?

ACTION REQUIRED: The only way to be one hundred percent certain with regards to asbestos in a property is to have an asbestos report with samples taken and the recommended action carried out.

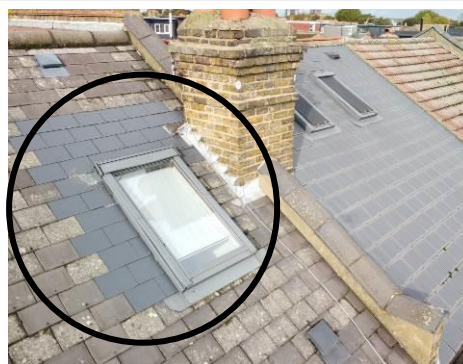
Mixture of old and new slates

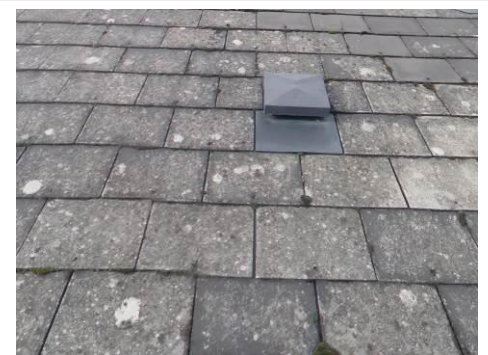
Slates may have asbestos content

We would advise we are not asbestos surveyors and would recommend asbestos surveyors are instructed and that you have your own asbestos survey carried out. We cannot be certain but would comment they are a white coloured slate which are generally manmade and the older slates had an asbestos content although it can be relatively small.

We would always recommend any asbestos is removed from a property as it can not only be dangerous, it can affect the value of the property.

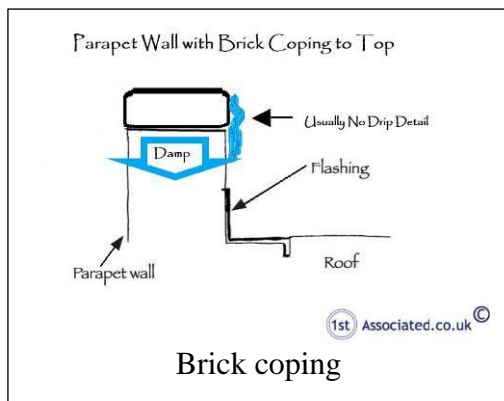
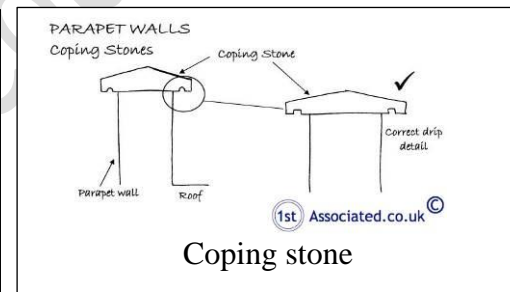
There seems to be leaks to the parapet walls, both left and right side, and also to the roof window which has a felt flashing which is not ideal, we much prefer to see lead. The left parapet wall and the roof window are highlighted in blue.

ACTION REQUIRED: Ultimately the only way to stop dampness is to cap the parapet wall or you could put a coping stone on them after removing the top course of brickwork.

ANTICIPATED COST: All of these are quite costly and for a capping or new coping stone we would expect costs in the region of £5,000 - £10,000 plus access scaffolding or access via the roof window that we discuss below; please obtain quotations before you legally commit to purchase the property.

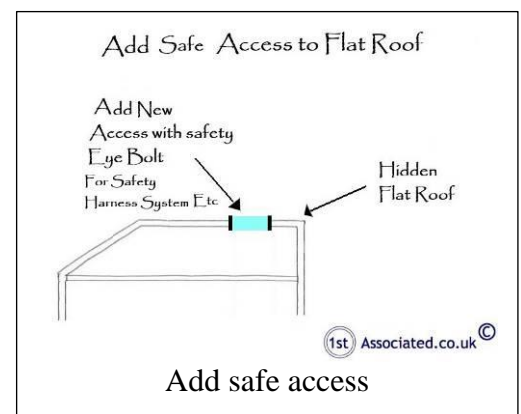
Difficulty of accessing the hidden flat roof

The property has had a loft extension, part of which has included adding a hidden flat roof which is not unusual. However, in this particular case, there is no easy way to access the hidden flat roof as far as we can see (unless we are mistaken and the owners can prove otherwise). The roof window does not open and there is no safety bolt for a harness line or similar to allow safe access on the roof which would mean expensive scaffolding would be the only way to access the roof.

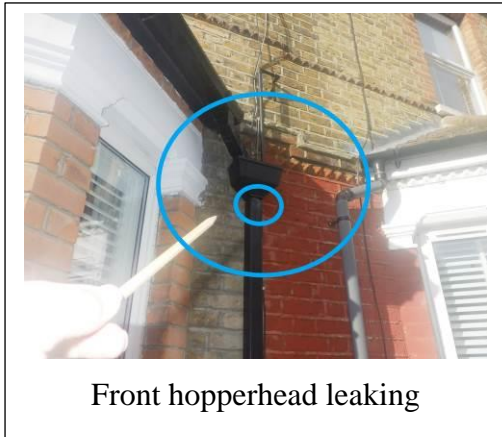
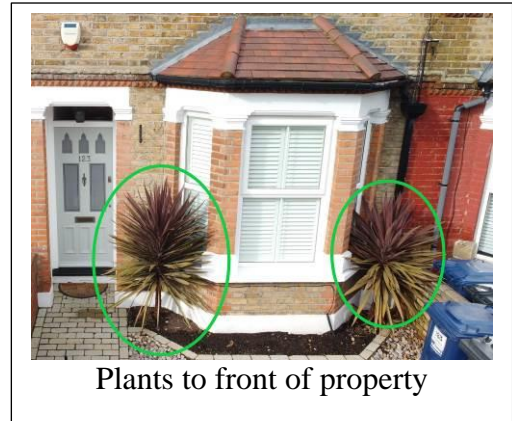
We found dampness to the front of the property which we believe relates to the downpipes and hopperheads leaking. It may be as simple as closing up the joint at the bottom of the hopperhead (small blue circle) or it may be that there is too much water going into the hopperhead and it blocks; we would recommend replacing with a larger hopperhead if this is the case.

We also noted that there are plants to the corner of the property highlighted in green. As much as we like plants it may reduce sunlight getting to the area and general air movement and won't allow the area to dry out.

We would recommend you stand outside the property next time it rains heavily and see how well the drains cope with the rainwater particularly looking at the hopperheads, guttering and the joints.

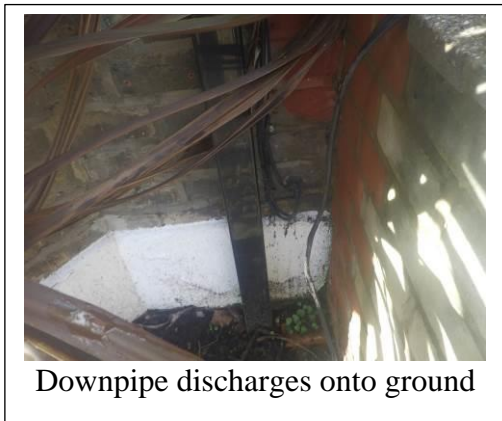
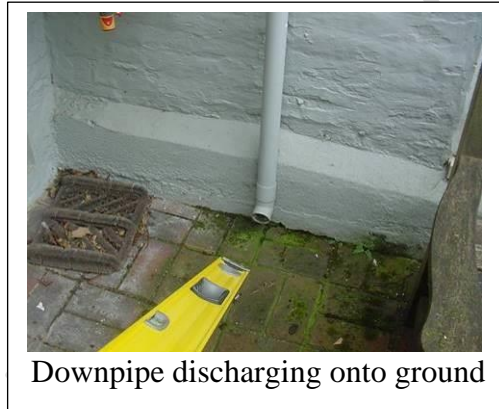
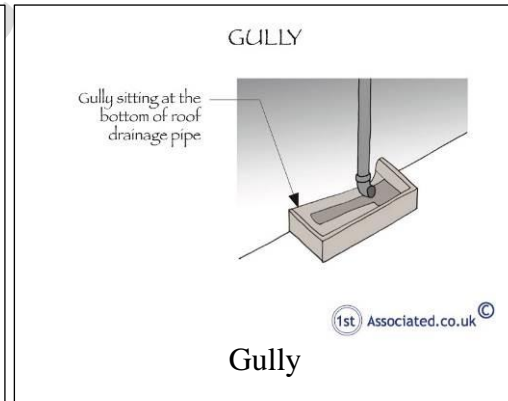
Rear dampness

Finally, we would draw your attention to the downpipe and the gully which may be overflowing which generally could be sorted out with a better gully.

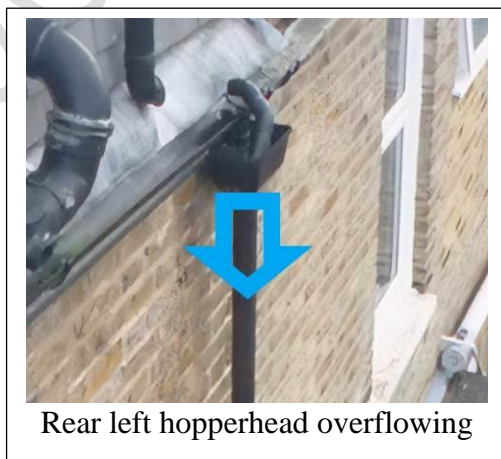
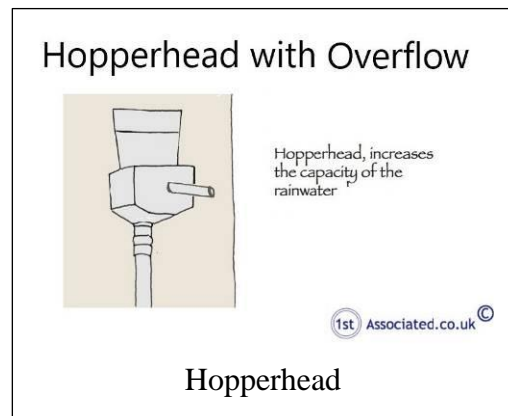
The rear left hopperhead looks to be taking the water from the flat roof as well as from the rear roof of the property. Again, we think this may overflow.

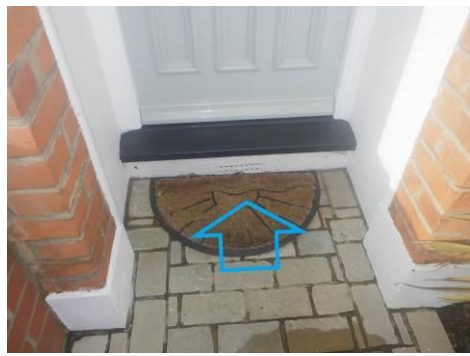
Front air vent acting as gutter

Unfortunately, whoever has carried out the paving to the front and rear has no understanding of older properties and how this type of property needs airflow underneath it.

ACTION REQUIRED: Normally we would recommend protecting the air vent however in this case in both instances we would recommend monitoring and if water is getting in we would recommend reducing the height of the ground / taking out the paving slabs to stop water getting in through the air vents.

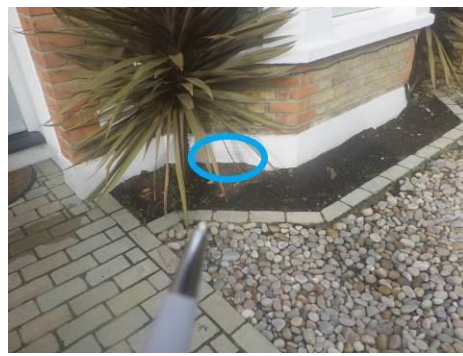
Front air vent

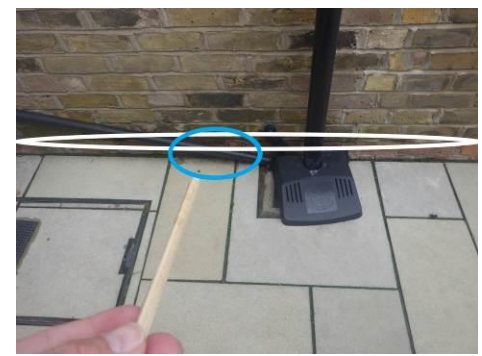
White – low damp proof course
Blue – Air vent

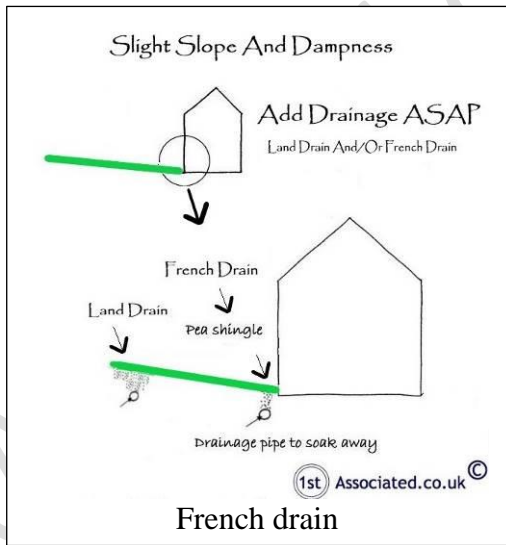
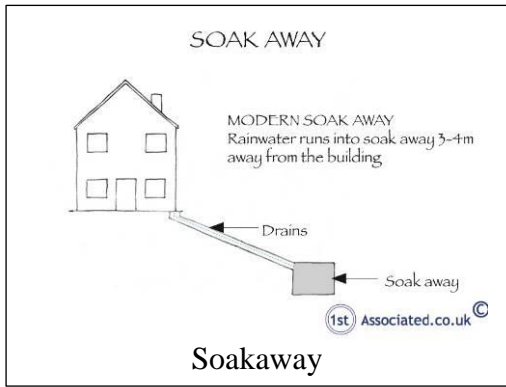
As already mentioned, there has been paving added to the rear which is quite popular however in this instance the paving looks to have been added on the existing ground level therefore reducing the height to the air vents and also to the damp proof membrane that we have already mentioned. It is very difficult to be certain on a dry day but it does look like the rear area is holding water and dampness is susceptible in this area and indeed we found dampness in our damp meter readings.

ACTION REQUIRED: The area needs to be monitored. If water is being held in this area then we would recommend a French drain and/or land drain diverts the water around the property and is discharged into a manhole (subject to obtaining approval) and/or a soakaway added (which will be additional cost).

ANTICIPATED COST: This work is likely to be costly and will involve removing quite a lot of the paving which is a shame however we cannot see any other way of doing it.

We would expect costs in the region of £5,000; please obtain quotations before legally committing to purchase the property.

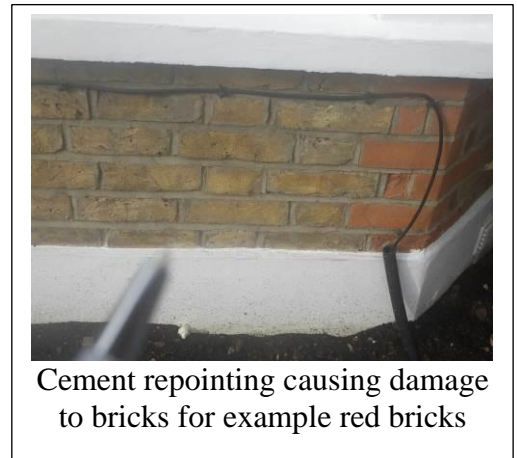
We would draw your attention to the cement mortar re-pointing that has been carried out on the exterior of the property that we feel is not appropriate to this building. Originally, it would have been built with a lime-based mortar which allows the building to breathe.

Cement re-pointing causes deterioration to brickwork and does lead to the face of the bricks deteriorating known as spalling and also leads to dampness and cracking.

ACTION REQUIRED: Find the oldest/most experienced bricklayer/mason you can who is skilled in using lime mortar and ask them to work on your property ideally during warmer days. A programme of work then needs to be carried out on replacing cement re-pointing with lime. This building needs to be able to breathe again.

ANTICIPATED COST: To repoint to approximately one metre high, which is how we would start, we would expect costs in the region of £2,500 to £5,000. To carry out the remainder of the property we would expect costs treble to quadruple this amount as scaffolding would be required.

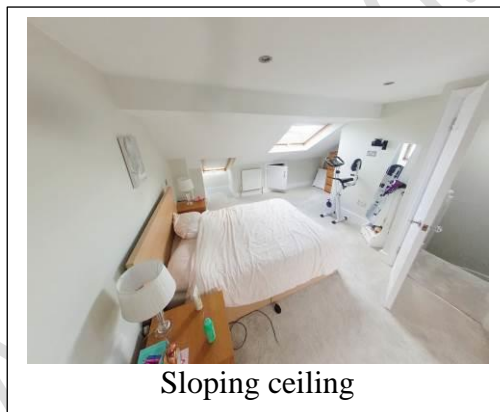
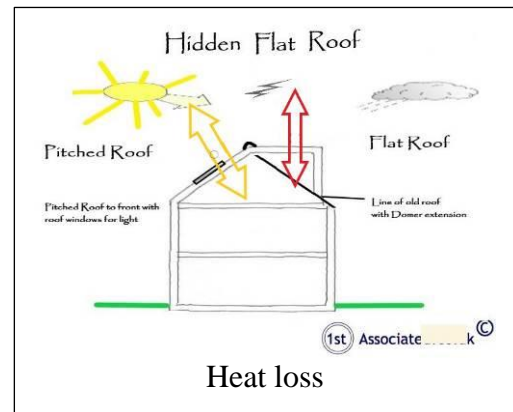
9.0) Heat gain and heat loss within the roof extension

We have not been able to open up the ceilings however we can see that the ceilings have been formed partly in the flat roof and partly in the pitched roof. We have been unable to establish how much insulation is in these however we can say from our experience that where bedrooms are formed in the roof they can during the hot weather have some heat gain unless they are very well insulated and equally in the colder weather will have heat loss.

ACTION REQUIRED: You need to be aware of this and consider this a characteristic of this property. We can advise you further if we are provided with drawings and photographs with regard to what work was carried out or if we are allowed to open up the structure.

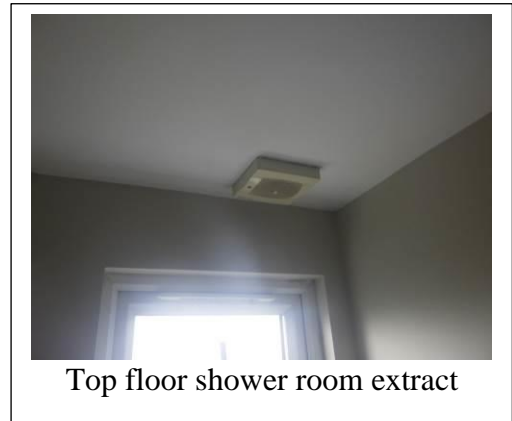
We noted an extract fan in the top floor shower room, we did not notice an extract fan within the kitchen.

ACTION REQUIRED: It is best to remove humidity as quickly as possible and therefore we would recommend upgrading extract fans to large good quality humidity controlled extract fans to the kitchen, bathrooms, shower room, plus any humidity generating areas:

By large extract fans we mean 150mm. There are also PIR (passive infra-red) fans available which sense movement in a room.

ANTICIPATED COST: We would anticipate costs between £250 - £500 per extract fan, depending upon the wiring required. We always recommend quotes are obtained before you legally commit to purchase the property.

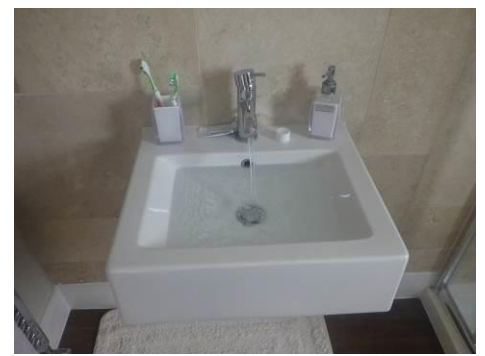
We ran the tap in the top floor shower room for fifteen minutes and found the water was slow to drain away however this could be due to the awkward external waste pipes that we sometimes have when properties have been extended like this.

Sink in top floor shower room slow to drain

ACTION REQUIRED: We would prefer to be on the safe side and recommend a closed circuit TV camera report of the drains.

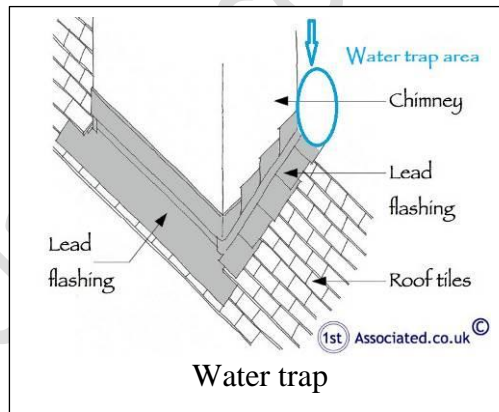
This chimney is brick finished with a lead flashing and four chimney pots. From what we could see from ground level it looked in below average condition considering its age, type and style. There is a water trap behind the chimney which looks to have been repaired previously. Also, the flashing looks like it may be coming away.

Water trap

We would expect costs in the region of a few hundred pounds if work can be carried out via a ladder and crawler boards assuming the problem is as simple as repairing the flashing; please obtain quotations before you legally commit to purchase the property.

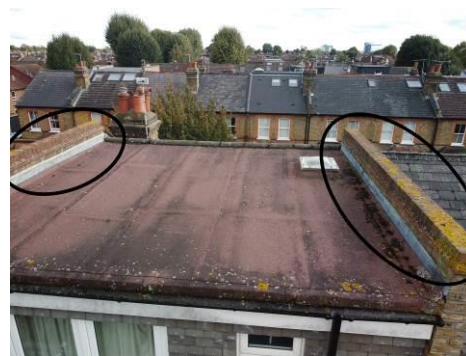
The flat roof parapet walls are built from brick with a visible lead flashing and a coping stone of brick which does allow dampness in over time. We would comment that generally they are in average condition considering their age, type and style with the exception of the rear left parapet wall which we believe is leaking.

Parapet walls to rear high level flat roof

ACTION REQUIRED: Ultimately, the brick parapet walls may require a capping on the top of them. Please see the Executive Summary.

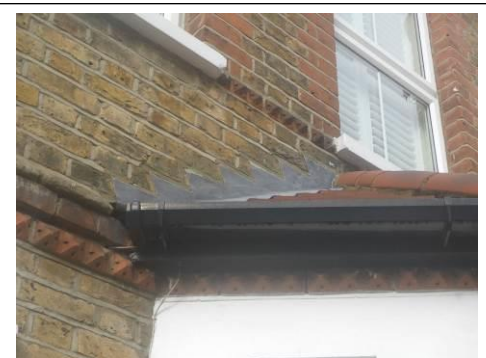
Stepped flashing and cement

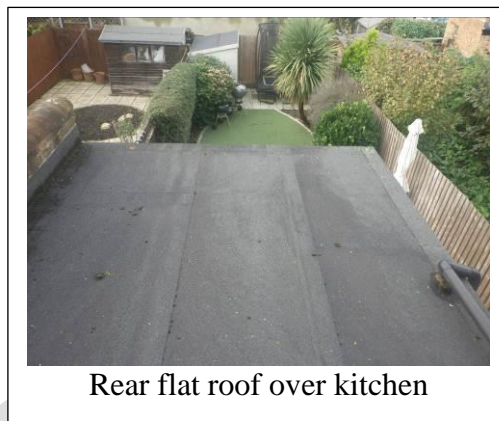
REAR LEFT FLAT ROOF OVER KITCHEN

The flat roof is located to the rear left and is covered with mineral felt. We would comment it is in average condition for its age, type and style.

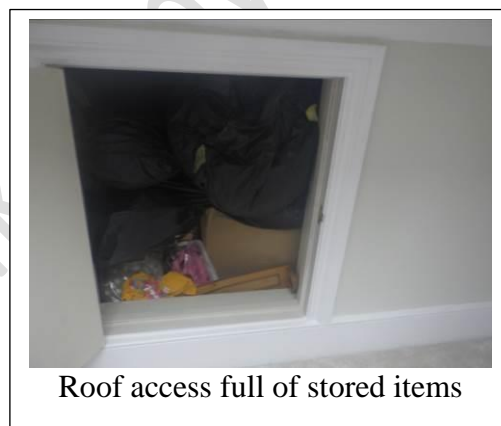
As rooms have been formed in the roof there is no roof access. There is a cupboard store area which was lined and we could not see the roof structure.

Roof access full of stored items

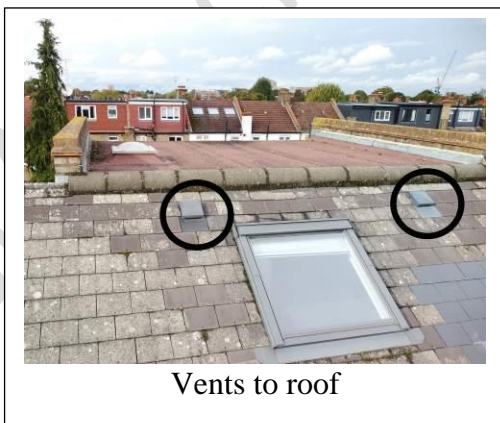
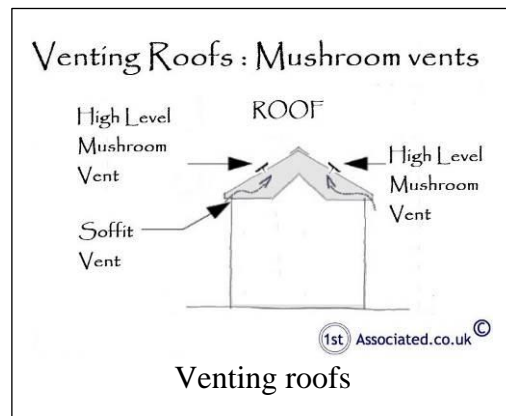
VENTILATION

We noted mushroom vents on the roof.

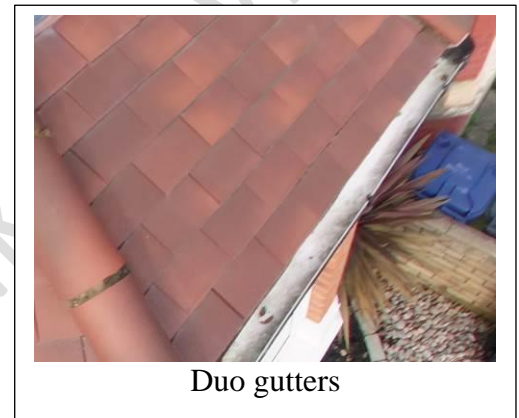
The property has plastic hopperheads, gutters and downpipes. Where we could inspect them properly they looked to be duo gutters which are modern gutters which are double lined and do not expand and contract as much as the older style black gutters.

There may be some minor leaks but most people would be happy to live with these providing repairs are carried out within the next three to six months.

ACTION REQUIRED: Please see the Executive Summary with regards to the downpipe problem to the front of the property.

We would recommend you stand outside the property next time it rains heavily and see how well the drains cope with the rainwater particularly looking at the guttering and the joints.

We also recommend that the gutters and downpipes are cleaned out, the joints are checked and the alignment checked to ensure that the gutters fall towards the downpipes.

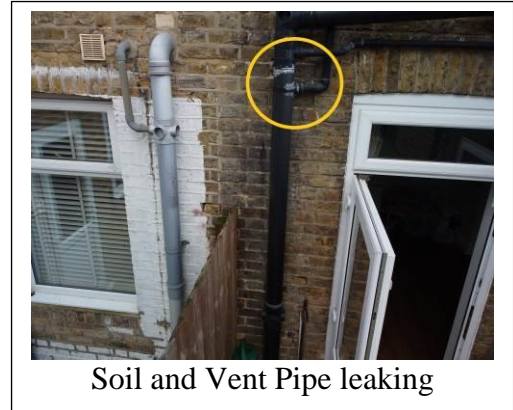
The property has a mixture of plastic and cast iron soil and vent pipes. The majority of the soil and vent pipes are cast iron and they look to have some minor leaks.

The cast iron may be saveable but it may be more economical to replace, we always recommend trying to save if at all possible. In our experience, cast iron soil and vent pipes last longer than plastic providing they are regularly maintained by this we mean redecorated and any cracks repaired.

ACTION REQUIRED: Your legal advisor to specifically ask the owners about leaks that have occurred to the soil and vent pipes.

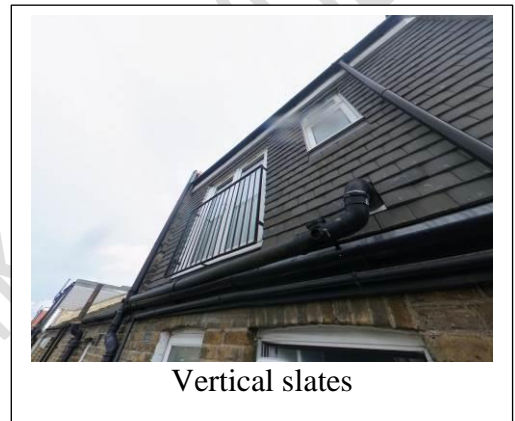
The property has vertical slates which we believe are in average condition for its age, type and style.

ACTION REQUIRED: We recommend you ask the owner for details of the way the cladding has been installed and/or open up a section of the wall.

Your Legal Advisor to check and confirm when the cladding was installed, which contractor carried out the work and if there is any form of guarantee.

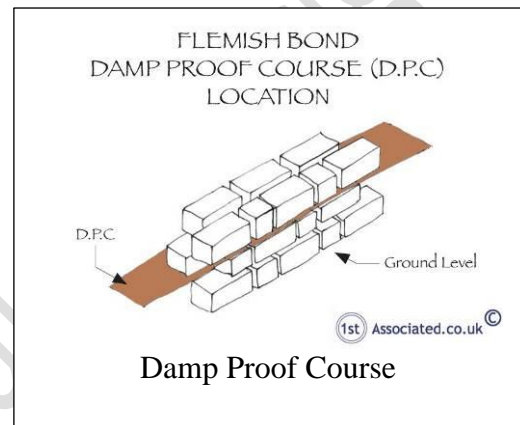
The property is likely to have a slate damp proof course as this was fairly standard in Victorian/Edwardian properties. In this case, the DPC is hidden by the plinth.

The DPC to the rear extension looks to be a felt. In this case the DPC is too low due to the height of the paving.

ACTION REQUIRED: Please see the Executive Summary.

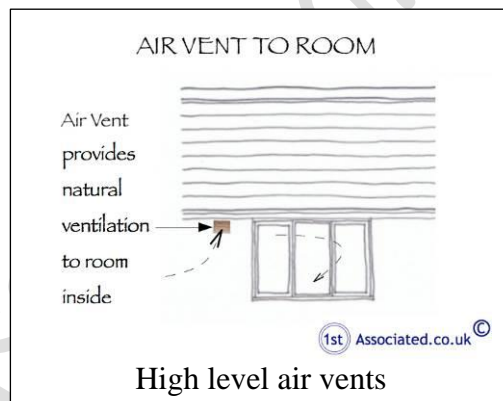
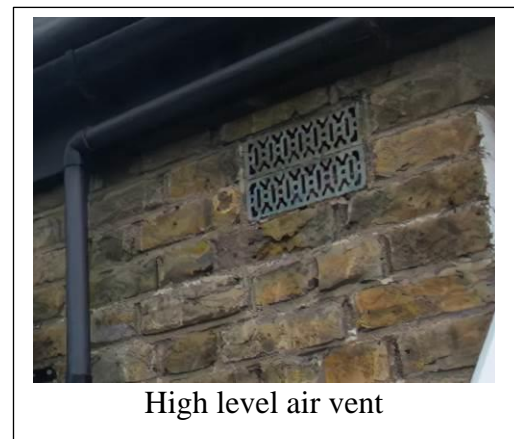
HIGH LEVEL AIR VENTS

High level air vents are to help air circulation within the property. In this case, there are vents at high level.

ACTION REQUIRED: Ensure the air vents are clear.

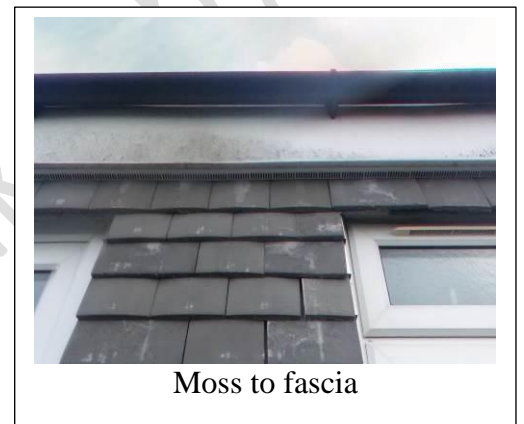
The fascias and soffits are plastic. We would comment they are in below average condition for their age, type and style with moss staining.

ACTION REQUIRED: Clean and ensure the vents are clear.

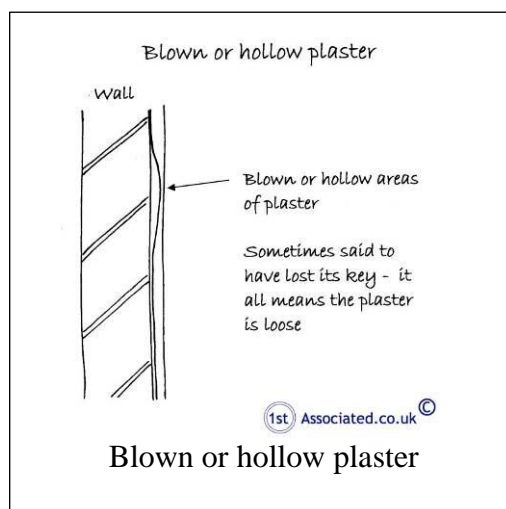
From tap testing to the staircase area we found some areas of blown plaster. It could be dry lining however we could also see some staining in this area.

When redecorating you may have to do some re-plastering.

ACTION REQUIRED: Please see our comments in the Executive Summary.

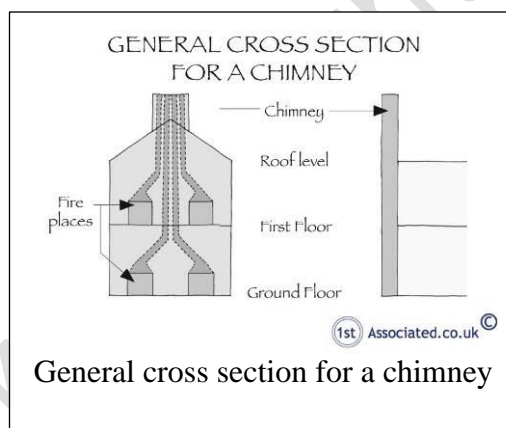
At the time of the survey no chimneys were in use. Any chimneys that you do not propose to use should be capped and ventilated to prevent dampness.

We believe that there may have been some rear chimneys removed.

ACTION REQUIRED: If you do intend to use the fireplaces then we recommend a chimney sweep checks the lining and that the chimney/s are clear and open up the chimney pots if required.

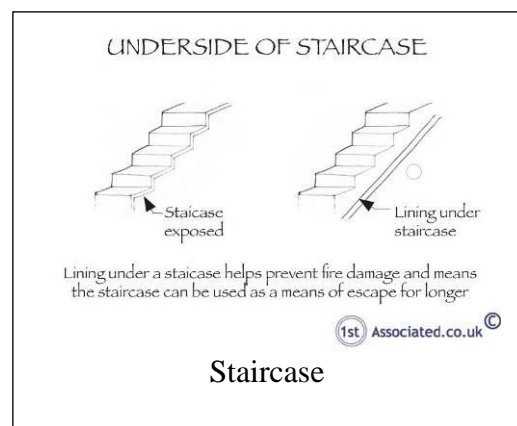
STAIRCASE

We noted that the underside of the staircase was exposed. It is more normal today to have a half hour fire barrier to stop fire spreading from the ground floor to the first floor in a worse case scenario. You may wish to take a view on whether you add this.

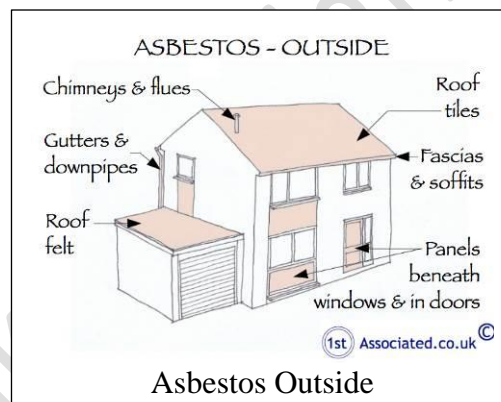
In a property of this age there may well be some asbestos. In this case, we have noted possible asbestos to the roof slates.

We are Building Surveyors and not Asbestos Surveyors and as such the only way to be a hundred per cent certain with regards to Asbestos in a property is to have an Asbestos report carried out.

ACTION REQUIRED: Please see the Executive Summary.

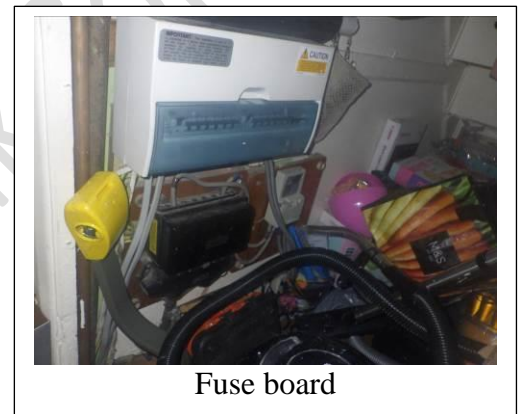
The fuse board is located under the stairs.

The fuse board looked from the 1980's/1990's and better are now available. We recommend it is replaced with a metal cased modern fuse board.

Fuse board

ACTION REQUIRED: We recommend a new fuse board with a fire resistant metal casing; please see the Executive Summary.

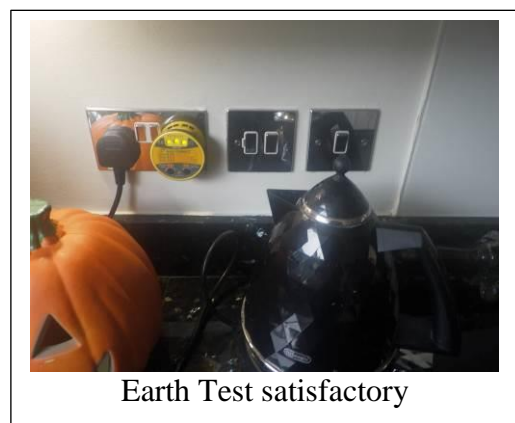
We carried out an earth test in the kitchen area to the socket point that is normally used for the kettle; this proved satisfactory.

Earth Test satisfactory

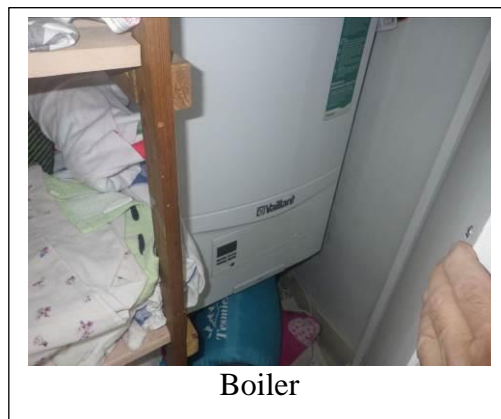
There is a wall mounted Vaillant boiler located in a cupboard in the front main bedroom, the owner advised the boiler was installed in ???Date and last serviced in ???Date.

Our limited inspection of the hot water and central heating system revealed no evidence to suggest any serious defects but we would nevertheless recommend that the system be tested and overhauled before exchange of contracts and that a regular maintenance contract be placed with an approved heating engineer.

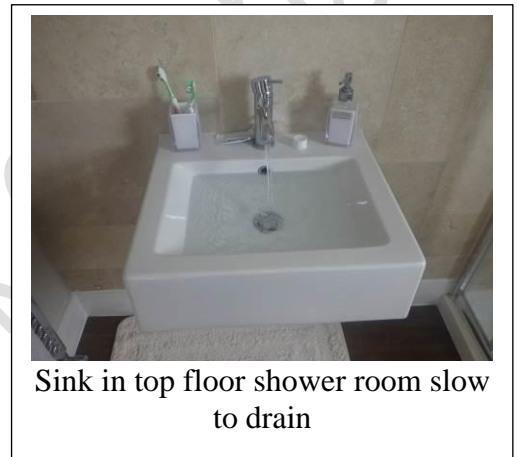
The cold taps have been run for approximately quarter of an hour in the top floor shower room and we found the water was slow to drain.

ACTION REQUIRED: Please see the Executive Summary.

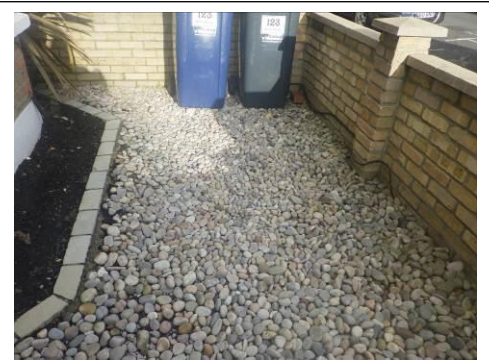
INSPECTION CHAMBER/ MANHOLE ONE- LOCATED TO THE FRONT

We were unable to find the front manhole, we are advised it is under the shingle.

Front manhole hidden under shingle

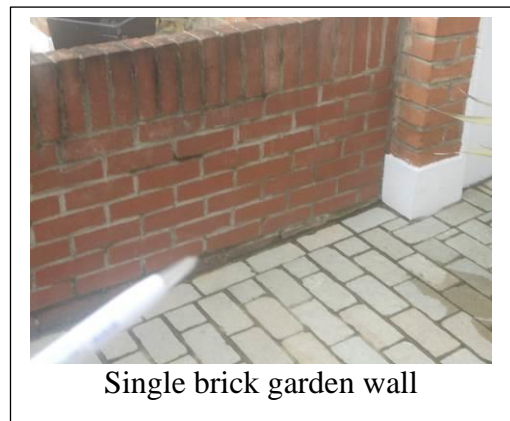
There is a small garden to the front of the property. The front garden had a single brick garden wall which are inherently unstable; you need to be aware of this.

Single brick garden wall

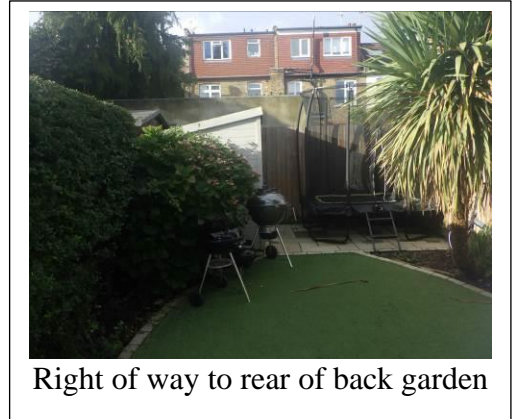
There looks to be a right of way to the rear of the property. Often these were originally used for delivering coal.

ACTION REQUIRED: Your legal advisor to check and confirm.
